Town of Germantown

Road-Stream Crossing Inventory & Management Plan

Town of Germantown Road-Stream Crossing Inventory

Executive Summary – December 2023

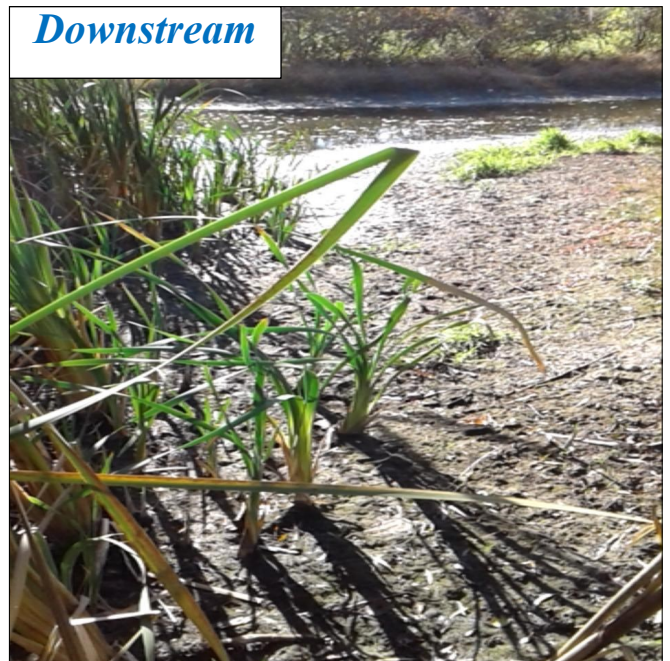
Scour Pool: None
Water Depth/Velocity Matches Stream:
Dry/Dry
Substrate Matches Stream: Comparable
Substrate Type: Silt
Substrate Coverage: 100%

Crossing Comments: Outlets to pond

Return Interval (Years)	Peak Flow (cfs)	Culvert Capacity (cfs)	Pass/Fail
2	3.1	0.6	FAIL
5	5.1	0.6	FAIL
25	9.1	0.6	FAIL
50	11.1	0.6	FAIL
100	13.2	0.6	FAIL
200	15.8	0.6	FAIL

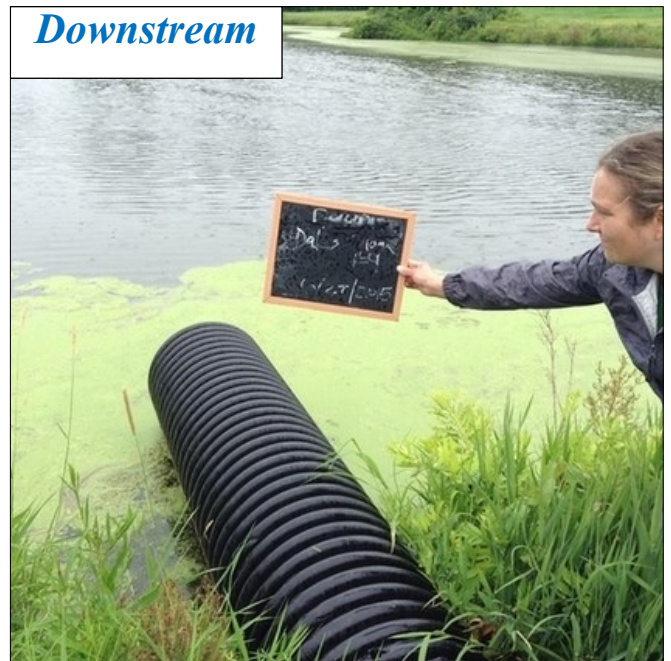
Scour Pool: None
Water Depth/Velocity Matches Stream:
Yes/Yes
Substrate Matches Stream: None
Substrate Type: None
Substrate Coverage: None

Crossing Comments: Culvert is open to storm drain half way down its length. Dammed pond with tail water starts 8 feet upstream.

Return Interval (Years)	Peak Flow (cfs)	Culvert Capacity (cfs)	Pass/Fail
2	2.8	0.4	FAIL
5	4.9	0.4	FAIL
25	9.1	0.4	FAIL
50	11.0	0.4	FAIL
100	13.2	0.4	FAIL
200	16.0	0.4	FAIL

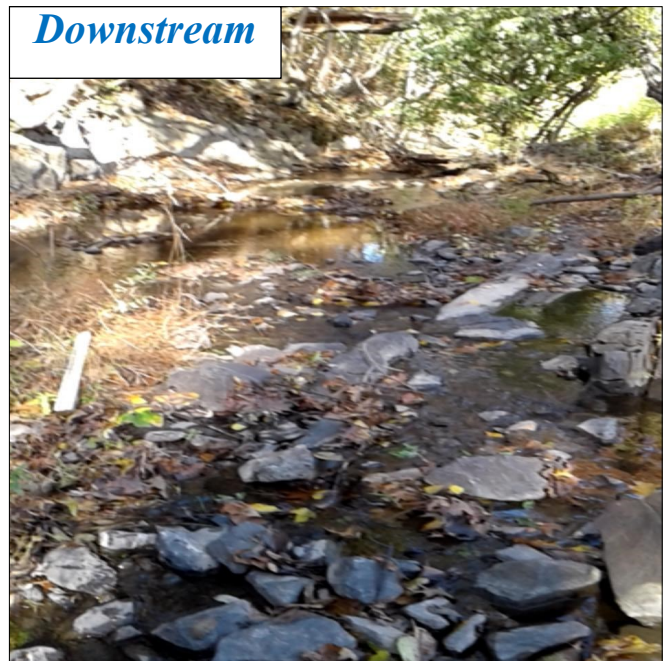
Scour Pool: Large
Water Depth/Velocity Matches Stream:
Dry/Dry
Substrate Matches Stream: None
Substrate Type: None
Substrate Coverage: None

Crossing Comments: Only one culvert with water

Return Interval (Years)	Peak Flow (cfs)	Culvert Capacity (cfs)	Pass/Fail
2	6.7	5.2	FAIL
5	16.0	5.2	FAIL
25	39.5	5.2	FAIL
50	50.5	5.2	FAIL
100	63.0	5.2	FAIL
200	78.9	5.2	FAIL

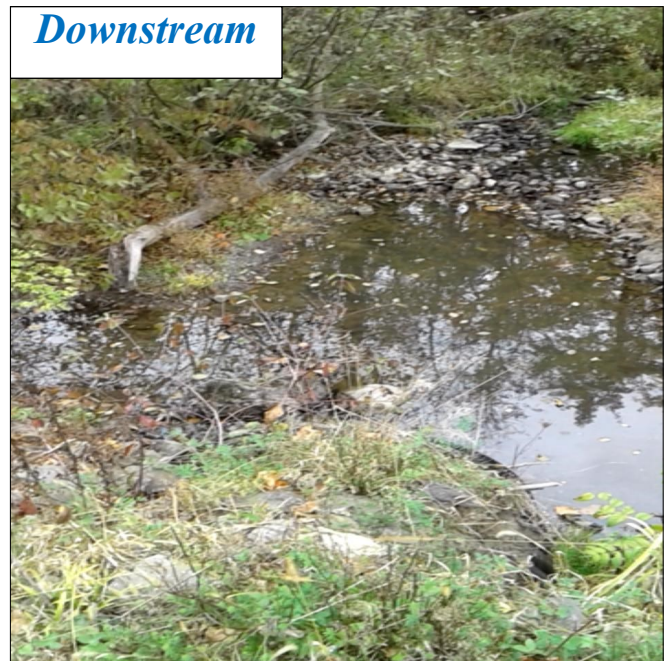
Scour Pool: Large
Water Depth/Velocity Matches Stream:
No-Shallower/Unknown
Substrate Matches Stream: None
Substrate Type: None
Substrate Coverage: None

Crossing Comments: 2 culverts

Return Interval (Years)	Peak Flow (cfs)	Culvert Capacity (cfs)	Pass/Fail
2	6.8	1.7	FAIL
5	16.1	1.7	FAIL
25	39.7	1.7	FAIL
50	50.8	1.7	FAIL
100	63.3	1.7	FAIL
200	79.3	1.7	FAIL

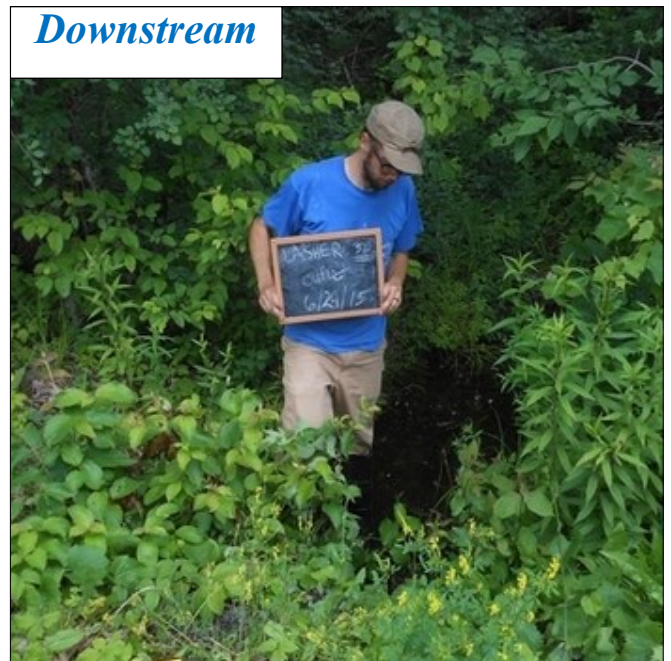
Scour Pool: Small
Water Depth/Velocity Matches Stream:
No-Shallower/Yes
Substrate Matches Stream: Contrasting
Substrate Type: Gravel
Substrate Coverage: Unknown

Crossing Comments: stagnant water - unsure which side is the inlet and which is the outlet

Return Interval (Years)	Peak Flow (cfs)	Culvert Capacity (cfs)	Pass/Fail
2	0.2	0.2	FAIL
5	0.3	0.2	FAIL
25	0.6	0.2	FAIL
50	0.7	0.2	FAIL
100	0.8	0.2	FAIL
200	1.0	0.2	FAIL

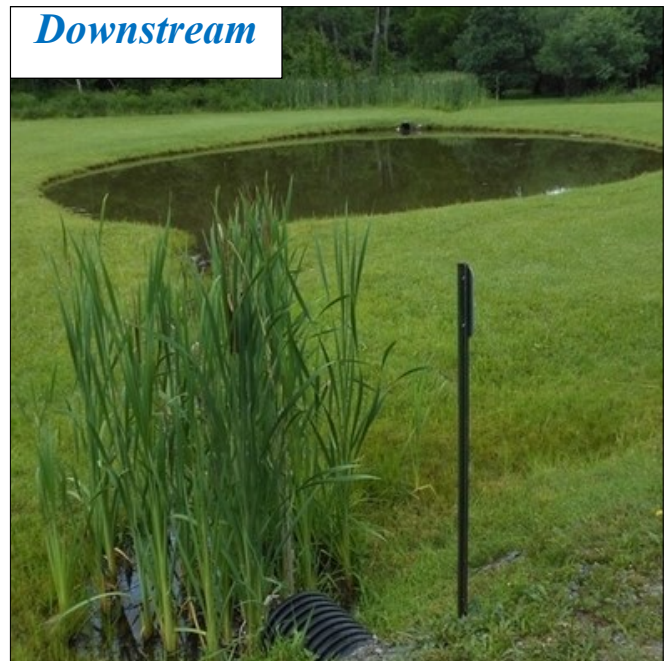
Crossing Comments: Took slope at outlet; Pond just upstream of culvert

Return Interval (Years)	Peak Flow (cfs)	Culvert Capacity (cfs)	Pass/Fail
2	0.2	0.2	FAIL
5	0.4	0.2	FAIL
25	0.7	0.2	FAIL
50	0.9	0.2	FAIL
100	1.0	0.2	FAIL
200	1.2	0.2	FAIL

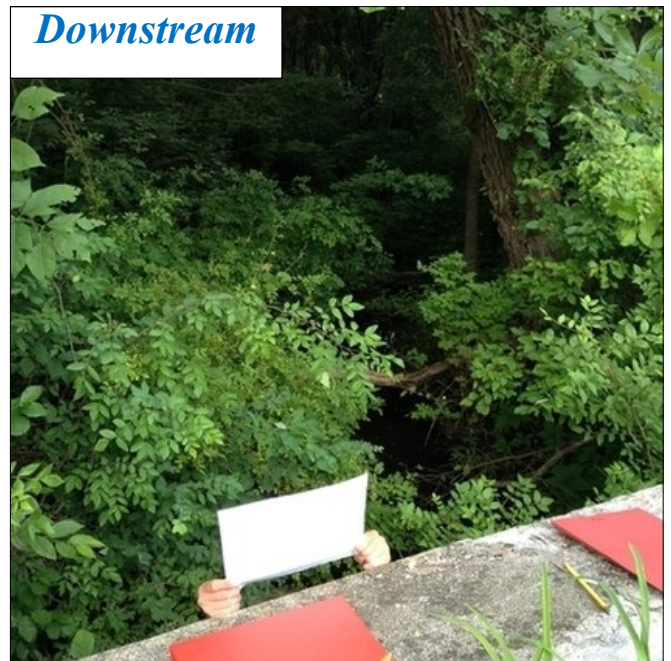
Scour Pool: Small
Water Depth/Velocity Matches Stream:
Yes/Yes
Substrate Matches Stream: Comparable
Substrate Type: Silt
Substrate Coverage: 100%

Crossing Comments: Inlet is broken and angled at 45 degrees to abutments

Return Interval (Years)	Peak Flow (cfs)	Culvert Capacity (cfs)	Pass/Fail
2	1.1	1.0	FAIL
5	2.7	1.0	FAIL
25	6.3	1.0	FAIL
50	8.0	1.0	FAIL
100	9.9	1.0	FAIL
200	12.3	1.0	FAIL

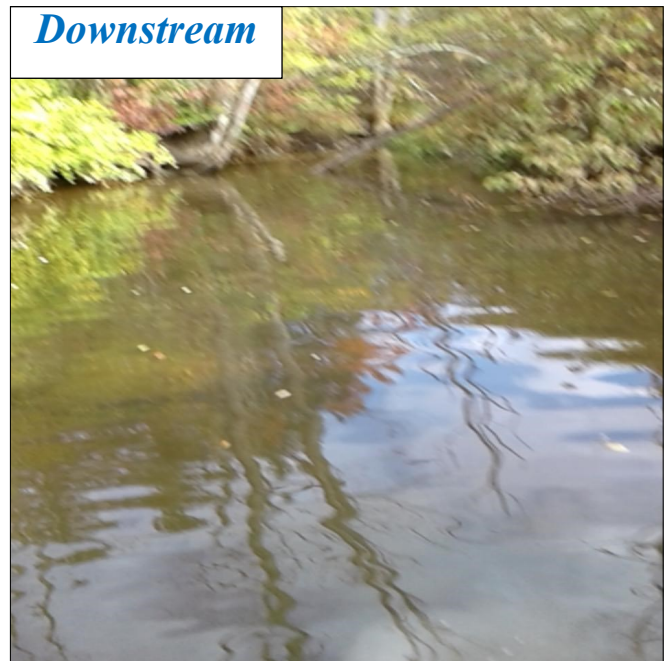
Scour Pool: Small
Water Depth/Velocity Matches Stream:
No-Shallower/No-Faster
Substrate Matches Stream: None
Substrate Type: None
Substrate Coverage: None

Crossing Comments: Broken outlet wingwalls

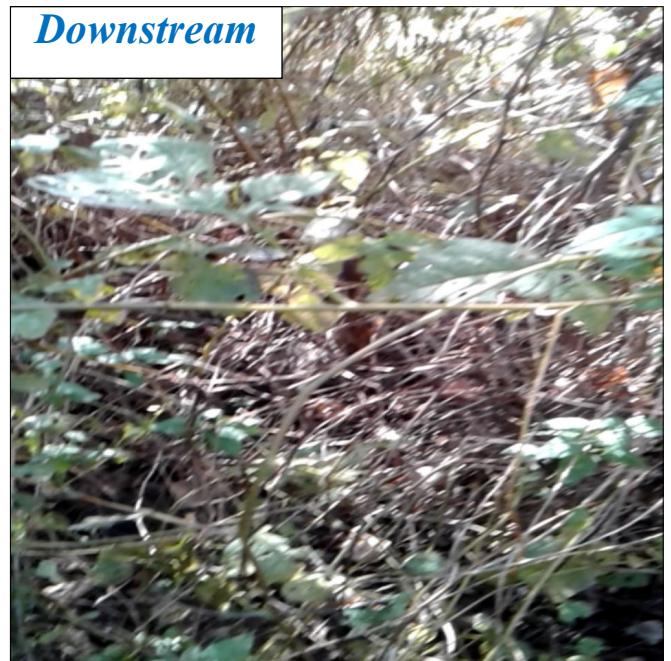
Scour Pool: Small
Water Depth/Velocity Matches Stream:
Dry/Dry
Substrate Matches Stream: None
Substrate Type: None
Substrate Coverage: None

Crossing Comments: Old concrete culvert

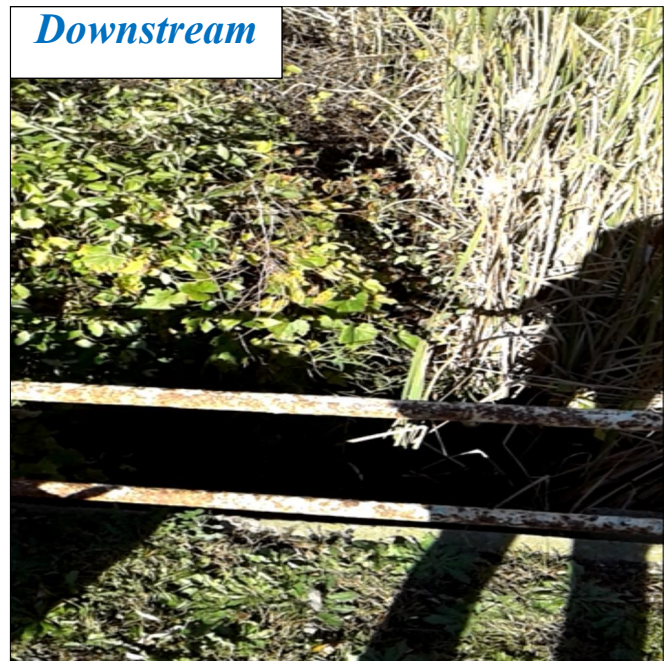
Scour Pool: None
Water Depth/Velocity Matches Stream:
Unknown/Unknown
Substrate Matches Stream: Comparable
Substrate Type: Silt
Substrate Coverage: 100%

Crossing Comments: New bridge over old 3ft dam upstream of inlet

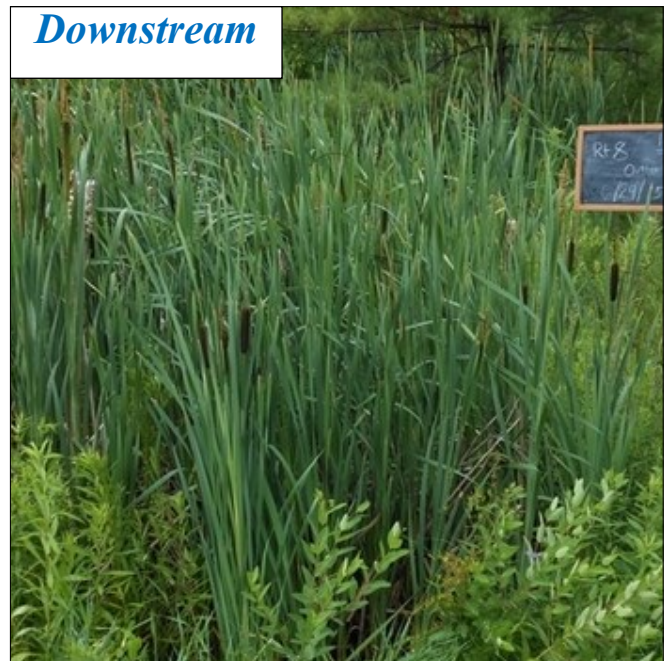
Scour Pool: Small
Water Depth/Velocity Matches Stream:
Yes/Yes
Substrate Matches Stream: Comparable
Substrate Type: Silt
Substrate Coverage: 100%

Crossing Comments: Culvert drains to seeping wetland

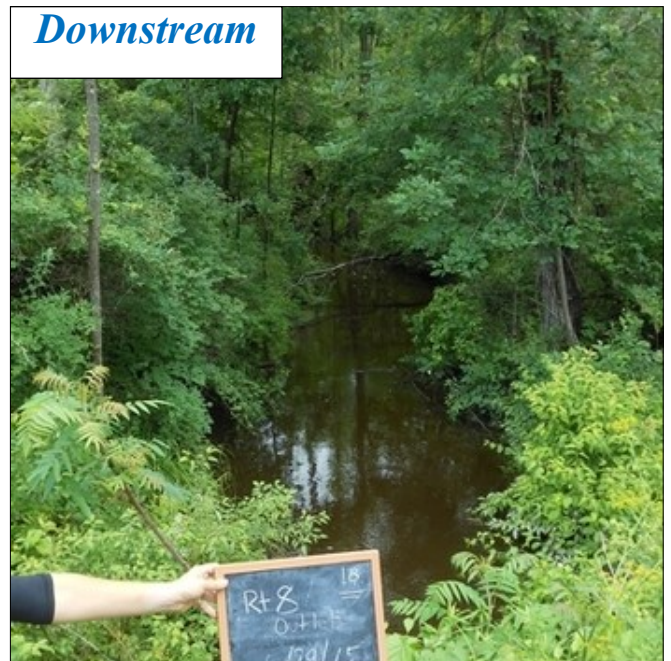
Scour Pool: Large
Water Depth/Velocity Matches Stream:
Yes/Yes
Substrate Matches Stream: None
Substrate Type: None
Substrate Coverage: None

Crossing Comments: Old Bridge Crossing to Left when facing upstream (on right when facing downstream)= Structure #2

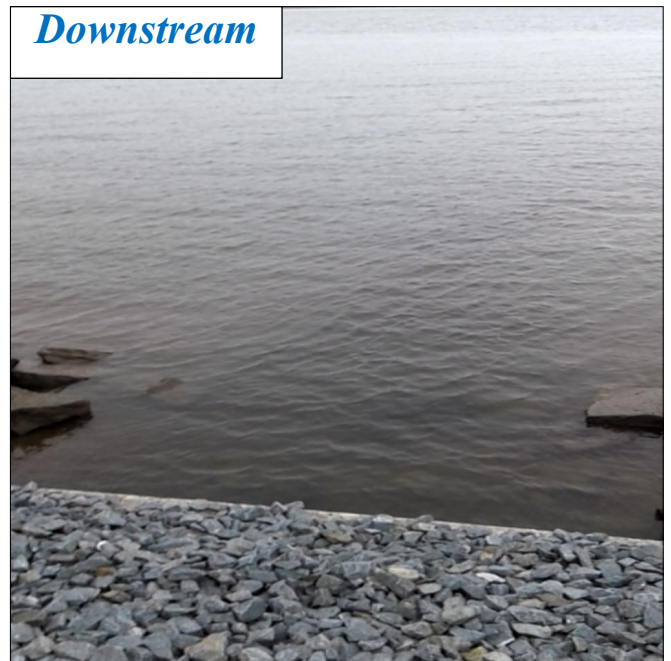
Scour Pool: Small
Water Depth/Velocity Matches Stream:
Unknown/Unknown
Substrate Matches Stream: Contrasting
Substrate Type: Gravel
Substrate Coverage: 100%

Crossing Comments: Crossing drains tidal bay
