Town of Germantown

Road-Stream Crossing Inventory & Management Plan

Town of Germantown Road-Stream Crossing Inventory

Executive Summary – December 2023

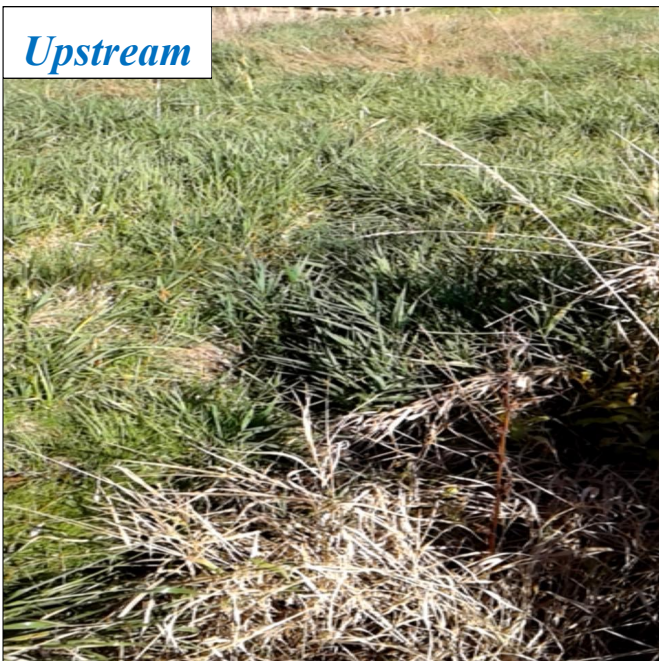
Upstream

Barrier Evaluation: Insignificant barrier
Aquatic Organism Passage Score: Reduced
AOP
Condition/Maintenance: OK
Max Return Interval: 0

Scour Pool: None
Water Depth/Velocity Matches Stream: Dry/Dry
Substrate Matches Stream: Comparable
Substrate Type: Silt
Substrate Coverage: 100%

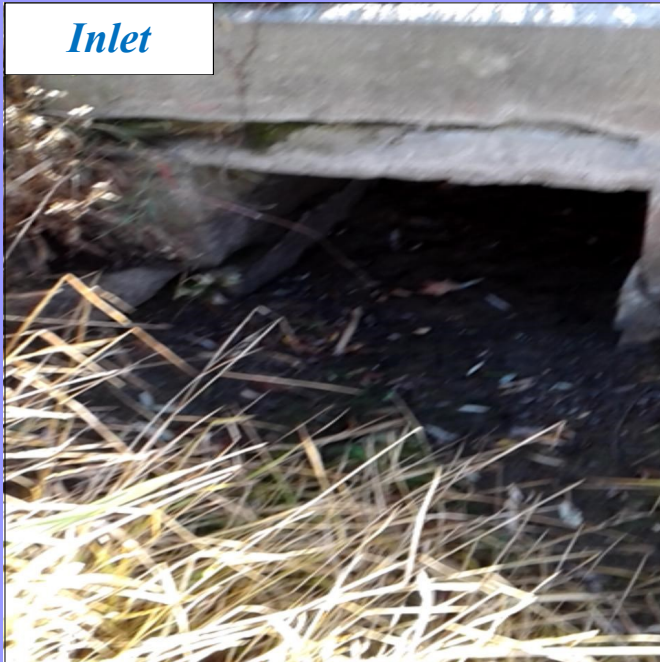
Inlet Shape/Type: Box Culvert, Headwall
 Inlet Drop/Grade: At Stream Grade
 Width: 2.3, Height: 2.0
 Substrate/Water Width: 2.30
 Water Depth: 0.00

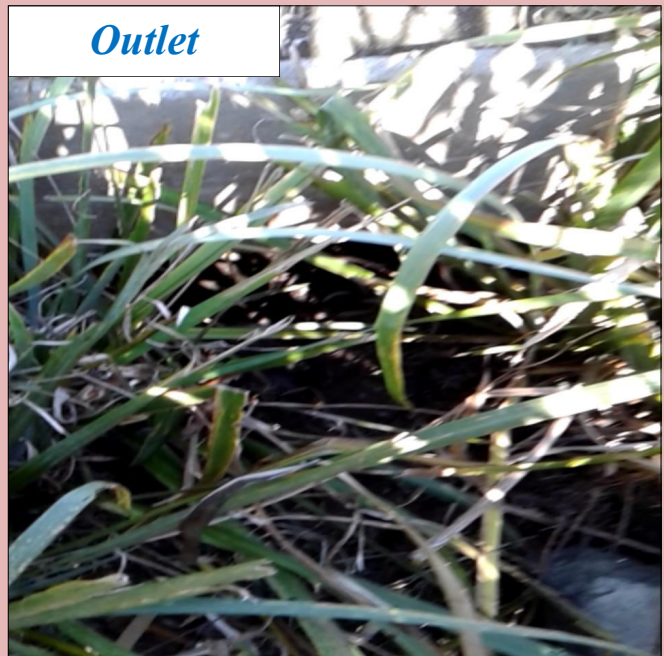
Outlet Shape:
 Outlet Drop/Grade: At Stream Grade
 Drop to Stream Surface/Bottom: 0.00/0.00
 Width: 2.0, Height: 1.5
 Substrate/Water Width: 1.50
 Water Depth: 0.00

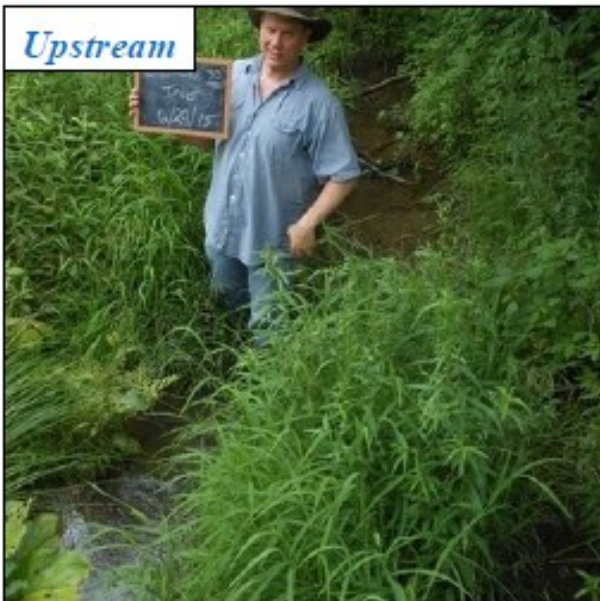
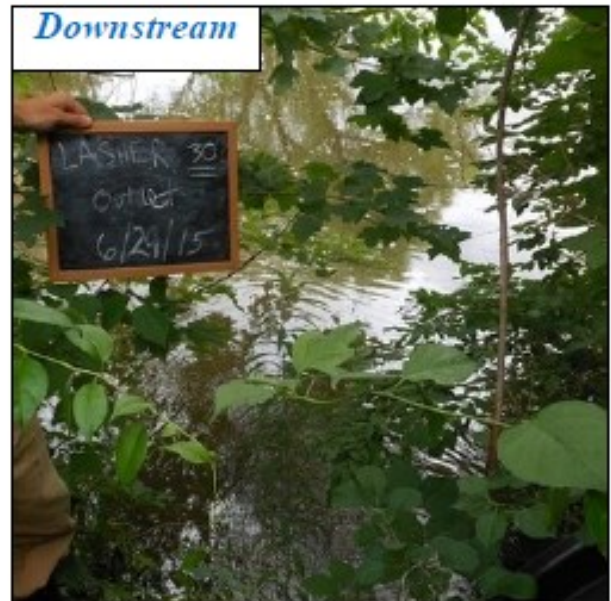
Barrier Evaluation: Severe barrier
Aquatic Organism Passage Score: No AOP
Condition/Maintenance: OK
Max Return Interval: 0

Scour Pool: Large
Water Depth/Velocity Matches Stream: Yes/Yes
Substrate Matches Stream: None
Substrate Type: None
Substrate Coverage: None

Crossing Comments: no comments

Return Interval (Years)	Peak Flow (cfs)	Culvert Capacity (cfs)	Pass/Fail
2	2.1	1.0	FAIL
5	3.8	1.0	FAIL
25	7.6	1.0	FAIL
50	9.2	1.0	FAIL
100	11.1	1.0	FAIL
200	13.5	1.0	FAIL

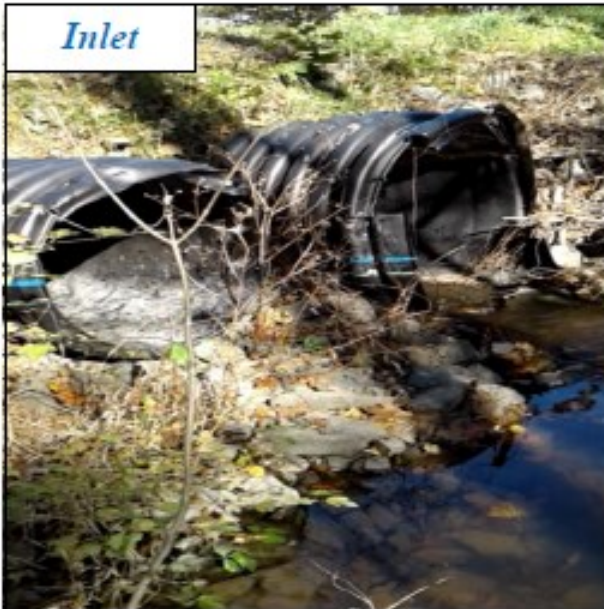
Barrier Evaluation: Severe barrier
Aquatic Organism Passage Score: No AOP
Condition/Maintenance: OK
Max Return Interval: 2

Scour Pool: Large
Water Depth/Velocity Matches Stream:
Dry/Dry
Substrate Matches Stream: None
Substrate Type: None
Substrate Coverage: None

Crossing Comments: Only one culvert with water

Return Interval (Years)	Peak Flow (cfs)	Culvert Capacity (cfs)	Pass/Fail
2	6.7	5.2	FAIL
5	16.0	5.2	FAIL
25	39.5	5.2	FAIL
50	50.5	5.2	FAIL
100	63.0	5.2	FAIL
200	78.9	5.2	FAIL

Inlet Shape/Type: Round Culvert, Projecting
 Inlet Drop/Grade: Perched
 Width: 3.0, Height: 3.0
 Substrate/Water Width: 0.00
 Water Depth: 0.00

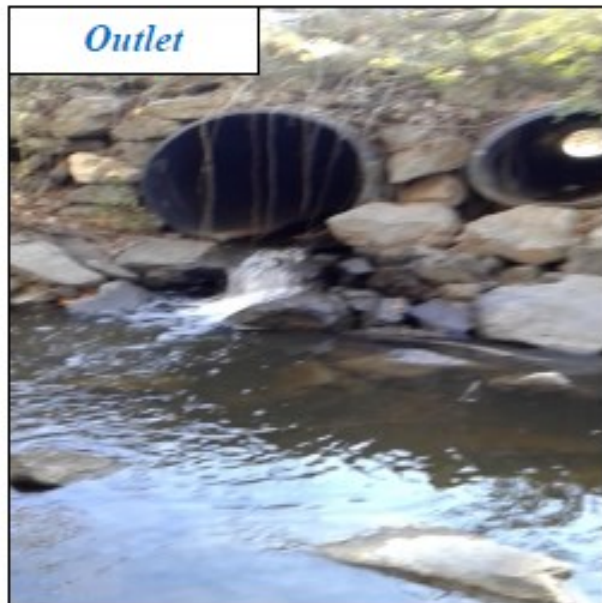
Slope Matches Stream (%): No data
 Structure Comments: No data
 Outlet Armoring: Extensive

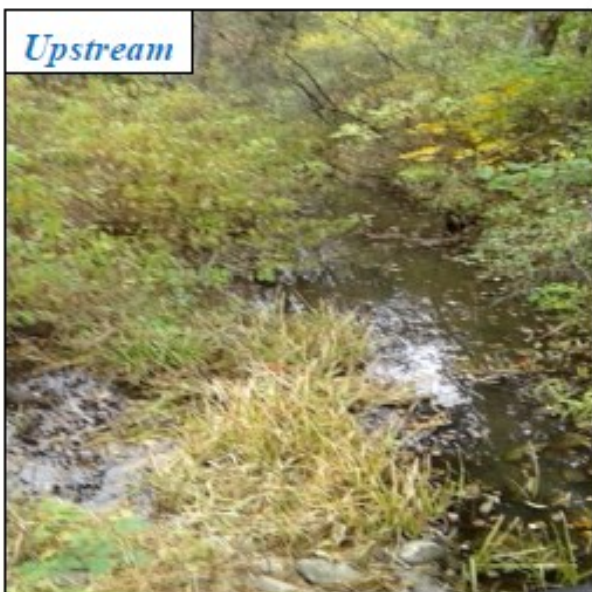
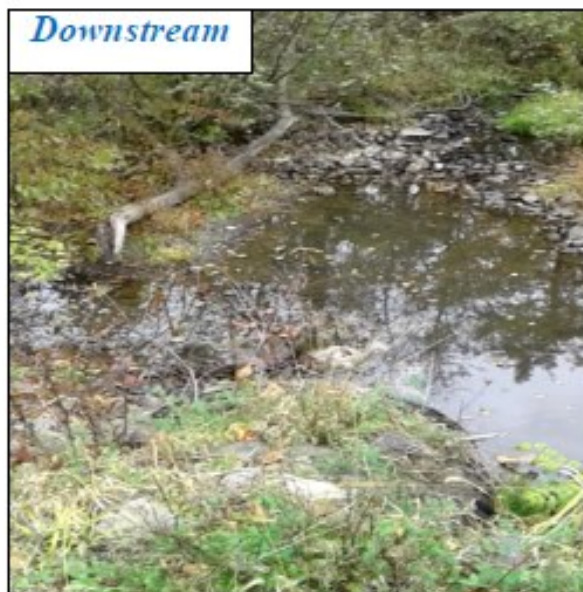
Barrier Evaluation: Significant barrier
Aquatic Organism Passage Score: No AOP
Condition/Maintenance: Poor
Max Return Interval: 1

Scour Pool: Large
Water Depth/Velocity Matches Stream: No-Shallower/Unknown
Substrate Matches Stream: None
Substrate Type: None
Substrate Coverage: None

Crossing Comments: 2 culverts

Return Interval (Years)	Peak Flow (cfs)	Culvert Capacity (cfs)	Pass/Fail
2	6.8	1.7	FAIL
5	16.1	1.7	FAIL
25	39.7	1.7	FAIL
50	50.8	1.7	FAIL
100	63.3	1.7	FAIL
200	79.3	1.7	FAIL

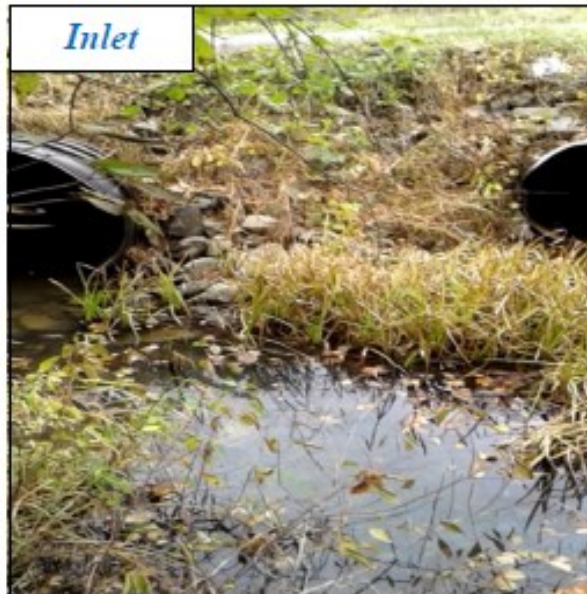
Inlet

Structure Comments: Culvert not level

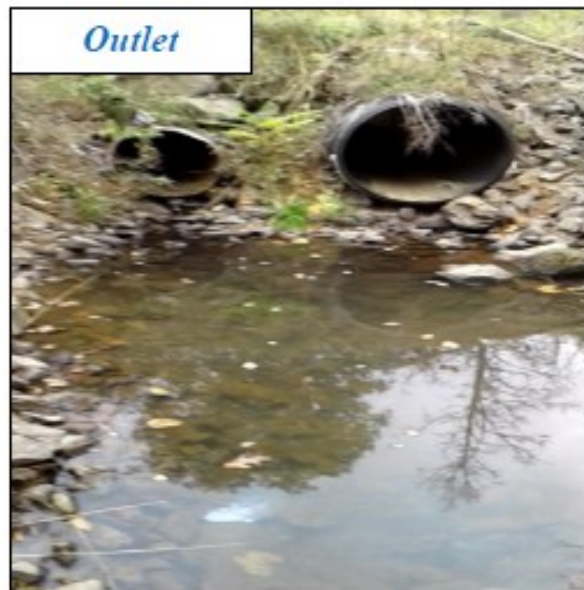
Outlet Armoring: Not Extensive

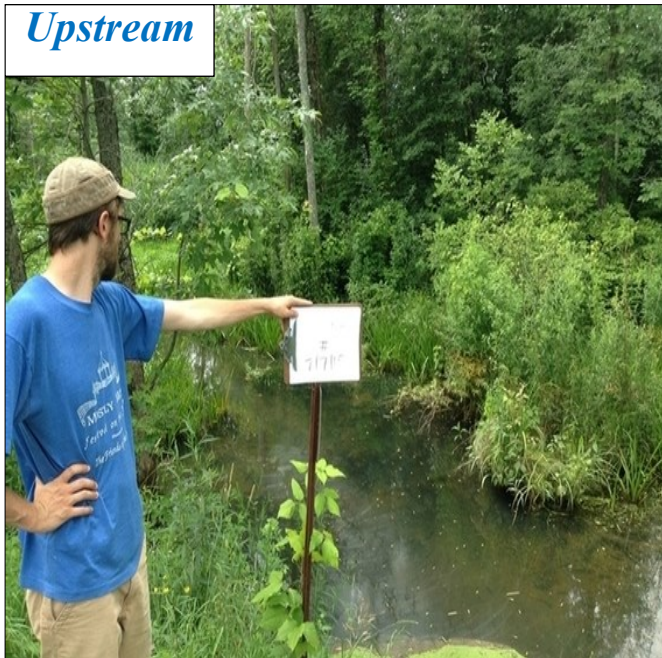
Upstream

Crossing Comments: Large wetland up/down stream. Water ~4 feet deep. In/out submerged.
UNABLE TO MEASURE

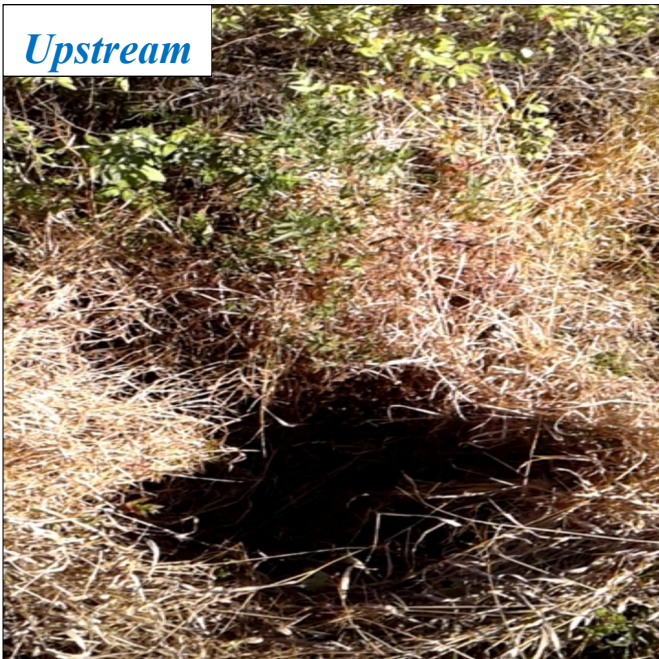
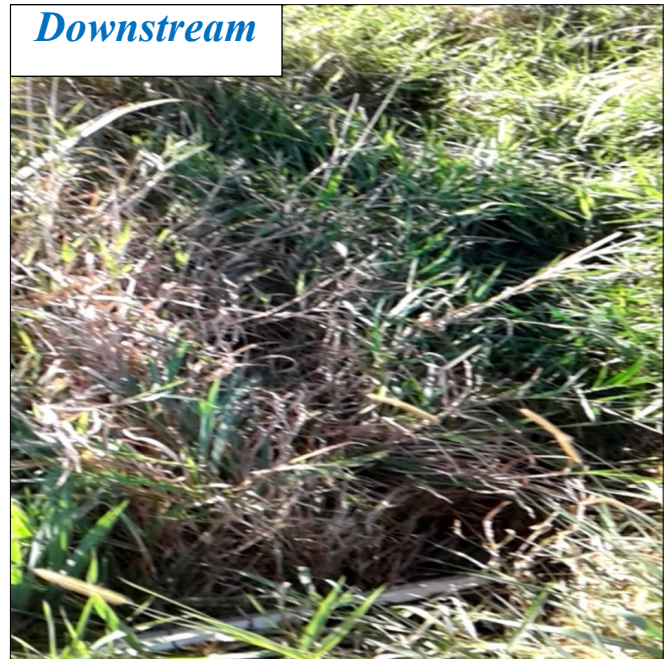
Crossing Comments: Heavy vegetation

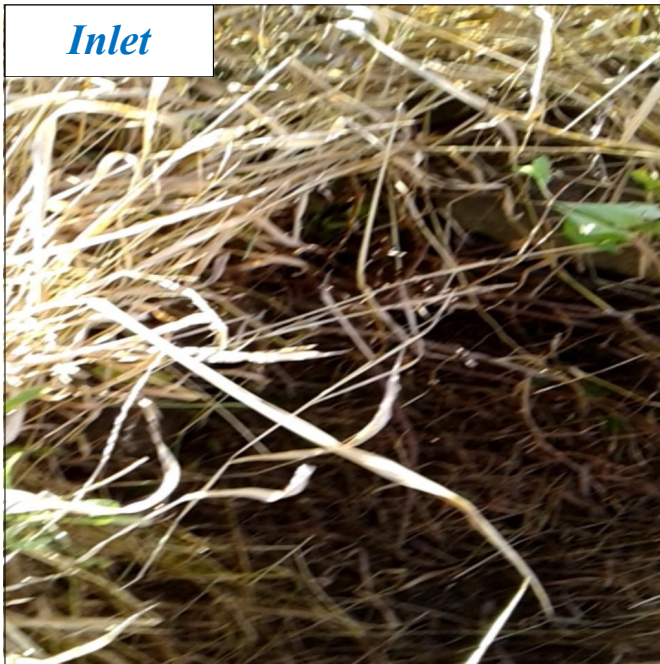
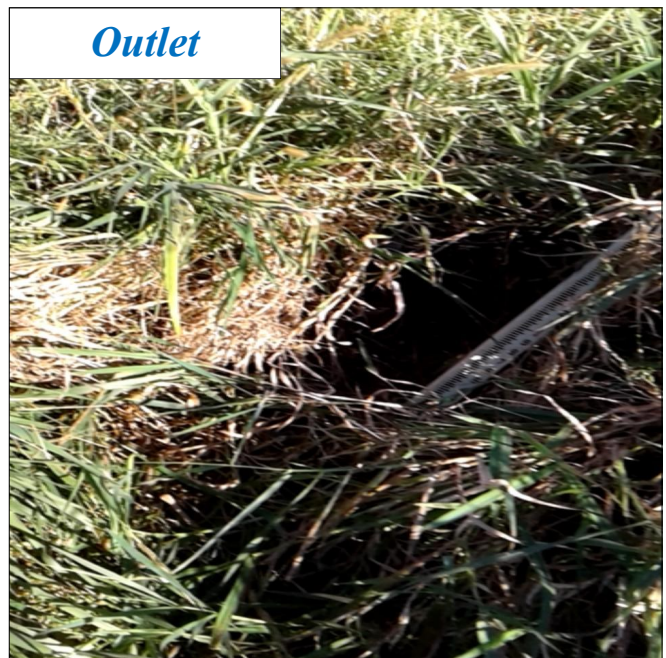
Slope Matches Stream (%): No data
 Structure Comments: Culvert outlets pond
 Outlet Armoring: None

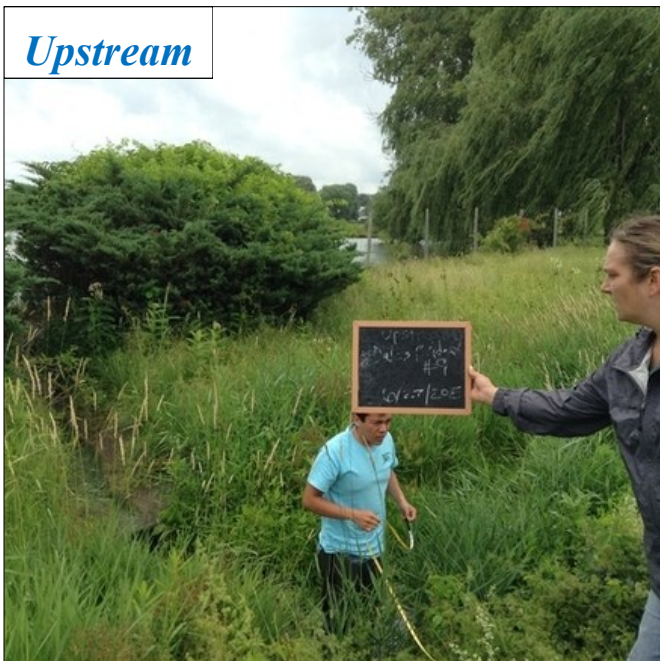
Crossing Comments: Culvert is open to storm drain half way down its length. Dammed pond with tail water starts 8 feet upstream.

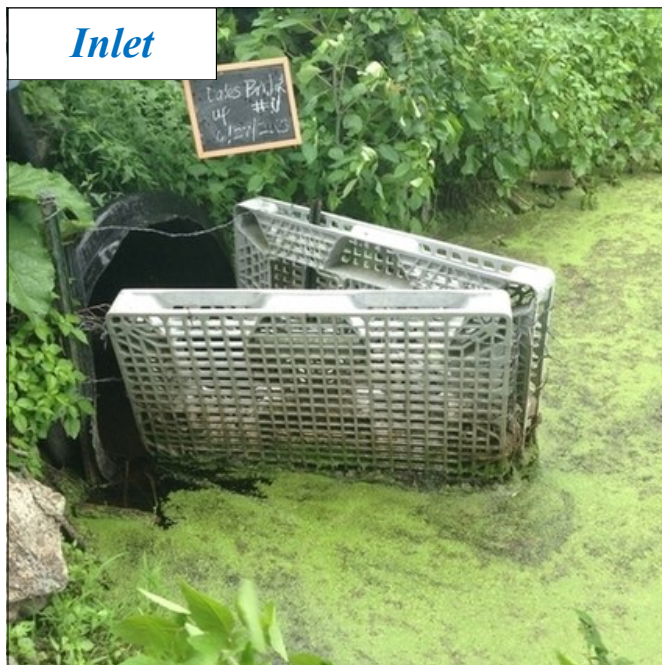
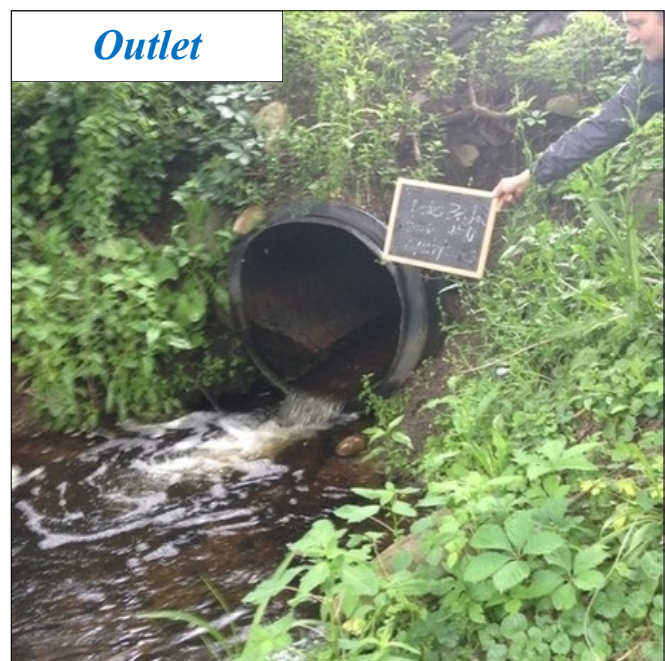
Slope Matches Stream (%): 5.1
 Structure Comments: Pipe seems slightly bent in the middle.

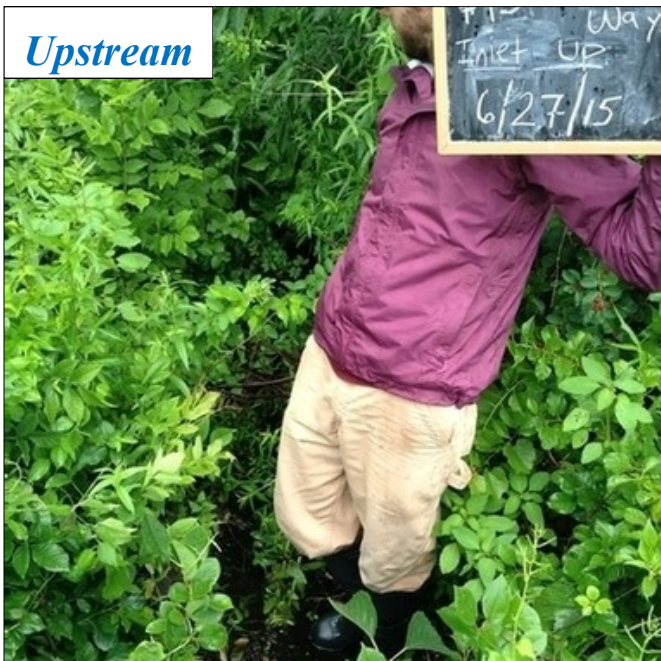
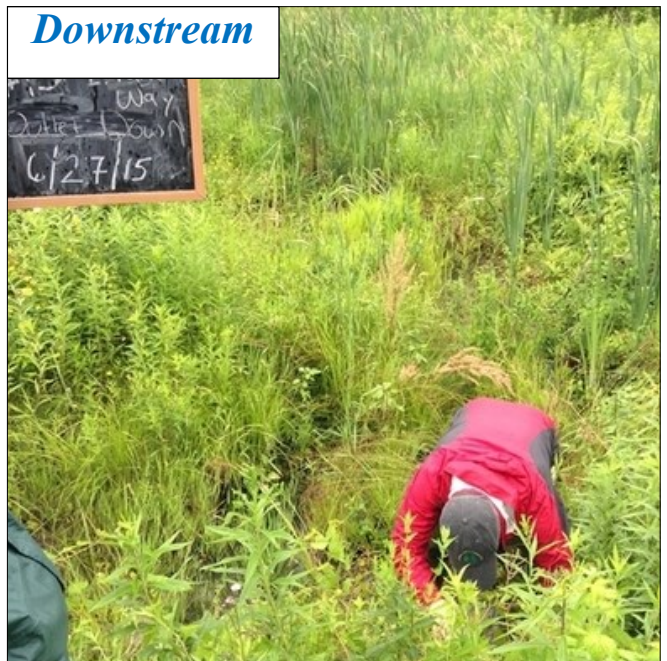
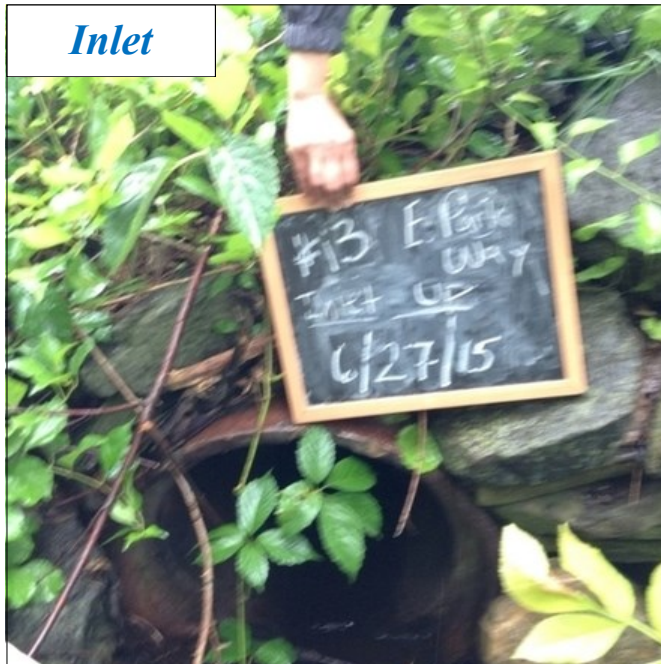
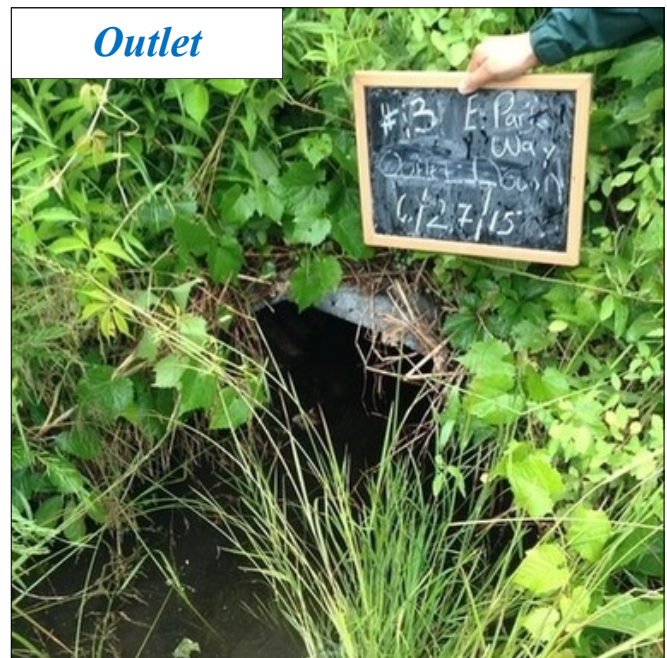
Coordinates: 42.14081, -73.85129
Location Description: none
Date Observed: 6/27/2015
Survey ID: 20607

Barrier Evaluation: Moderate barrier
Aquatic Organism Passage Score: Reduced
AOP
Condition/Maintenance: Poor
Max Return Interval: 1

Scour Pool: Large
Water Depth/Velocity Matches Stream:
No-Deeper/Yes
Substrate Matches Stream: None
Substrate Type: None
Substrate Coverage: None

Return Interval (Years)	Peak Flow (cfs)	Culvert Capacity (cfs)	Pass/Fail
2	1.0	0.7	FAIL
5	1.7	0.7	FAIL
25	3.2	0.7	FAIL
50	3.9	0.7	FAIL
100	4.7	0.7	FAIL
200	5.6	0.7	FAIL

Slope Matches Stream (%): 2.7
 Structure Comments: 2 different culvert materials- metal outlet cannot be seen

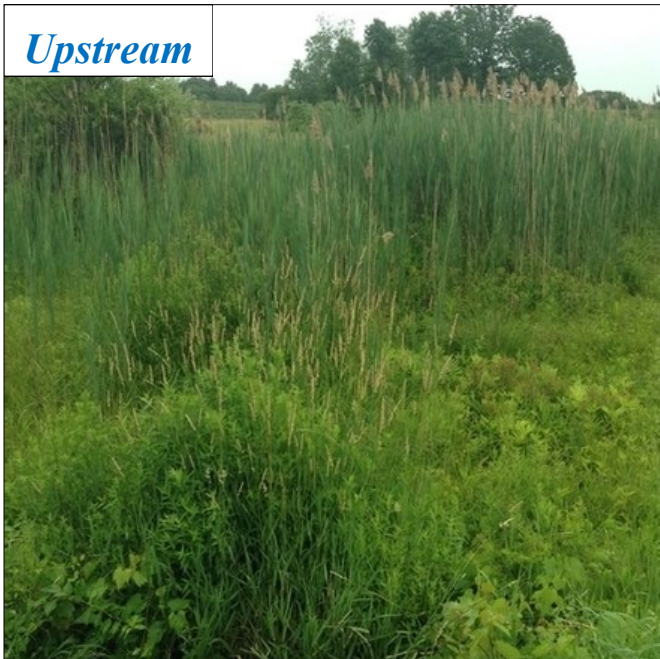
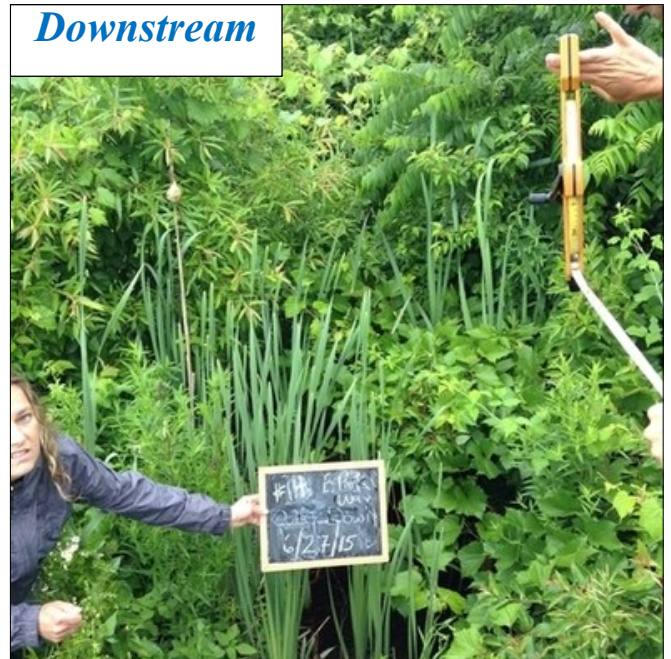
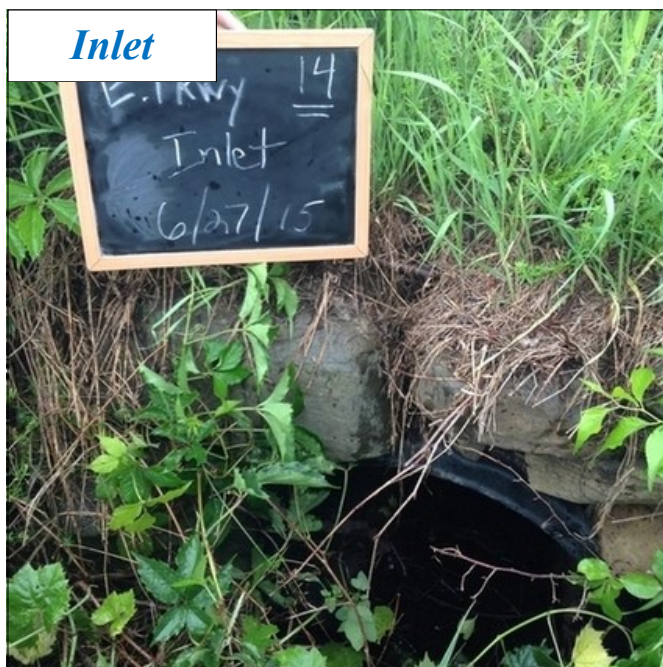
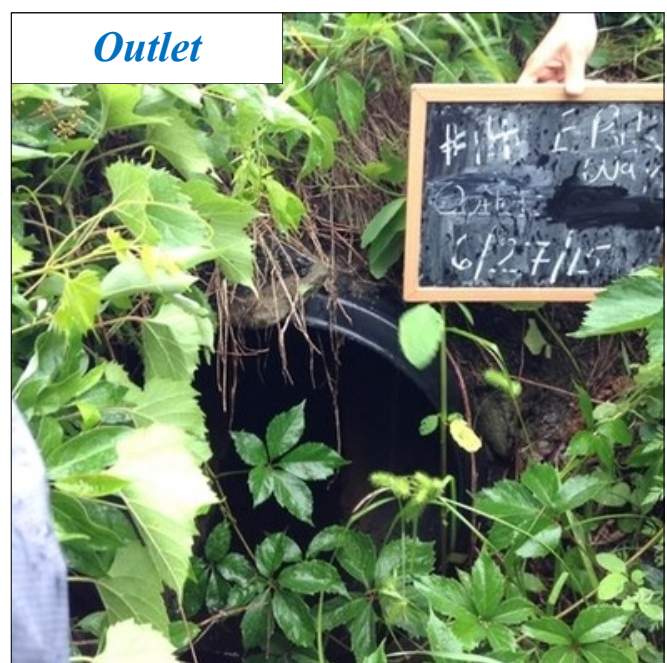
Coordinates: 42.13787, -73.85048
Location Description: 150 East Parkway
Date Observed: 6/27/2015
Survey ID: 20614

Barrier Evaluation: Moderate barrier
Aquatic Organism Passage Score: No AOP
Condition/Maintenance: OK
Max Return Interval: 1

Scour Pool: None
Water Depth/Velocity Matches Stream:
No-Shallower/No-Faster
Substrate Matches Stream: None
Substrate Type: None
Substrate Coverage: None

Return Interval (Years)	Peak Flow (cfs)	Culvert Capacity (cfs)	Pass/Fail
2	1.1	0.7	FAIL
5	2.5	0.7	FAIL
25	5.6	0.7	FAIL
50	7.1	0.7	FAIL
100	8.7	0.7	FAIL
200	10.7	0.7	FAIL

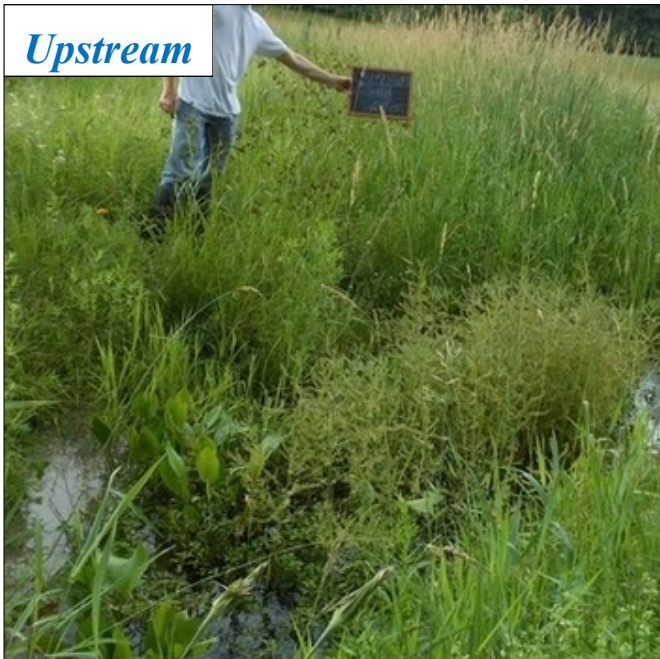
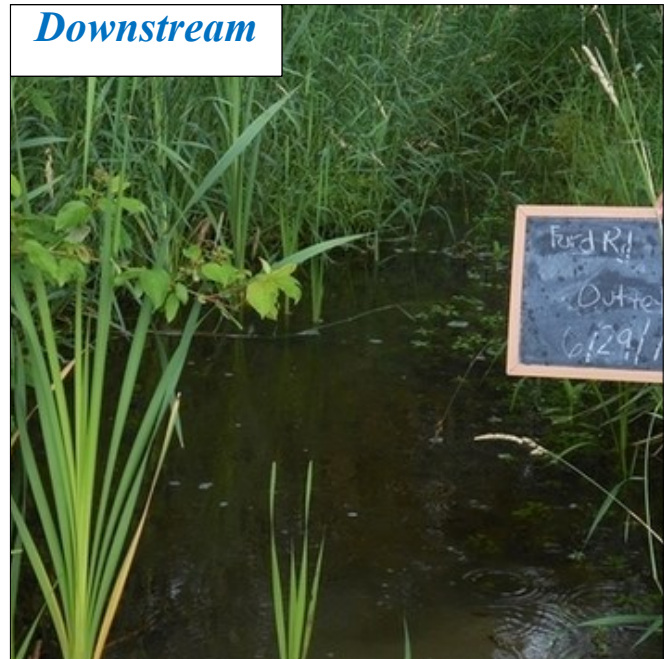
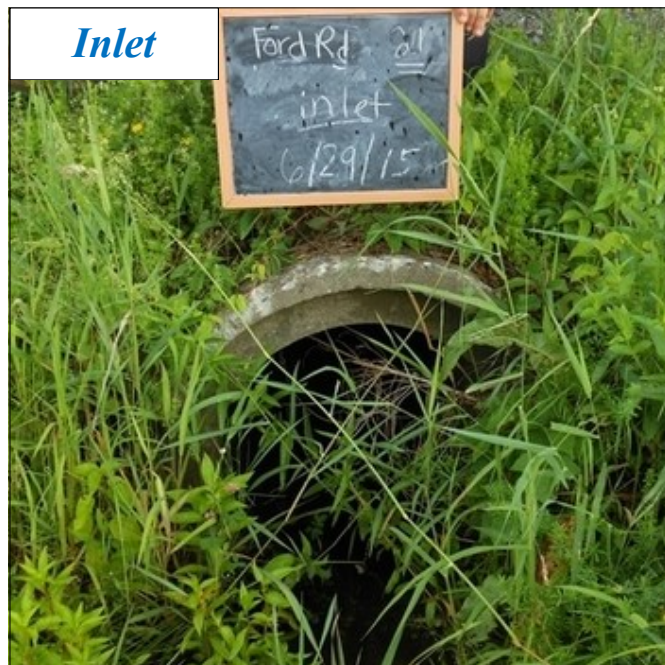
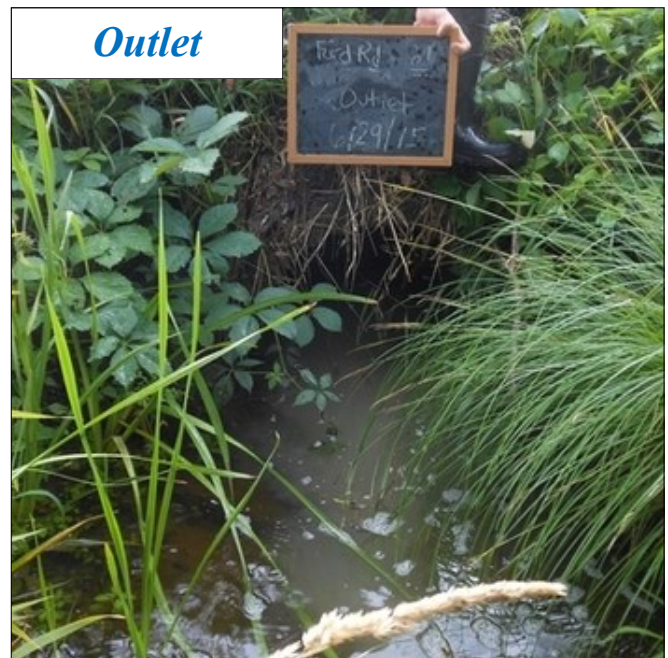
Coordinates: 42.13305, -73.85008
Location Description: located a couple hundred feet from Eastern Parkway
Date Observed: 6/29/2015
Survey ID: 29347

Barrier Evaluation: Minor barrier
Aquatic Organism Passage Score: Reduced AOP
Condition/Maintenance: OK
Max Return Interval: 0

Scour Pool: Large
Water Depth/Velocity Matches Stream: Yes/Yes
Substrate Matches Stream: None
Substrate Type: None
Substrate Coverage: None

Return Interval (Years)	Peak Flow (cfs)	Culvert Capacity (cfs)	Pass/Fail
2	2.2	0.6	FAIL
5	3.9	0.6	FAIL
25	7.8	0.6	FAIL
50	9.4	0.6	FAIL
100	11.3	0.6	FAIL
200	13.8	0.6	FAIL

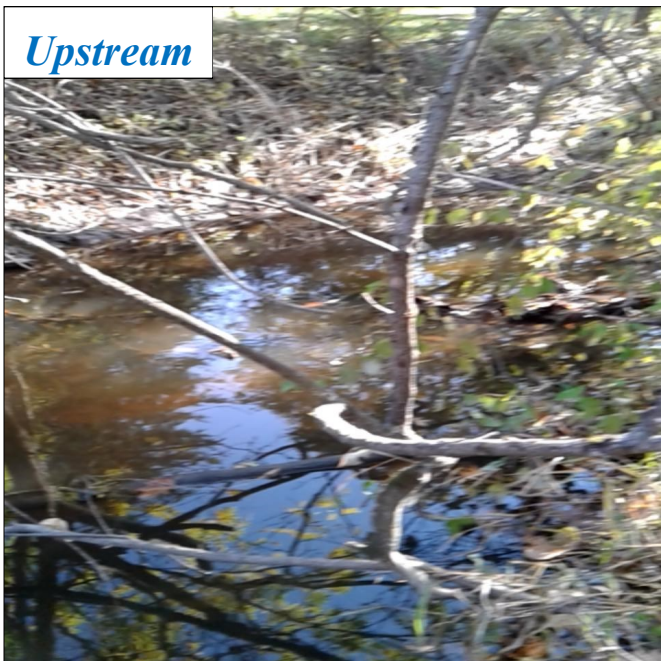
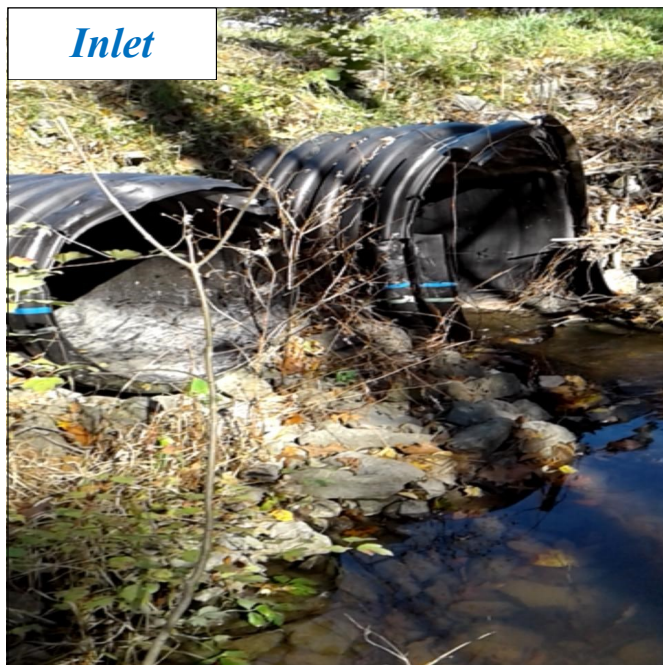
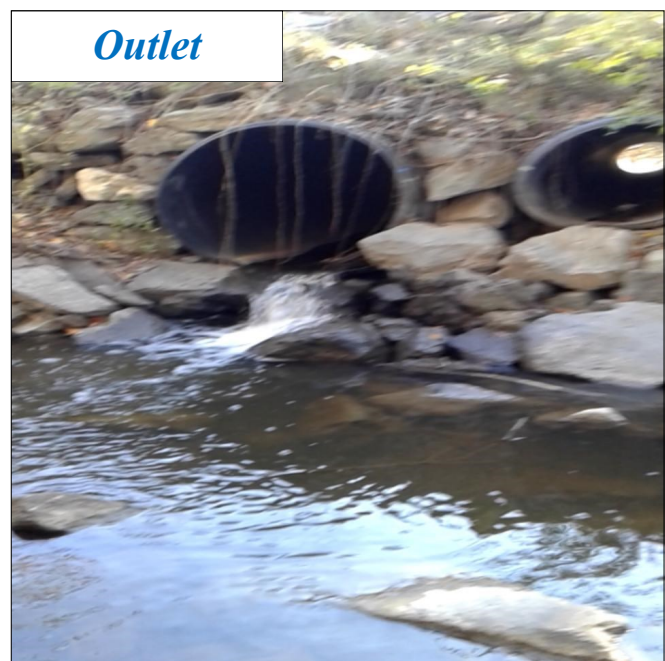
Coordinates: 42.12083, -73.90211
Location Description: Hunterstown north
Date Observed: 10/31/2017
Survey ID: 55728

Barrier Evaluation: Severe barrier
Aquatic Organism Passage Score: No AOP
Condition/Maintenance: OK
Max Return Interval: 2

Scour Pool: Large
Water Depth/Velocity Matches Stream:
Dry/Dry
Substrate Matches Stream: None
Substrate Type: None
Substrate Coverage: None

Crossing Comments: Only one culvert with water

Return Interval (Years)	Peak Flow (cfs)	Culvert Capacity (cfs)	Pass/Fail
2	6.7	5.2	FAIL
5	16.0	5.2	FAIL
25	39.5	5.2	FAIL
50	50.5	5.2	FAIL
100	63.0	5.2	FAIL
200	78.9	5.2	FAIL

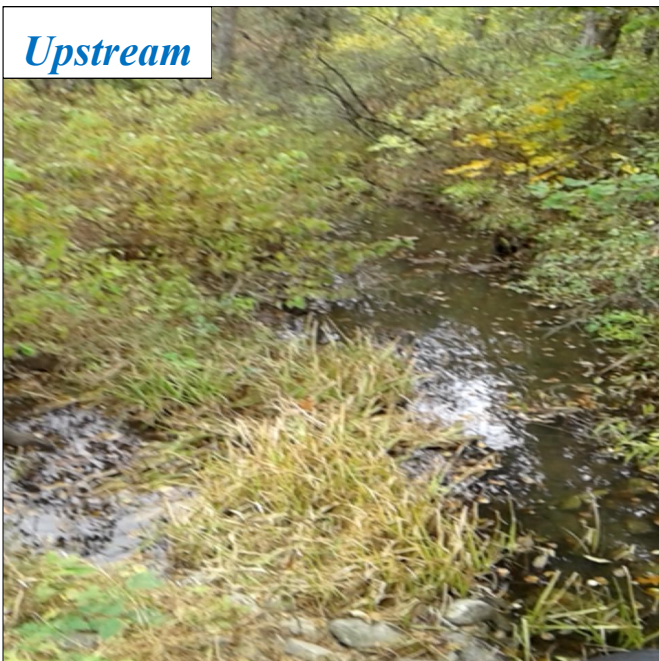
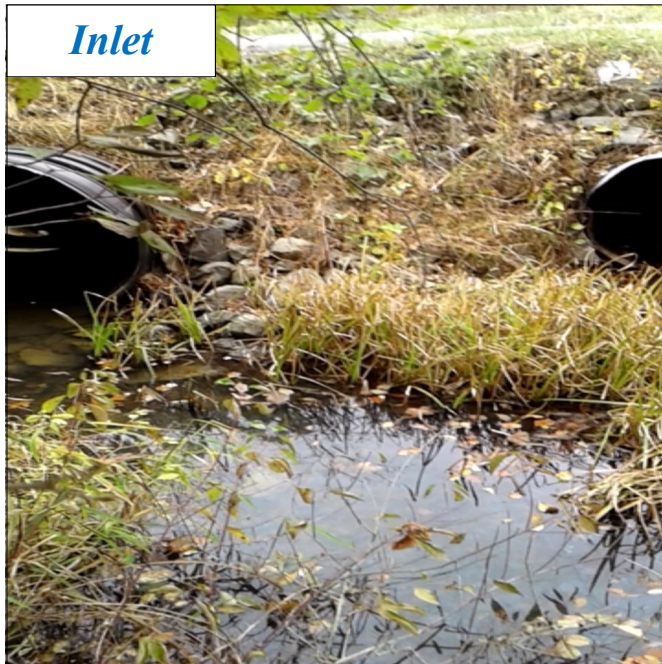
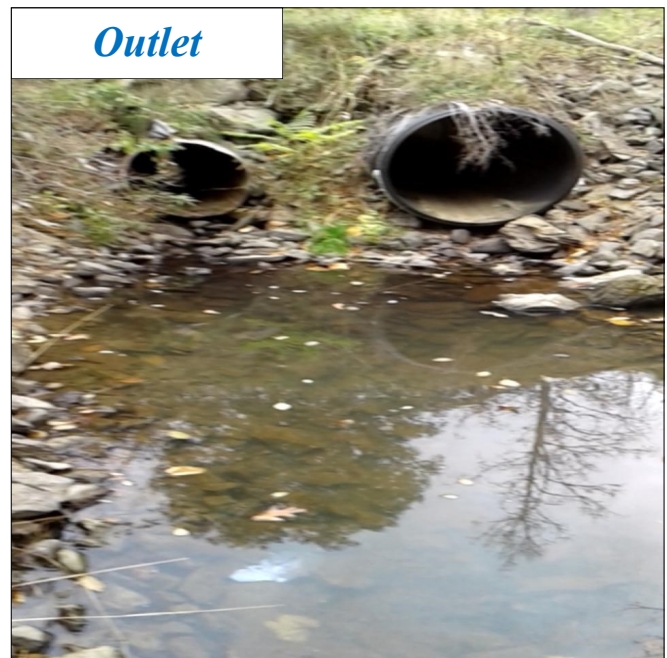
Coordinates: 42.11931, -73.90213
Location Description: Hunterstown
Date Observed: 10/23/2017
Survey ID: 55653

Barrier Evaluation: Significant barrier
Aquatic Organism Passage Score: No AOP
Condition/Maintenance: Poor
Max Return Interval: 1

Scour Pool: Large
Water Depth/Velocity Matches Stream:
No-Shallower/Unknown
Substrate Matches Stream: None
Substrate Type: None
Substrate Coverage: None

Crossing Comments: 2 culverts

Return Interval (Years)	Peak Flow (cfs)	Culvert Capacity (cfs)	Pass/Fail
2	6.8	1.7	FAIL
5	16.1	1.7	FAIL
25	39.7	1.7	FAIL
50	50.8	1.7	FAIL
100	63.3	1.7	FAIL
200	79.3	1.7	FAIL

Slope Matches Stream (%): No data
 Structure Comments: Culvert not level
 Outlet Armoring: Not Extensive

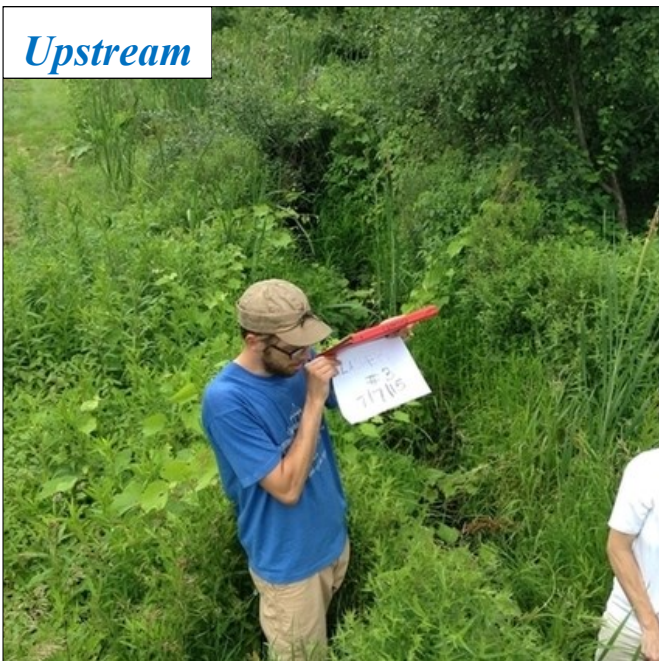
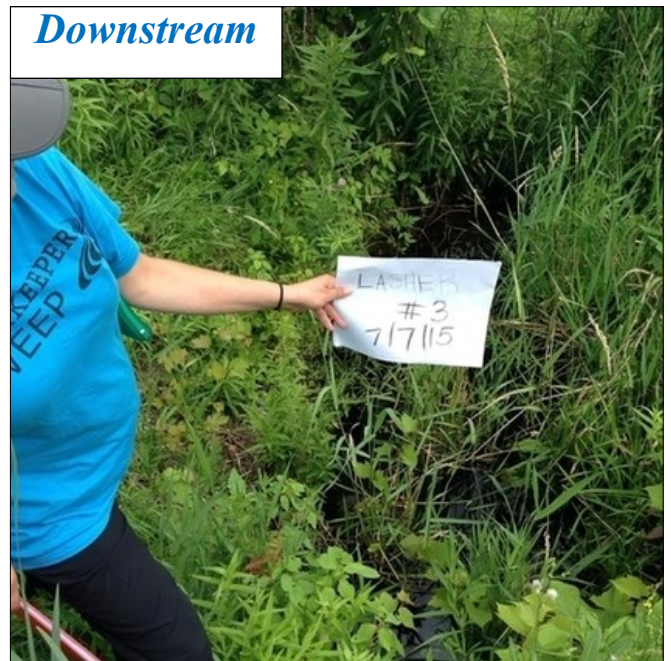
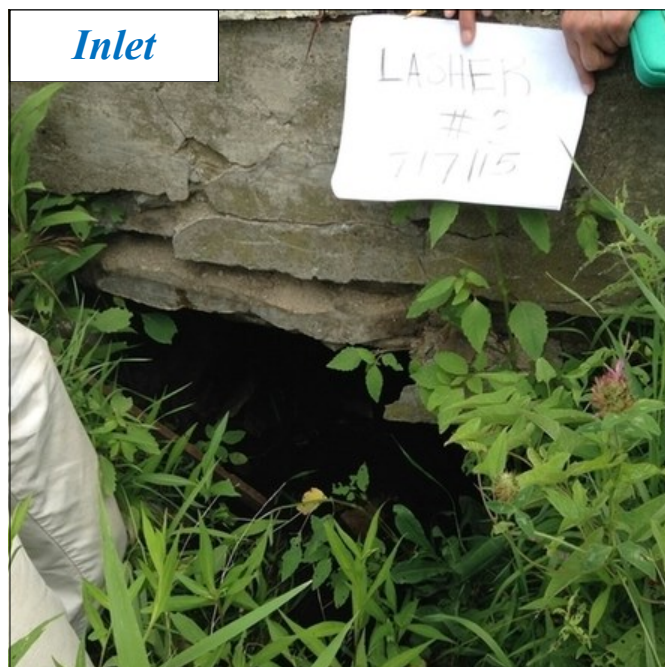
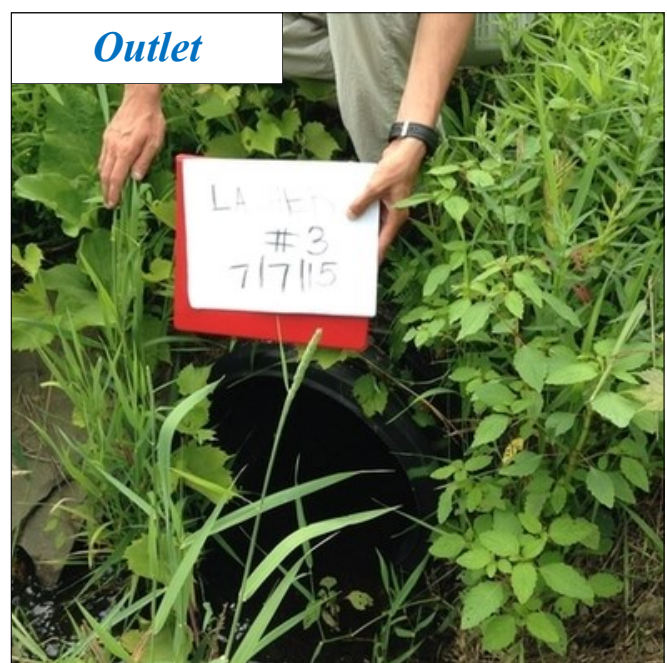
Barrier Evaluation: Minor barrier
Aquatic Organism Passage Score: Reduced
AOP
Condition/Maintenance: Poor
Max Return Interval: No data

Scour Pool: Small
Water Depth/Velocity Matches Stream:
No-Shallower/Yes
Substrate Matches Stream: Contrasting
Substrate Type: Cobble
Substrate Coverage: 50%

Slope Matches Stream (%): 1
 Structure Comments: none
 Outlet Armoring: None

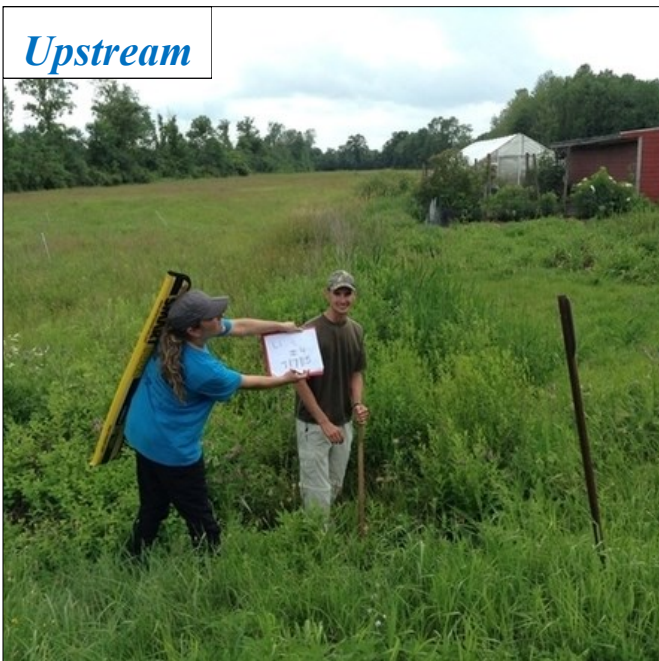
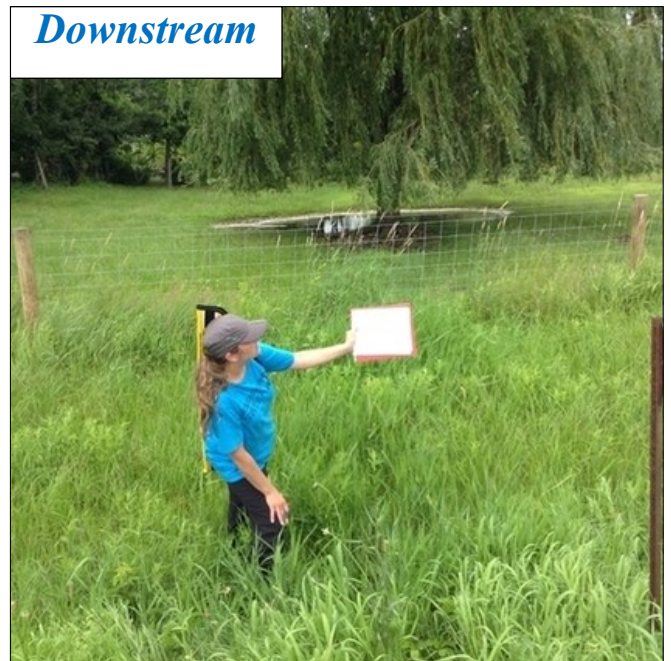
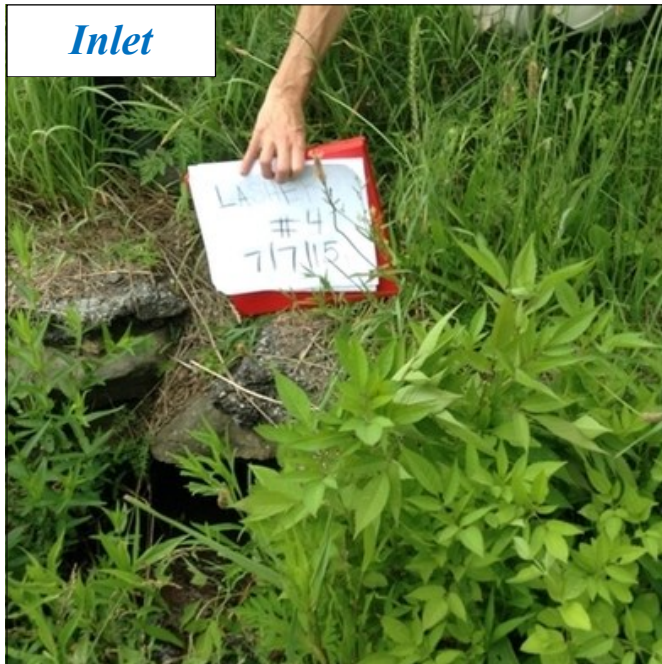
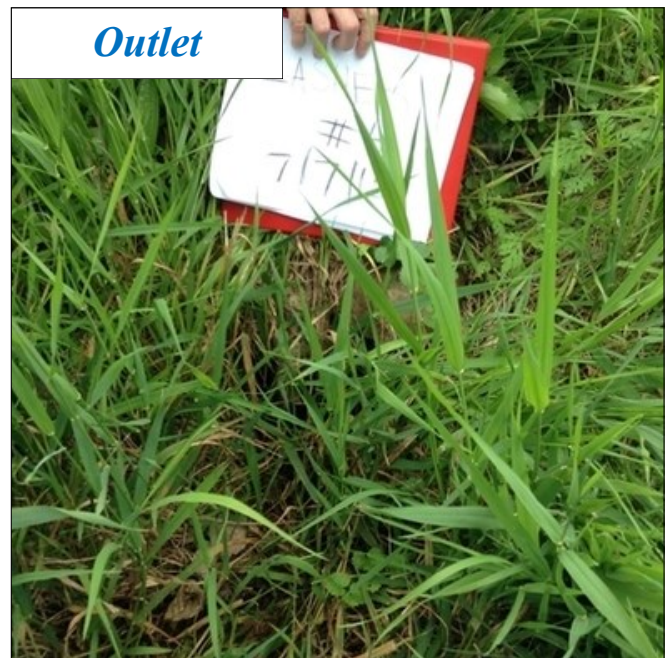
Barrier Evaluation: Insignificant barrier
Aquatic Organism Passage Score: Reduced
AOP
Condition/Maintenance: OK
Max Return Interval: 1

Scour Pool: None
Water Depth/Velocity Matches Stream:
Yes/Yes
Substrate Matches Stream: Comparable
Substrate Type: Silt
Substrate Coverage: 100%

Return Interval (Years)	Peak Flow (cfs)	Culvert Capacity (cfs)	Pass/Fail
2	0.2	0.2	FAIL
5	0.3	0.2	FAIL
25	0.6	0.2	FAIL
50	0.7	0.2	FAIL
100	0.9	0.2	FAIL
200	1.1	0.2	FAIL

Slope Matches Stream (%): 2.8
 Structure Comments: Tiny!
 Outlet Armoring: None

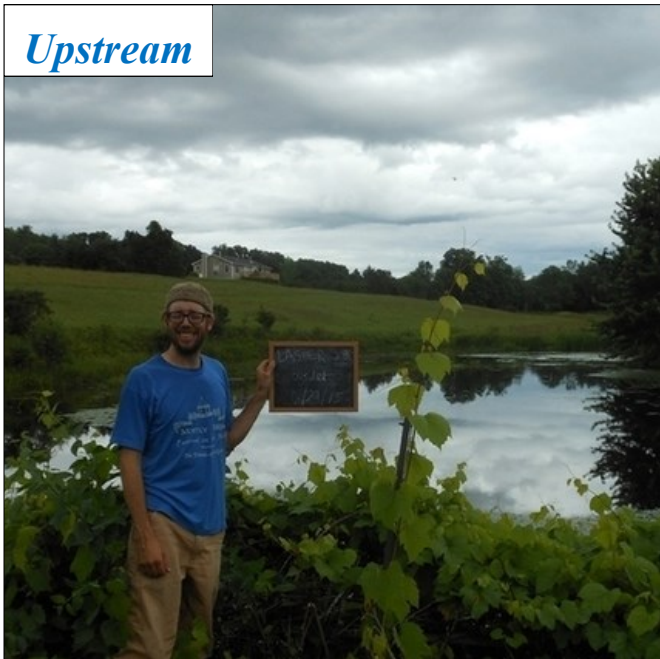
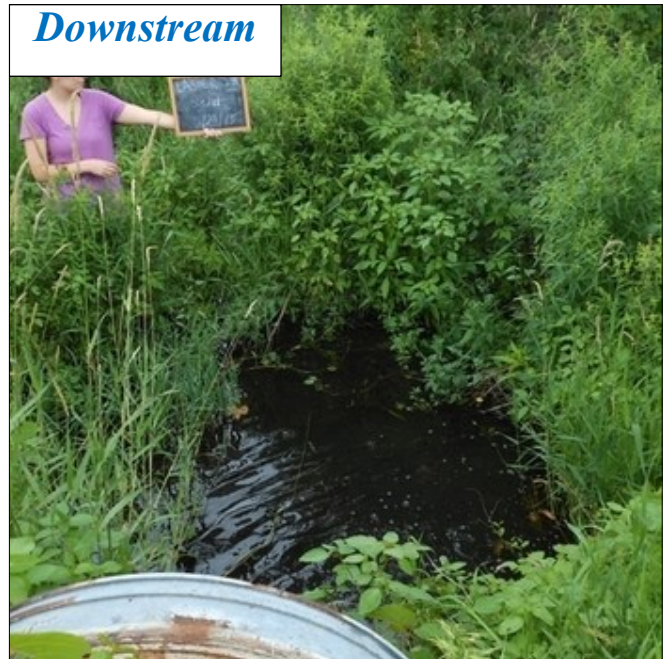
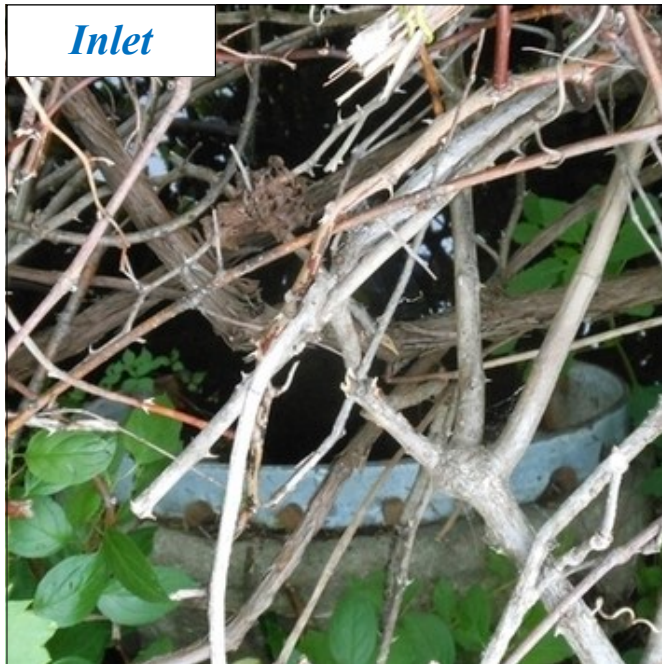
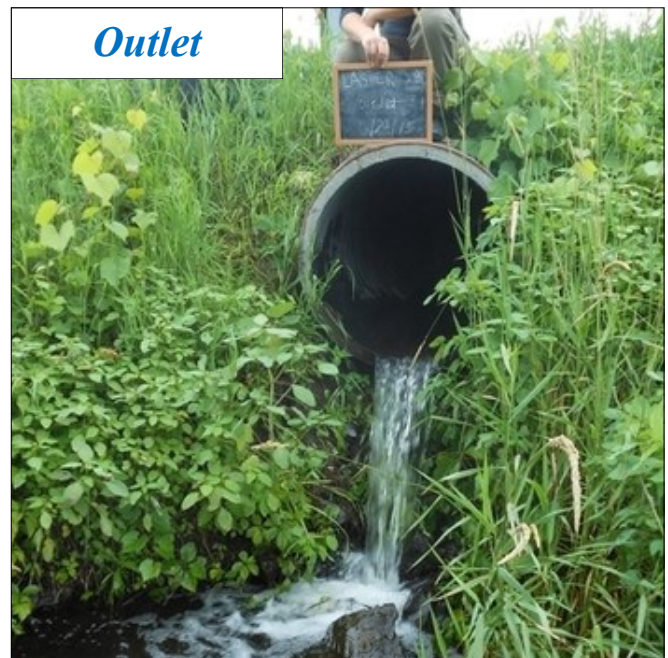
Barrier Evaluation: Severe barrier
Aquatic Organism Passage Score: No AOP
Condition/Maintenance: OK
Max Return Interval: 1

Scour Pool: Small
Water Depth/Velocity Matches Stream:
No-Shallower/No-Faster
Substrate Matches Stream: None
Substrate Type: None
Substrate Coverage: None

Crossing Comments: Concrete with metal in between concrete; pond upstream feeds into culvert; upstream pic labeled as outlet; inlet pic not labeled with chalkboard

Return Interval (Years)	Peak Flow (cfs)	Culvert Capacity (cfs)	Pass/Fail
2	1.3	0.8	FAIL
5	2.8	0.8	FAIL
25	6.1	0.8	FAIL
50	7.6	0.8	FAIL
100	9.3	0.8	FAIL
200	11.4	0.8	FAIL
