Town of Germantown

Road-Stream Crossing Inventory & Management Plan

Town of Germantown Road-Stream Crossing Inventory

Executive Summary – December 2023

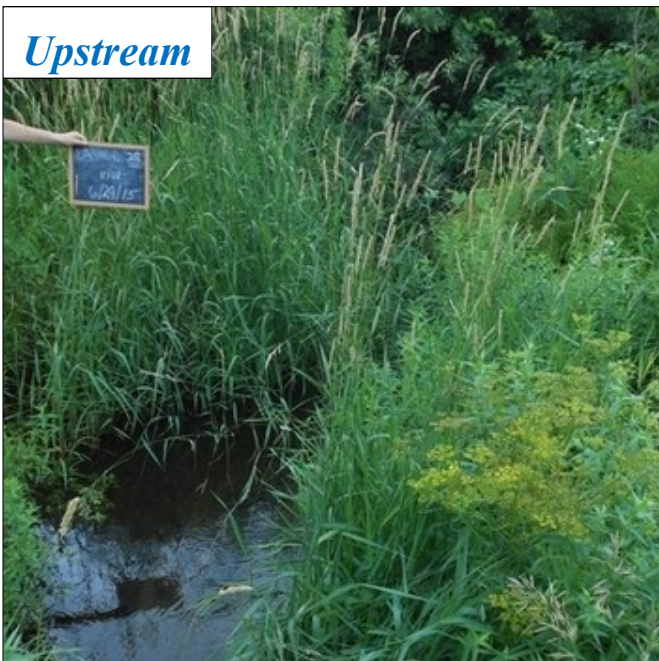
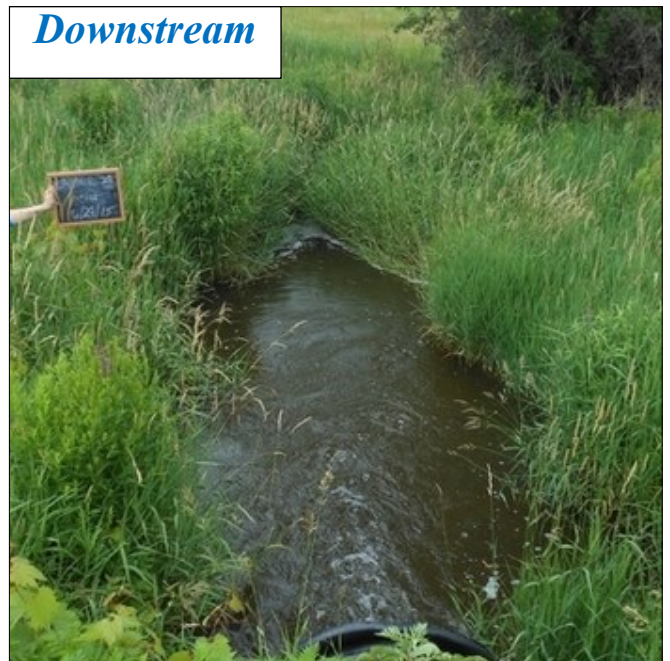
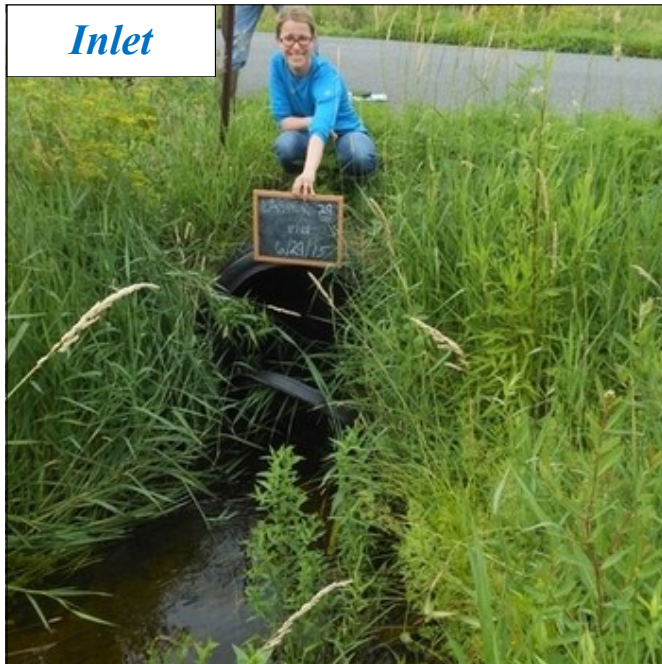
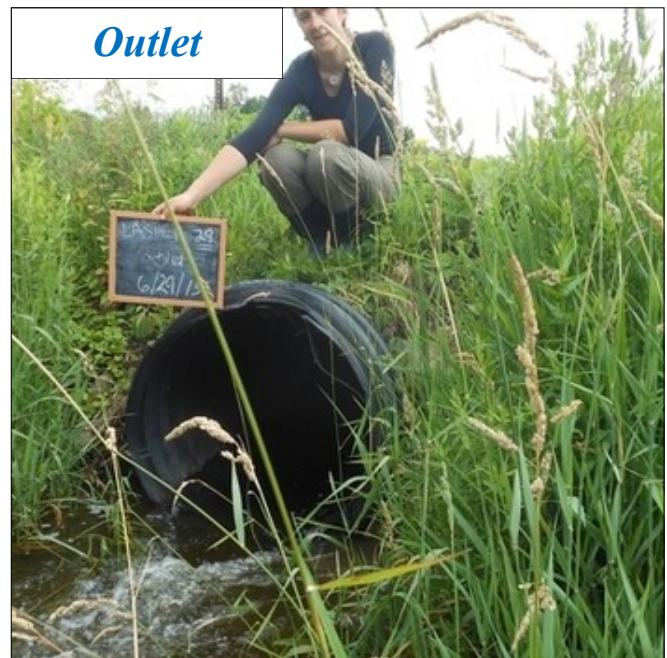
Barrier Evaluation: Moderate barrier
Aquatic Organism Passage Score: Reduced
AOP
Condition/Maintenance: OK
Max Return Interval: 0

Scour Pool: Large
Water Depth/Velocity Matches Stream:
No-Shallower/No-Faster
Substrate Matches Stream: None
Substrate Type: None
Substrate Coverage: None

Return Interval (Years)	Peak Flow (cfs)	Culvert Capacity (cfs)	Pass/Fail
2	2.6	0.9	FAIL
5	6.8	0.9	FAIL
25	17.7	0.9	FAIL
50	22.9	0.9	FAIL
100	28.9	0.9	FAIL
200	36.3	0.9	FAIL

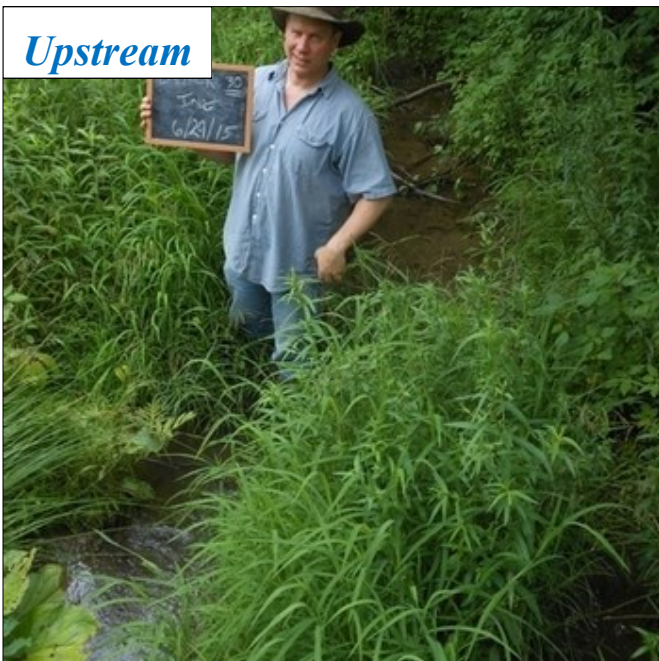
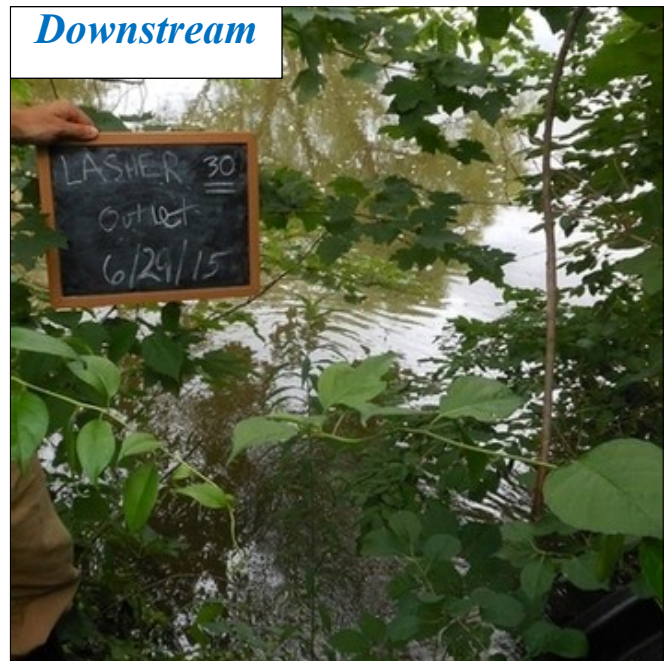
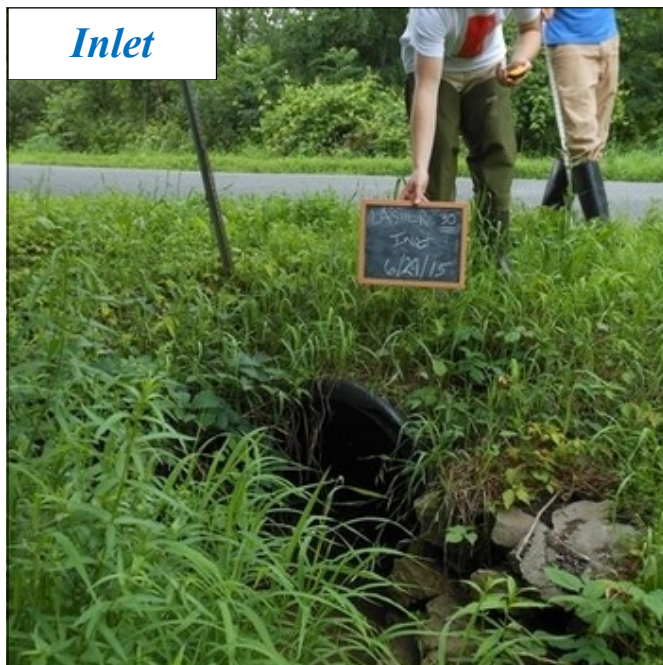
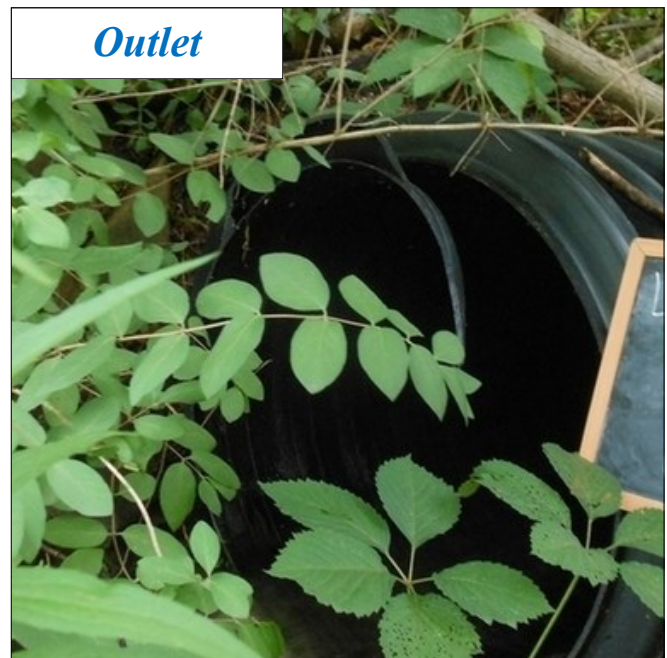
Barrier Evaluation: Severe barrier
Aquatic Organism Passage Score: No AOP
Condition/Maintenance: OK
Max Return Interval: 0

Scour Pool: Large
Water Depth/Velocity Matches Stream: Yes/Yes
Substrate Matches Stream: None
Substrate Type: None
Substrate Coverage: None

Return Interval (Years)	Peak Flow (cfs)	Culvert Capacity (cfs)	Pass/Fail
2	2.1	1.0	FAIL
5	3.8	1.0	FAIL
25	7.6	1.0	FAIL
50	9.2	1.0	FAIL
100	11.1	1.0	FAIL
200	13.5	1.0	FAIL

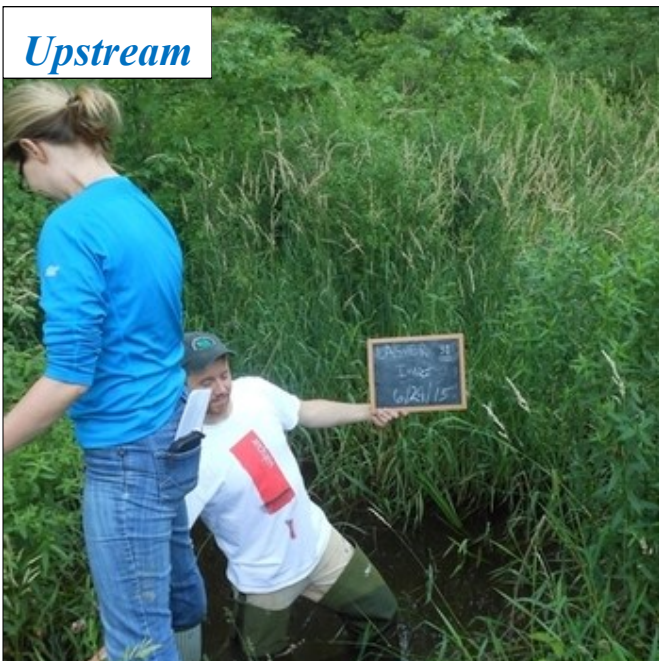
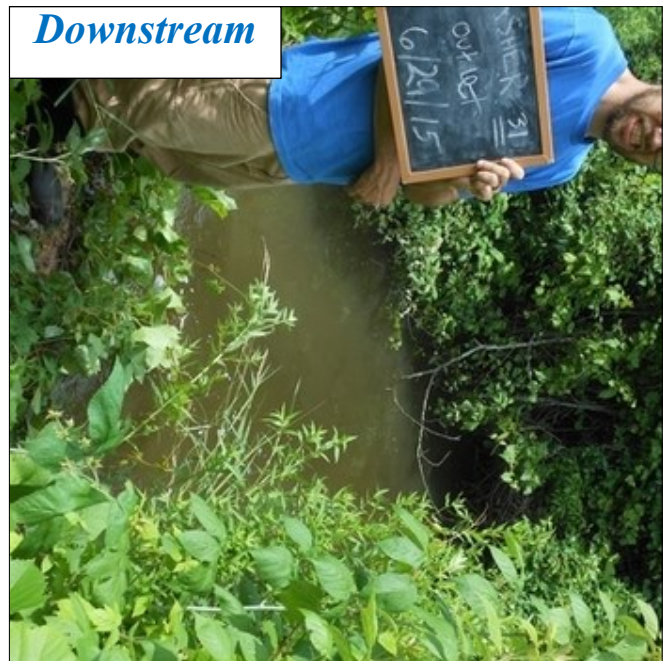
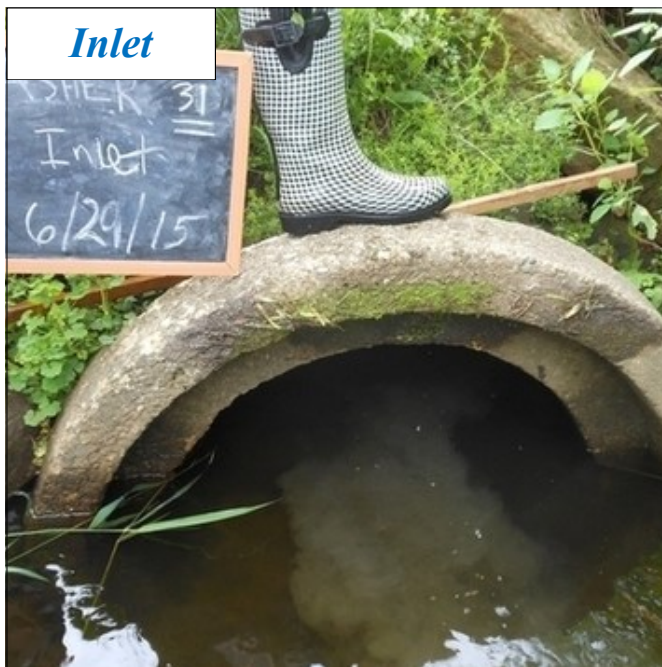
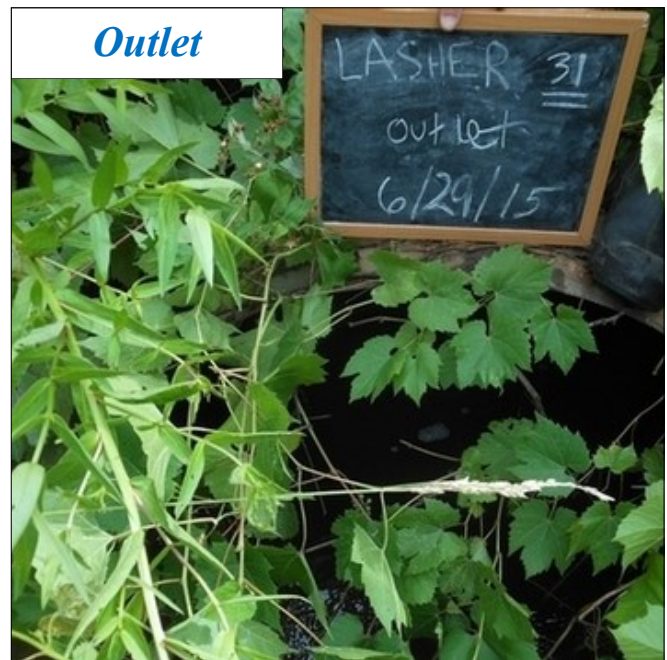
Barrier Evaluation: Moderate barrier
Aquatic Organism Passage Score: Reduced AOP
Condition/Maintenance: OK
Max Return Interval: 1

Scour Pool: Large
Water Depth/Velocity Matches Stream: No-Deeper/No-Faster
Substrate Matches Stream: None
Substrate Type: None
Substrate Coverage: None

Return Interval (Years)	Peak Flow (cfs)	Culvert Capacity (cfs)	Pass/Fail
2	3.2	1.7	FAIL
5	9.4	1.7	FAIL
25	27.0	1.7	FAIL
50	35.8	1.7	FAIL
100	45.8	1.7	FAIL
200	58.7	1.7	FAIL

Slope Matches Stream (%): 2.5
 Structure Comments: Outlet rusted out
 Outlet Armoring: None

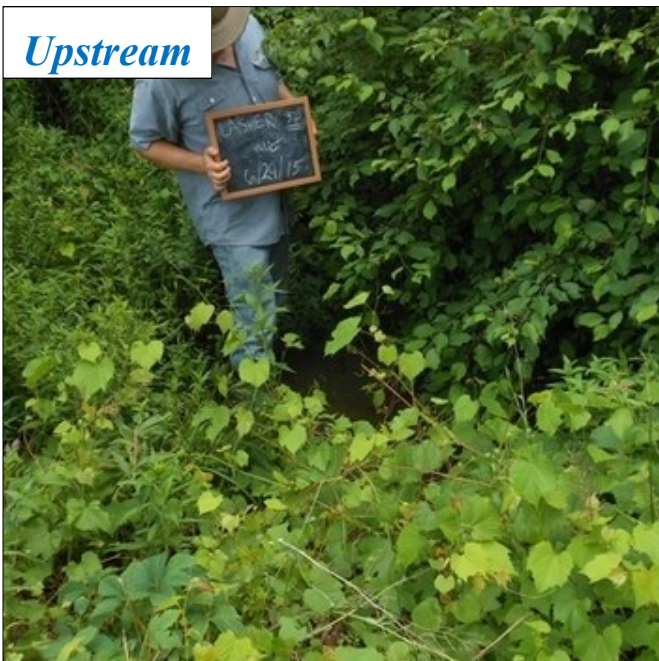
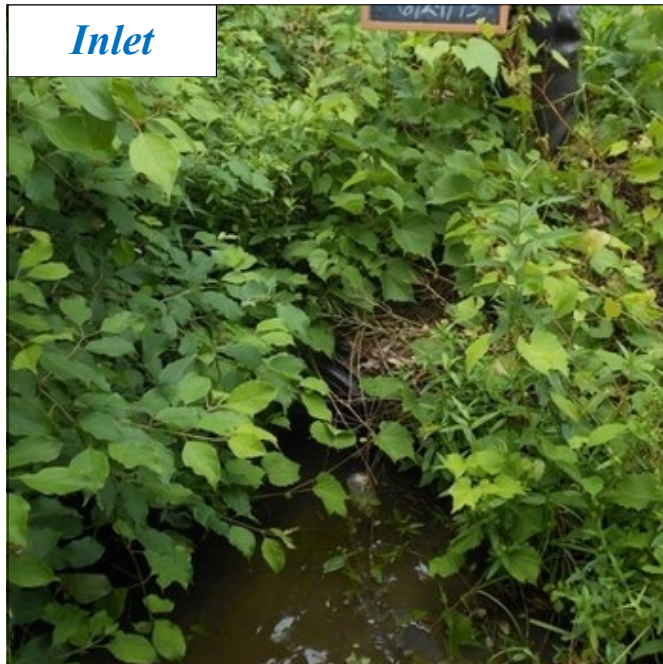
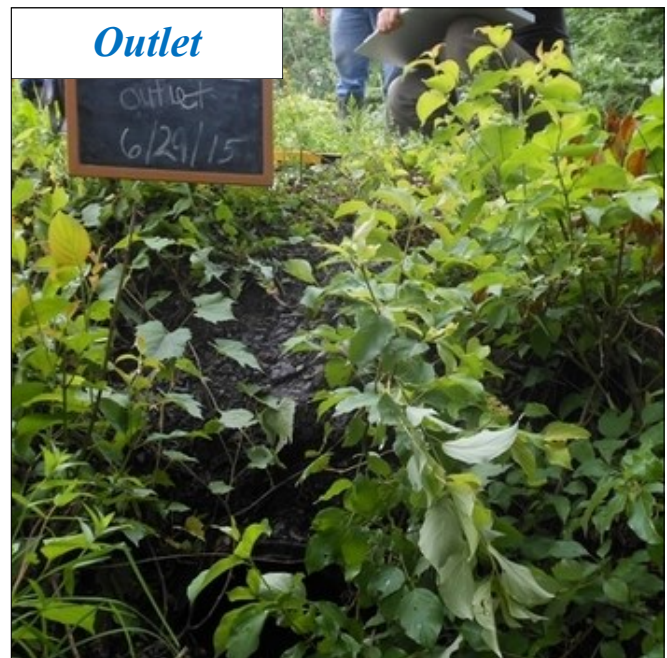
Barrier Evaluation: Moderate barrier
Aquatic Organism Passage Score: Reduced
AOP
Condition/Maintenance: OK
Max Return Interval: 1

Scour Pool: Small
Water Depth/Velocity Matches Stream:
No-Shallower/Yes
Substrate Matches Stream: Contrasting
Substrate Type: Gravel
Substrate Coverage: Unknown

Crossing Comments: stagnant water - unsure which side is the inlet and which is the outlet

Return Interval (Years)	Peak Flow (cfs)	Culvert Capacity (cfs)	Pass/Fail
2	0.2	0.2	FAIL
5	0.3	0.2	FAIL
25	0.6	0.2	FAIL
50	0.7	0.2	FAIL
100	0.8	0.2	FAIL
200	1.0	0.2	FAIL

Inlet Shape/Type: Round Culvert, Projecting
 Inlet Drop/Grade: Perched
 Width: 1.0, Height: 1.0
 Substrate/Water Width: 0.90
 Water Depth: 0.40

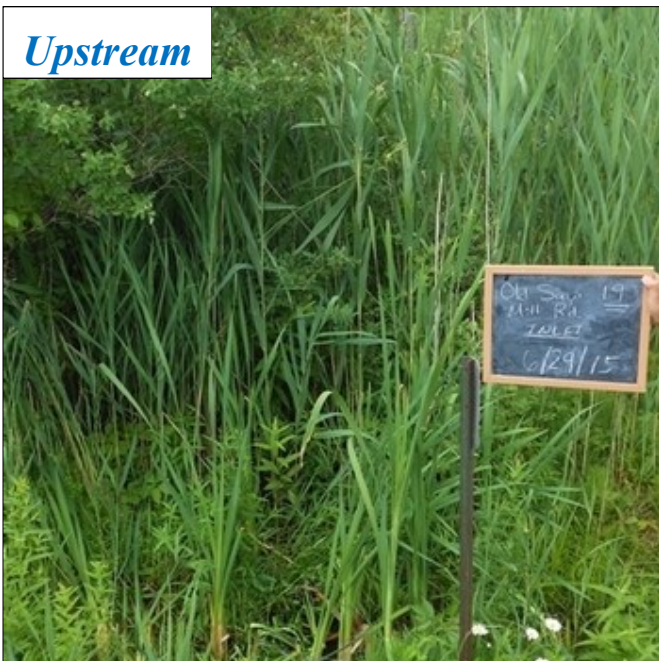
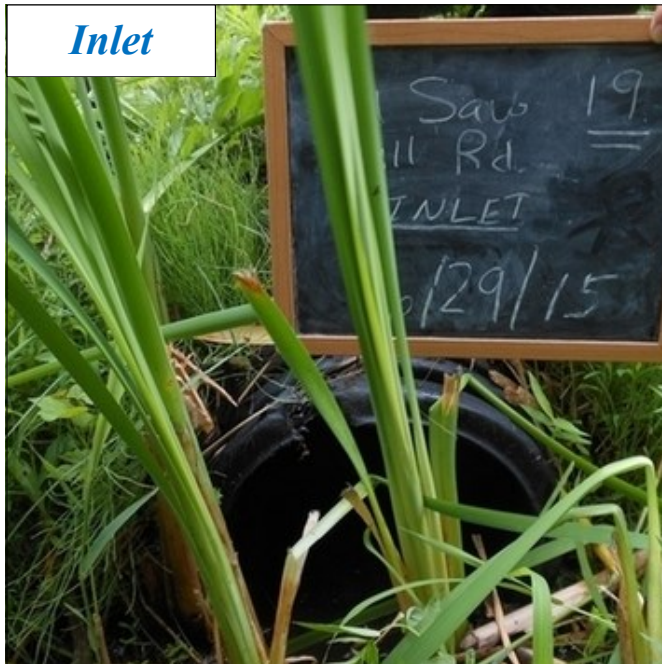
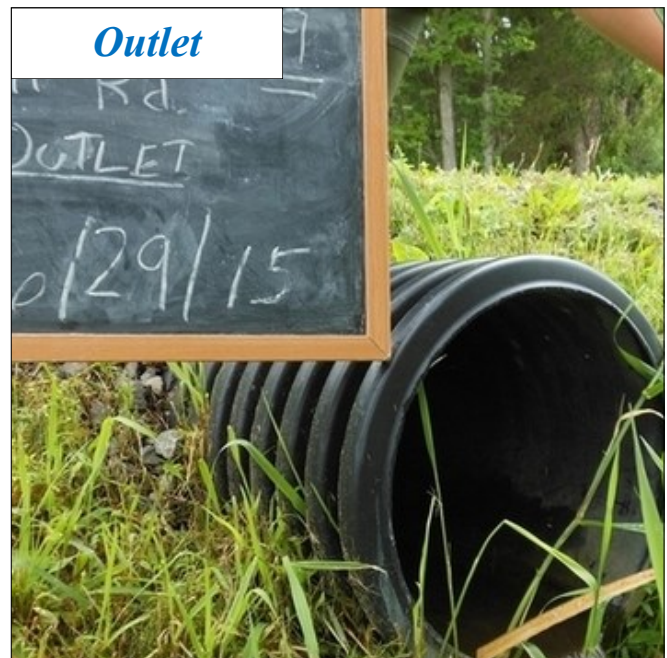
Crossing Comments: Took slope at outlet; Pond just upstream of culvert

Return Interval (Years)	Peak Flow (cfs)	Culvert Capacity (cfs)	Pass/Fail
2	0.2	0.2	FAIL
5	0.4	0.2	FAIL
25	0.7	0.2	FAIL
50	0.9	0.2	FAIL
100	1.0	0.2	FAIL
200	1.2	0.2	FAIL

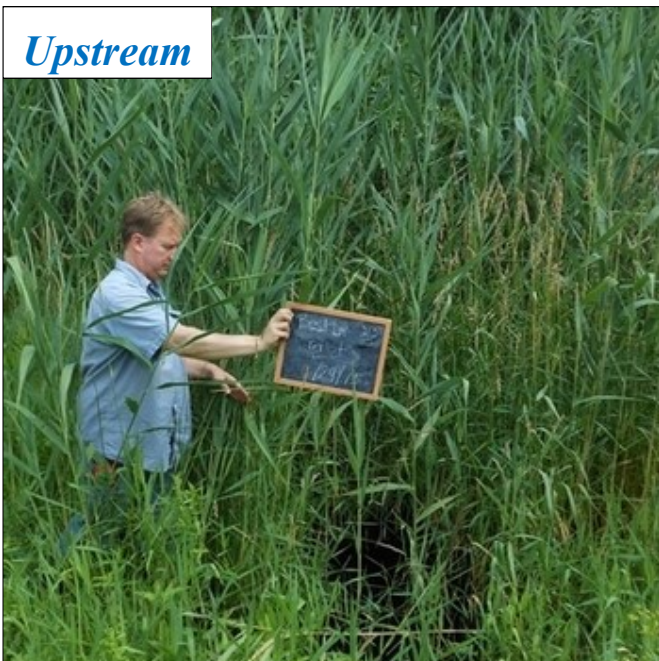
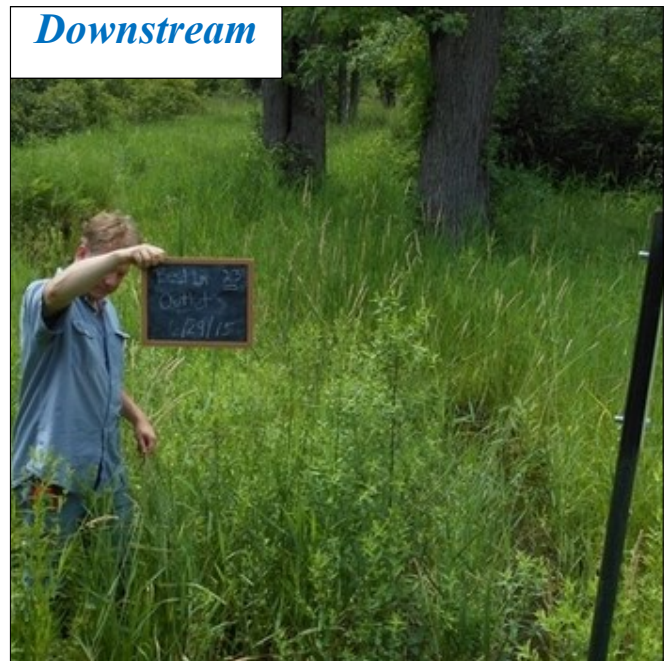
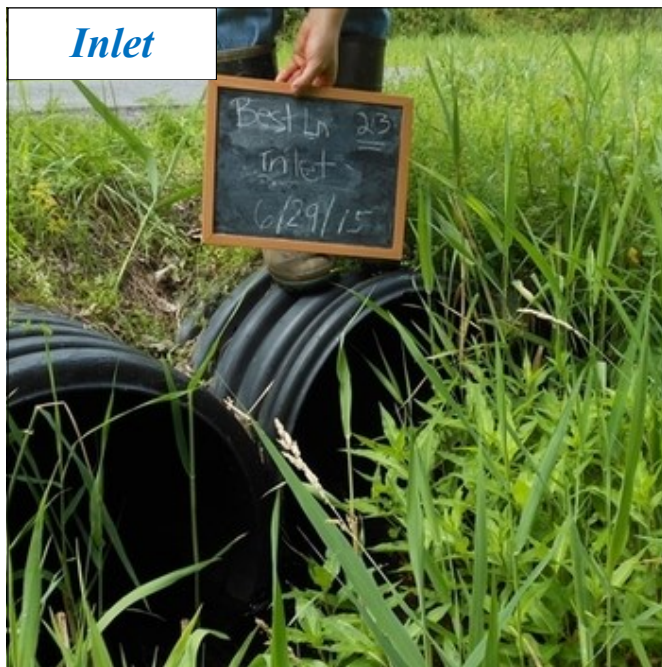
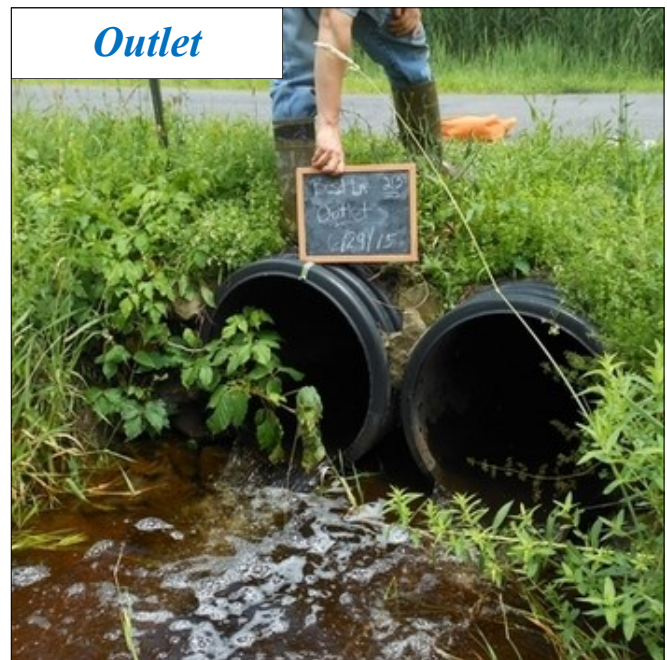
Barrier Evaluation: Minor barrier
Aquatic Organism Passage Score: No AOP
Condition/Maintenance: OK
Max Return Interval: 1

Scour Pool: Small
Water Depth/Velocity Matches Stream:
No-Deeper/Yes
Substrate Matches Stream: None
Substrate Type: None
Substrate Coverage: None

Return Interval (Years)	Peak Flow (cfs)	Culvert Capacity (cfs)	Pass/Fail
2	1.1	0.5	FAIL
5	3.7	0.5	FAIL
25	11.7	0.5	FAIL
50	15.8	0.5	FAIL
100	20.5	0.5	FAIL
200	26.6	0.5	FAIL

Inlet Shape/Type: Round Culvert, Projecting
 Inlet Drop/Grade: Perched
 Width: 2.0, Height: 2.2
 Substrate/Water Width: 1.90
 Water Depth: 0.60

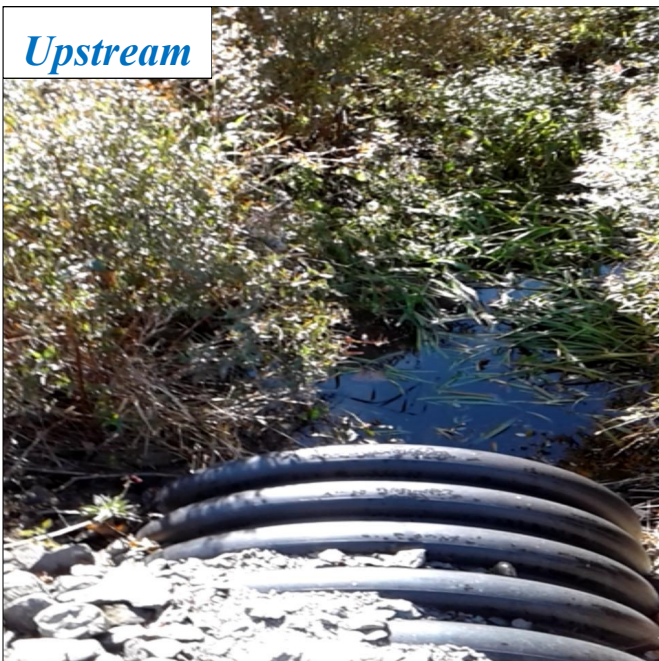
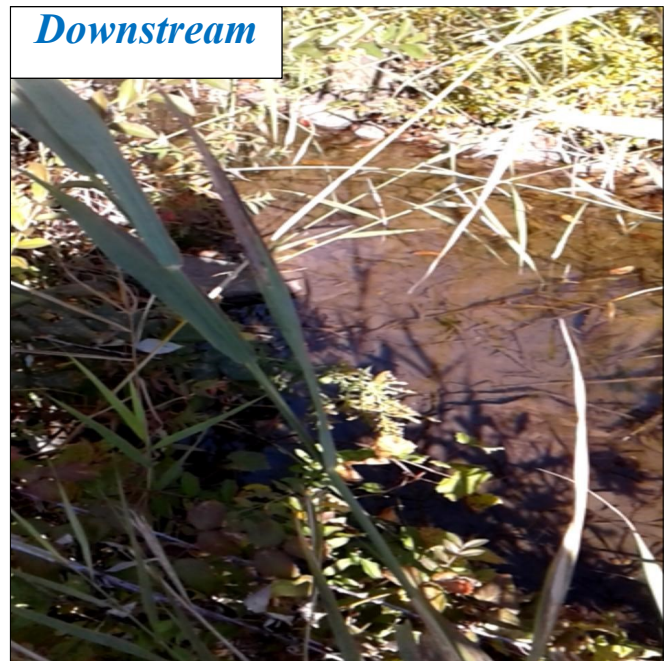
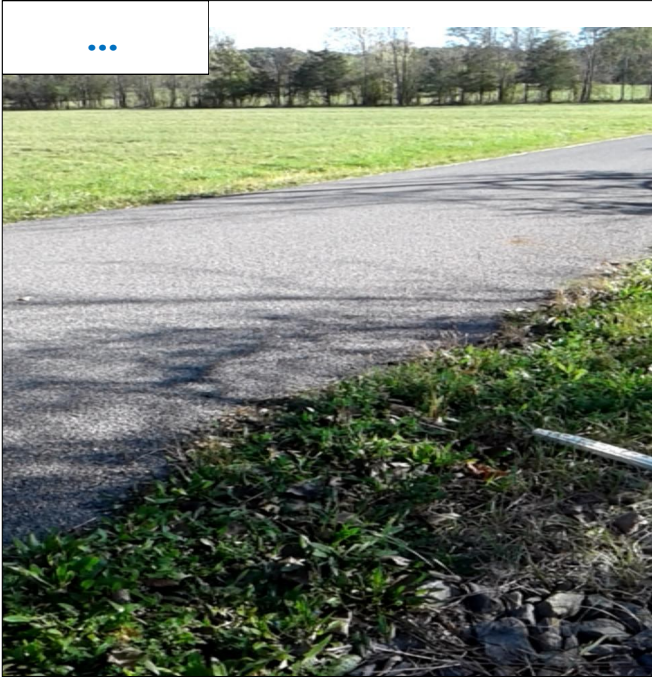
Scour Pool: Small
Water Depth/Velocity Matches Stream:
No-Shallower/No-Faster
Substrate Matches Stream: None
Substrate Type: None
Substrate Coverage: None

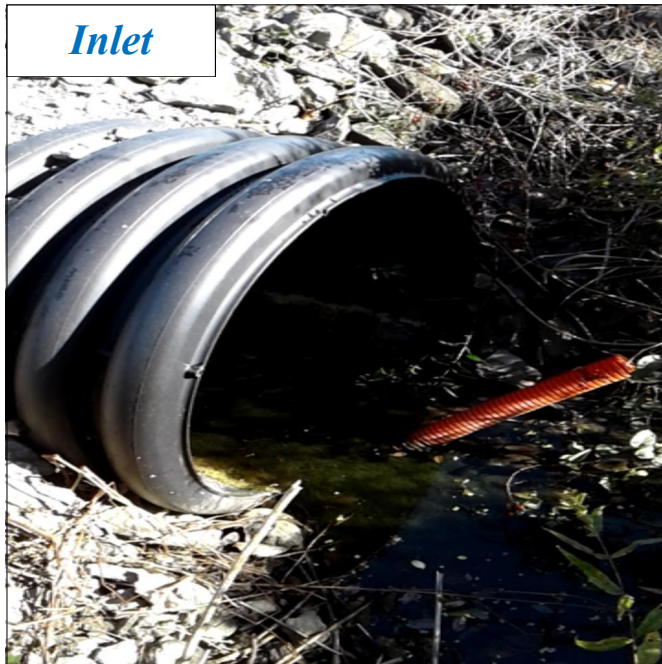
Inlet

Barrier Evaluation: Moderate barrier
Aquatic Organism Passage Score: No AOP
Condition/Maintenance: OK
Max Return Interval: 1

Return Interval (Years)	Peak Flow (cfs)	Culvert Capacity (cfs)	Pass/Fail
2	1.6	1.2	FAIL
5	5.0	1.2	FAIL
25	15.3	1.2	FAIL
50	20.4	1.2	FAIL
100	26.2	1.2	FAIL
200	33.6	1.2	FAIL

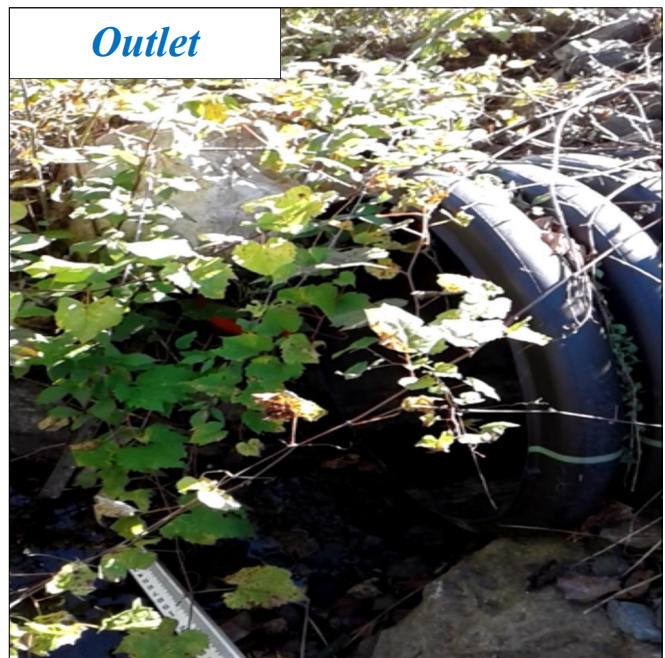
Outlet Shape:
 Outlet Drop/Grade: Free Fall
 Drop to Stream Surface/Bottom: 0.30/0.60
 Width: 3.0, Height: 3.0
 Substrate/Water Width: 0.40
 Water Depth: 0.10

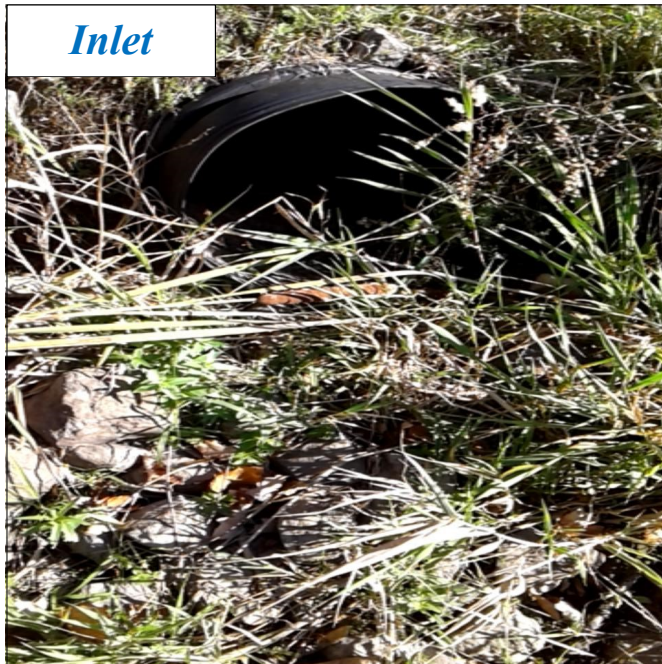
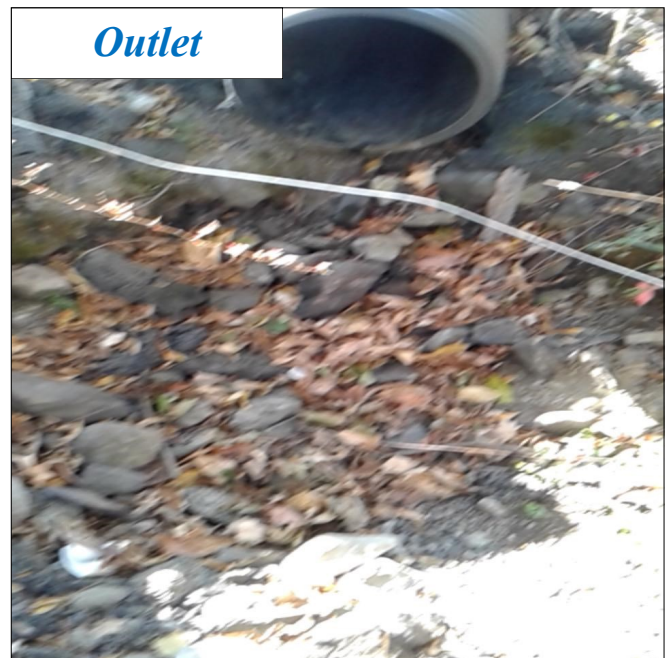
Slope Matches Stream (%): No data
 Structure Comments: Inlet controls pond level

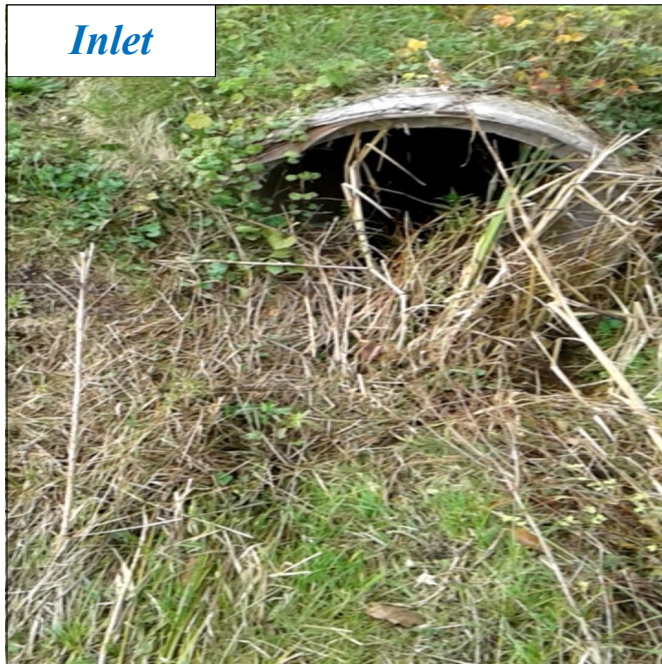
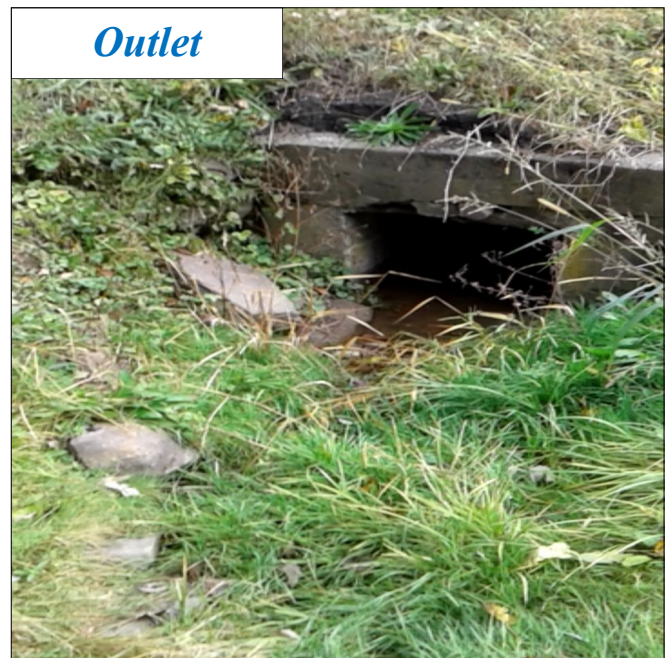
Slope Matches Stream (%): No data
 Structure Comments: Small Free fall in-
 side crossing

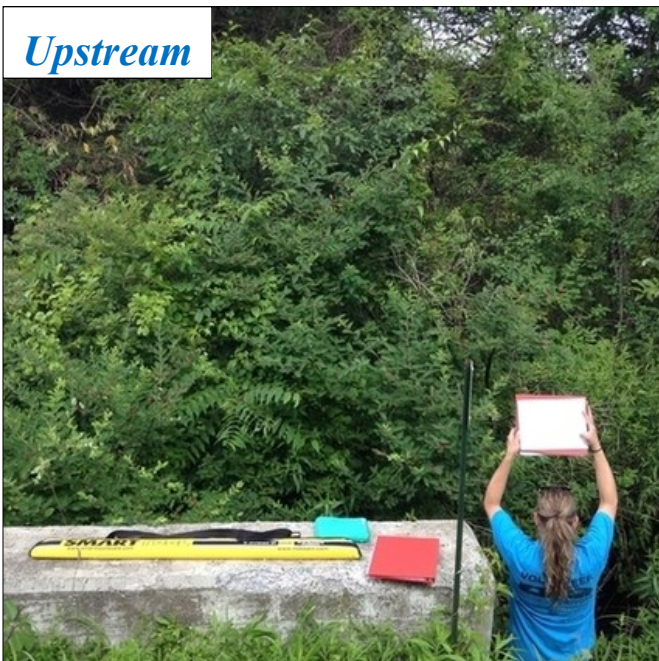
Crossing Comments: Inlet is broken and angled at 45 degrees to abutments

Slope Matches Stream (%): 0.6
 Structure Comments: Material is clay.
 Raccoon skull

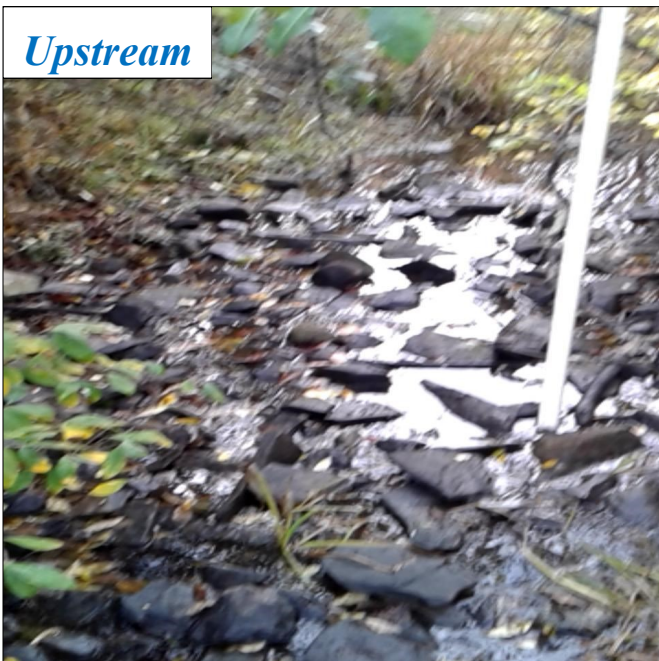
Crossing Comments: Broken outlet wingwalls

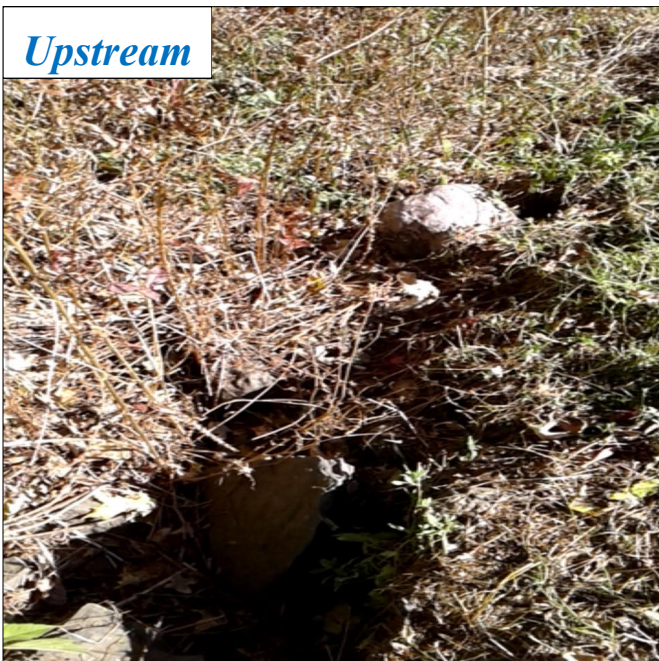
Crossing Comments: Old concrete culvert

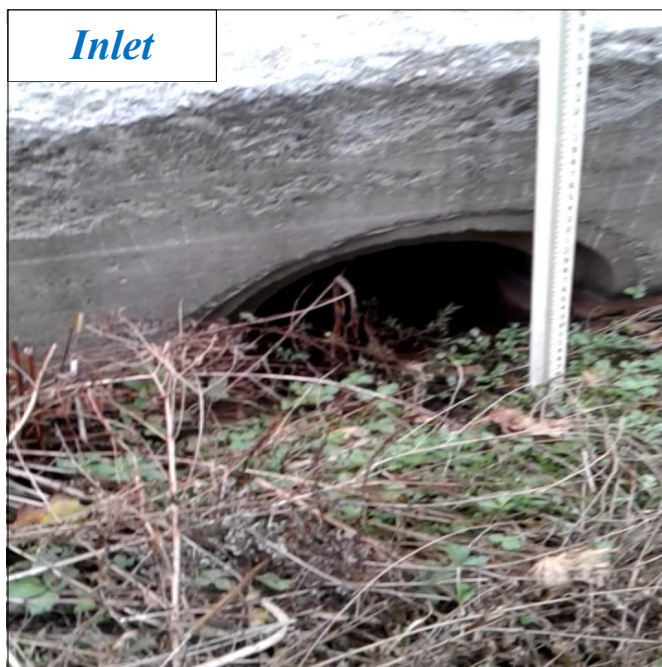
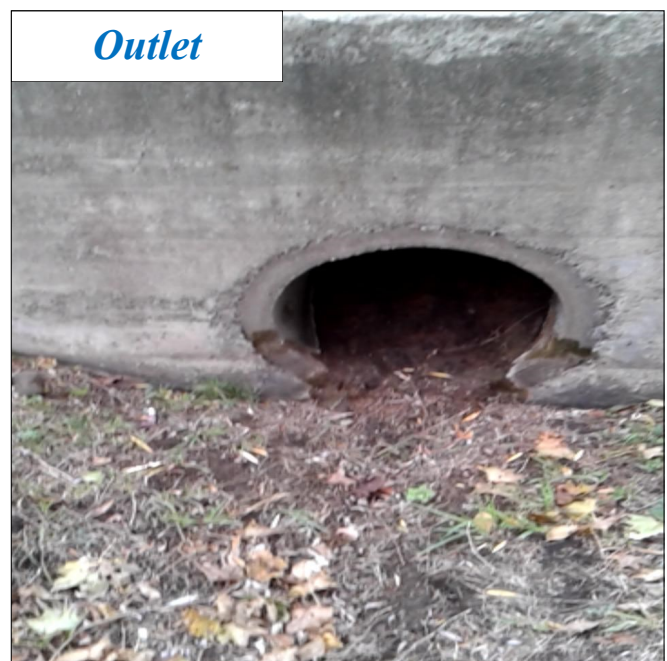
Material: Concrete
 Physical Barrier (s)/Severity: Debris/
 Sediment/Rock, Moderate

Slope Matches Stream (%): No data
 Structure Comments: Clogged with grass
 and silt

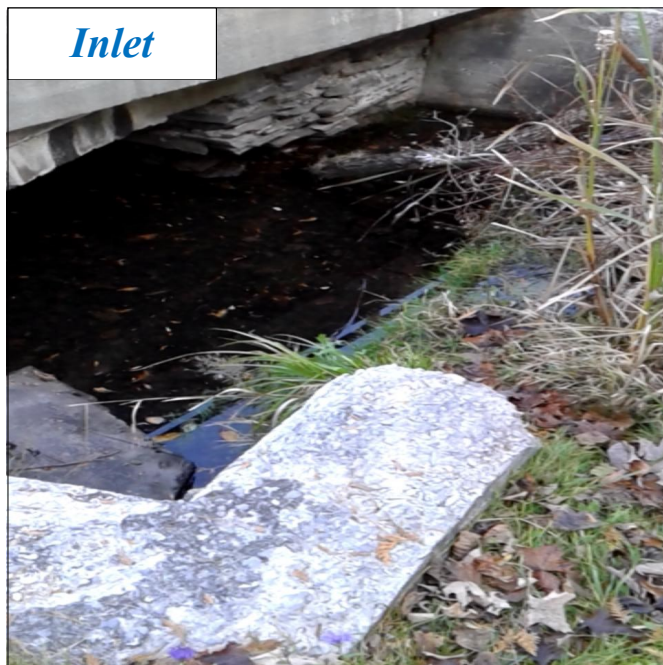
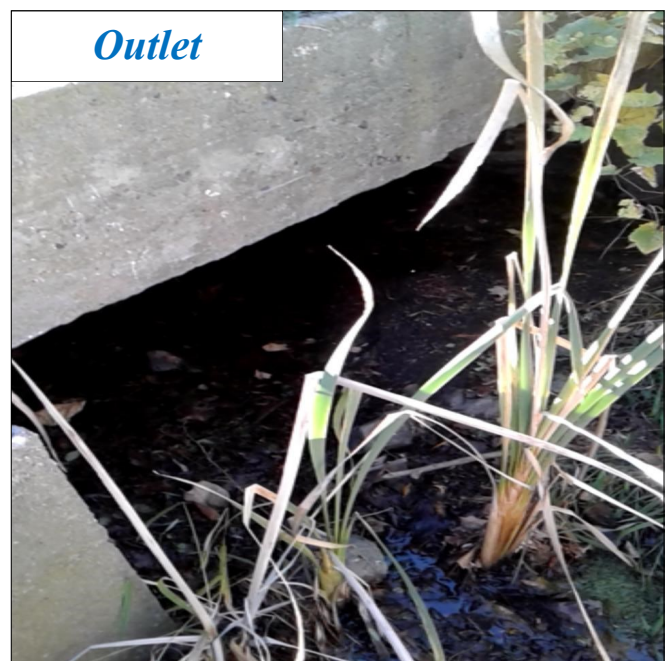
Crossing Comments: New bridge over old 3ft dam upstream of inlet

Material: Concrete
 Physical Barrier (s)/Severity: Debris/
 Sediment/Rock, Moderate

Slope Matches Stream (%): No data
 Structure Comments: Damned up
 Outlet Armoring: Not Extensive

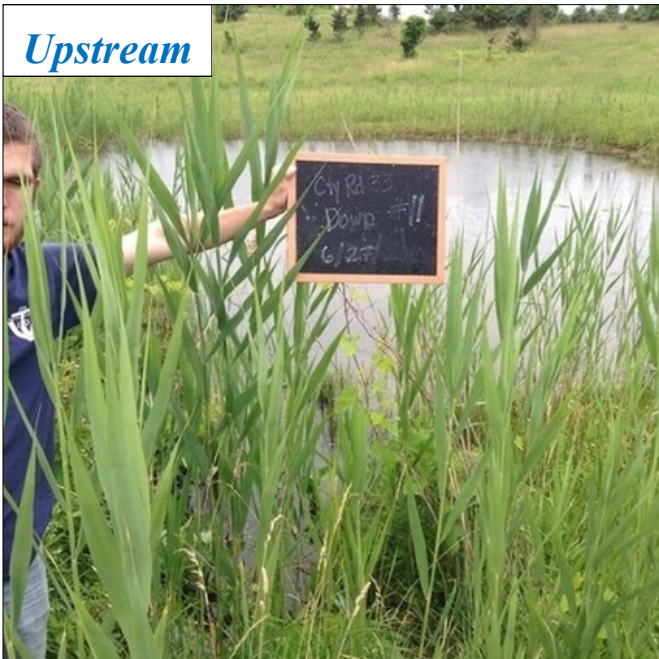
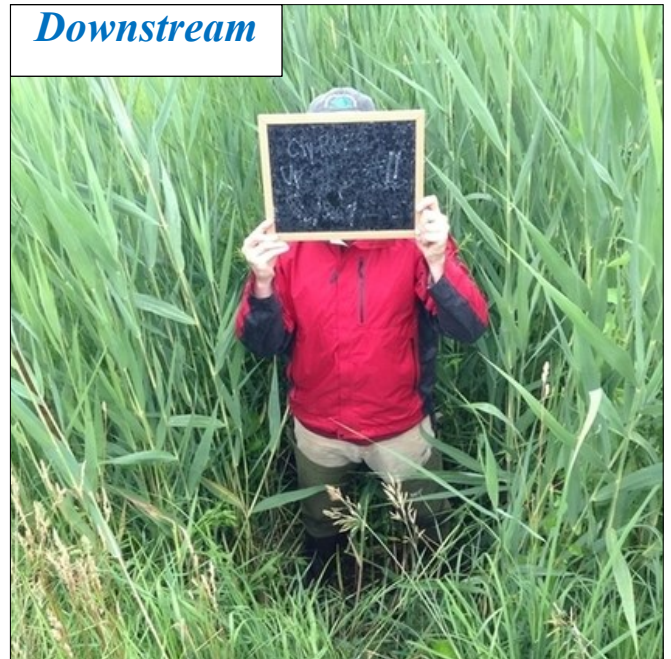
Crossing Comments: Inlet section 3' in disconnected/ fallen out.

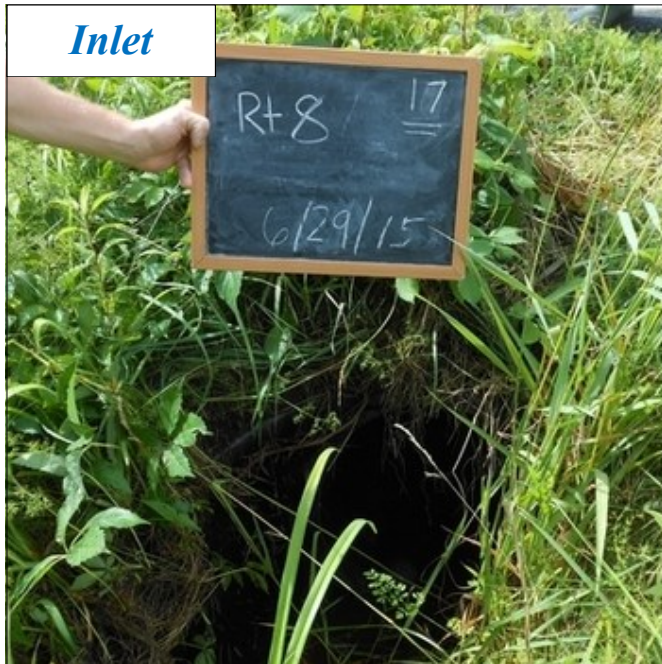
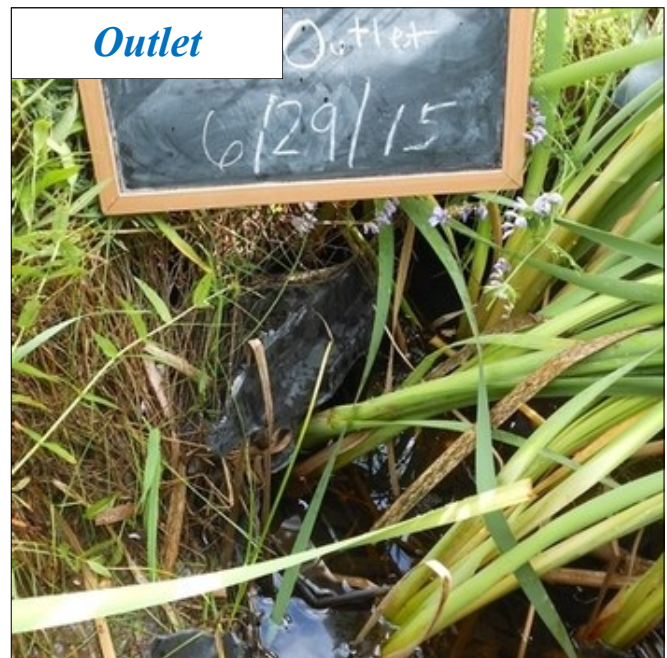
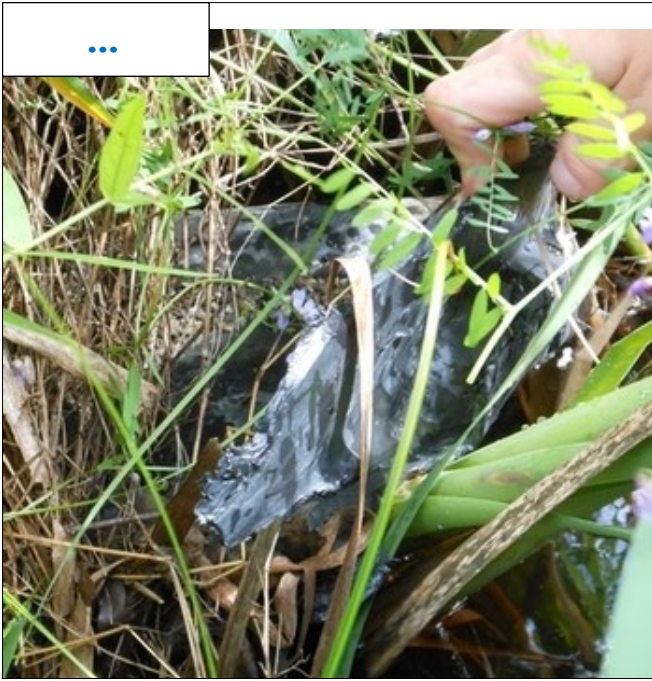
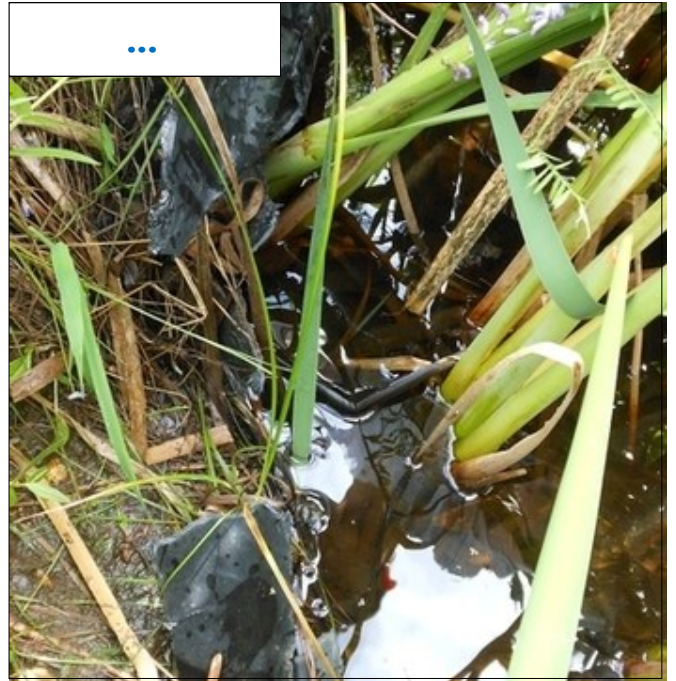
Barrier Evaluation: Insignificant barrier
Aquatic Organism Passage Score: Reduced
AOP
Condition/Maintenance: Poor
Max Return Interval: 2

Return Interval (Years)	Peak Flow (cfs)	Culvert Capacity (cfs)	Pass/Fail
2	0.3	0.4	PASS
5	0.5	0.4	FAIL
25	0.9	0.4	FAIL
50	1.1	0.4	FAIL
100	1.3	0.4	FAIL
200	1.6	0.4	FAIL

Material: Plastic
 Physical Barrier (s)/Severity: None, None
 Internal Features/Structures: None

Slope Matches Stream (%): 4.6
 Structure Comments: No data
 Outlet Armoring: None

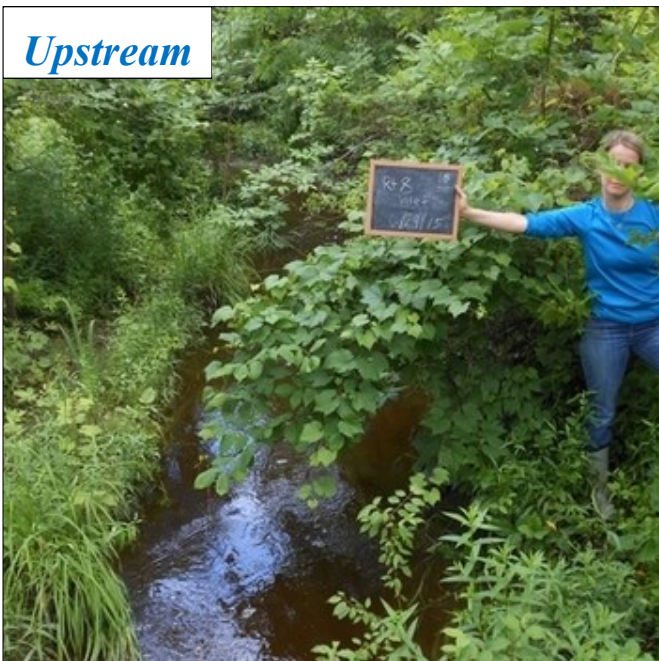
Scour Pool: Large
Water Depth/Velocity Matches Stream:
Yes/Yes
Substrate Matches Stream: None
Substrate Type: None
Substrate Coverage: None

Crossing Comments: Old Bridge Crossing to Left when facing upstream (on right when facing downstream)= Structure #2

Return Interval (Years)	Peak Flow (cfs)	Culvert Capacity (cfs)	Pass/Fail
2	1.5	13.7	PASS
5	5.6	13.7	PASS
25	23.6	13.7	FAIL
50	33.8	13.7	FAIL
100	45.9	13.7	FAIL
200	62.0	13.7	FAIL
