Town of Germantown

Road-Stream Crossing Inventory & Management Plan

Town of Germantown Road-Stream Crossing Inventory

Executive Summary – December 2023

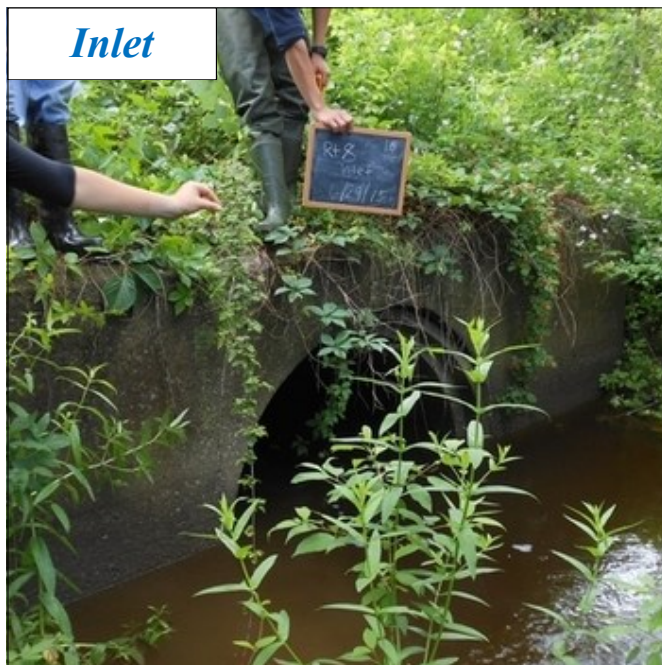
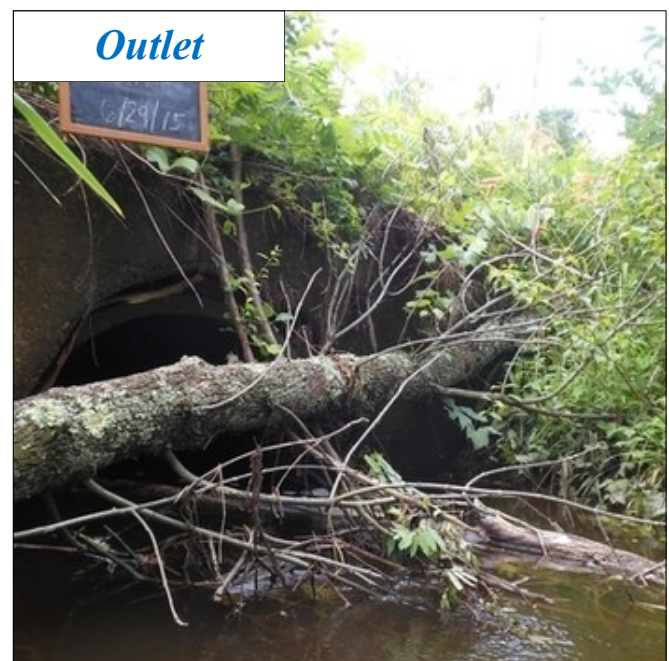
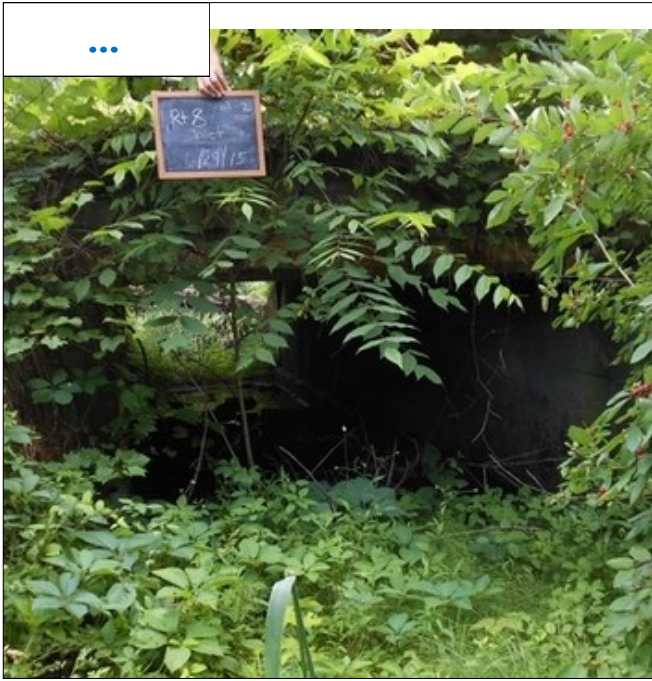
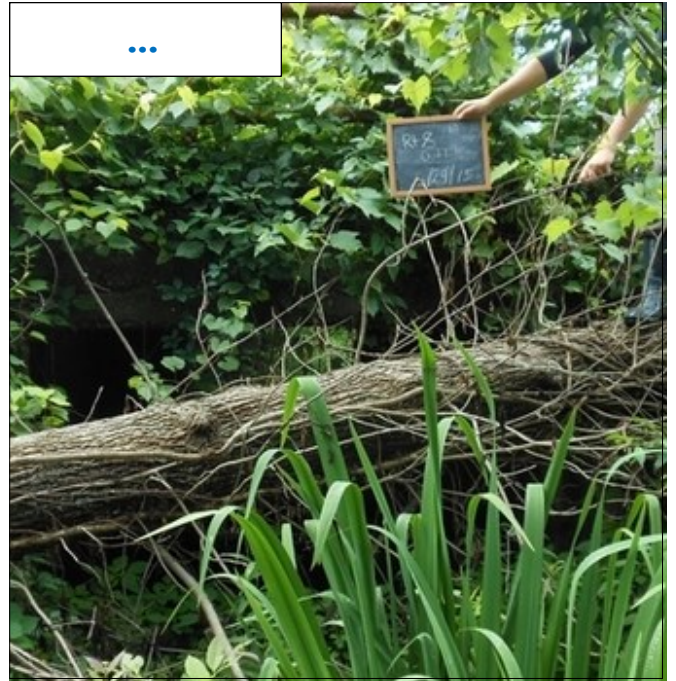
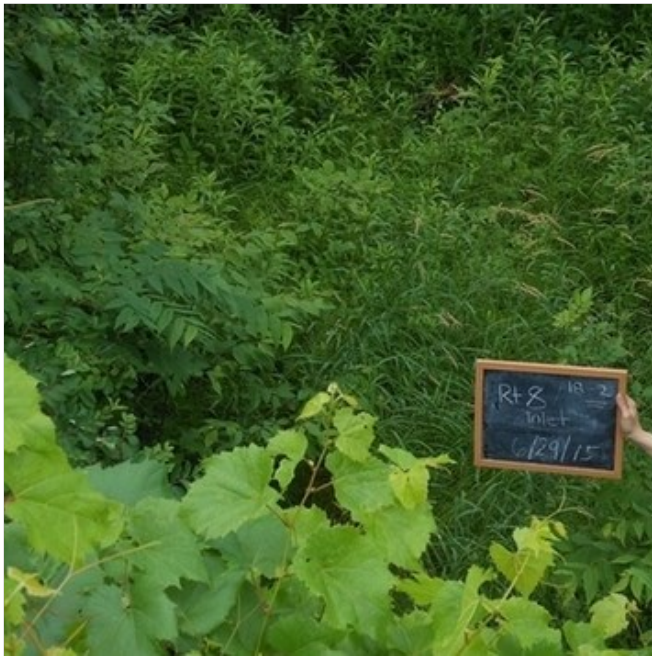
Material: Concrete
 Physical Barrier (s)/Severity: None, None
 Internal Features/Structures: None

Slope Matches Stream (%): 1.6
 Structure Comments: No data
 Outlet Armoring: None

Outlet Shape: Box/Bridge with Abutments
Outlet Drop/Grade: Cascade
Drop to Stream Surface/Bottom: 2.00, 4.20
Dimensions:
Width: 7.80, Height: 4.70
Substrate/Water Width: 0.00
Water Depth: 0.00

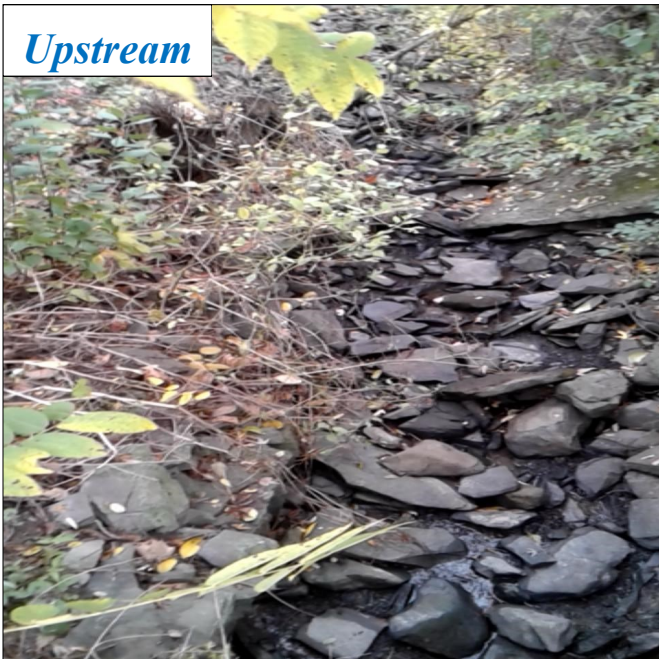
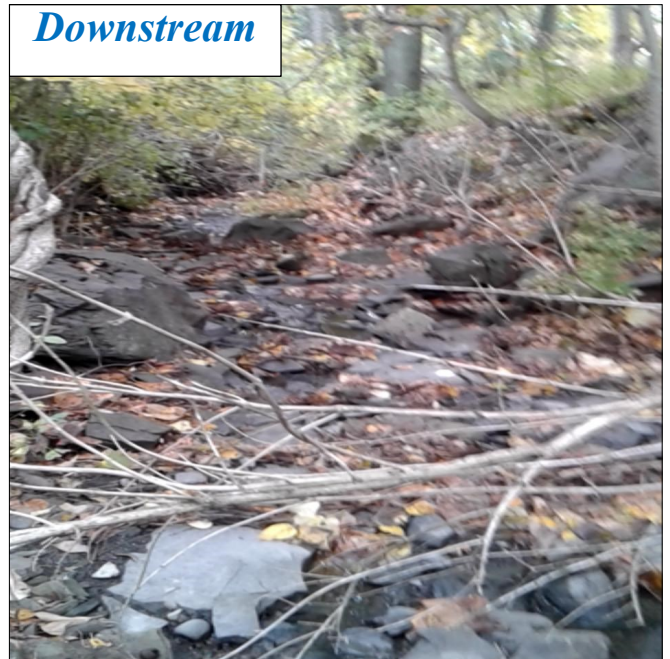
Barrier Evaluation: Moderate barrier
Aquatic Organism Passage Score: Reduced
AOP
Condition/Maintenance: Poor
Max Return Interval: No data

Scour Pool: None
Water Depth/Velocity Matches Stream:
No-Shallower/No-Faster
Substrate Matches Stream: Unknown
Substrate Type: Unknown
Substrate Coverage: Unknown

Crossing Comments: Double crossing

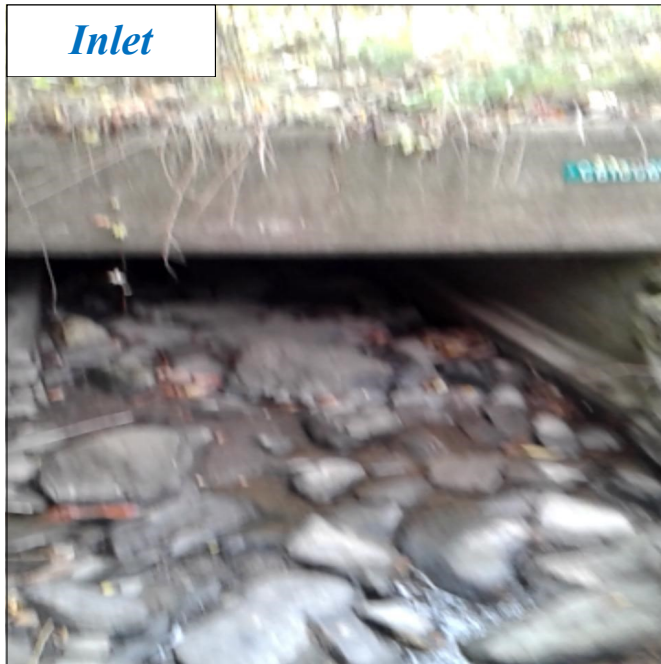
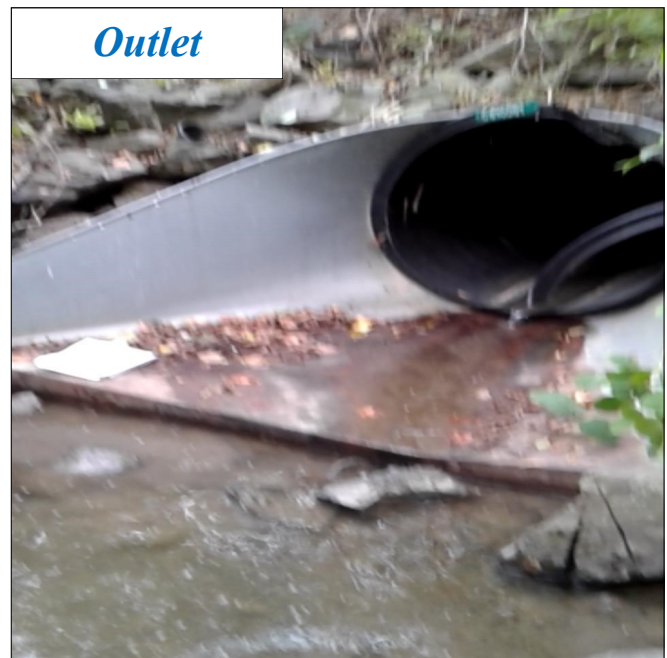
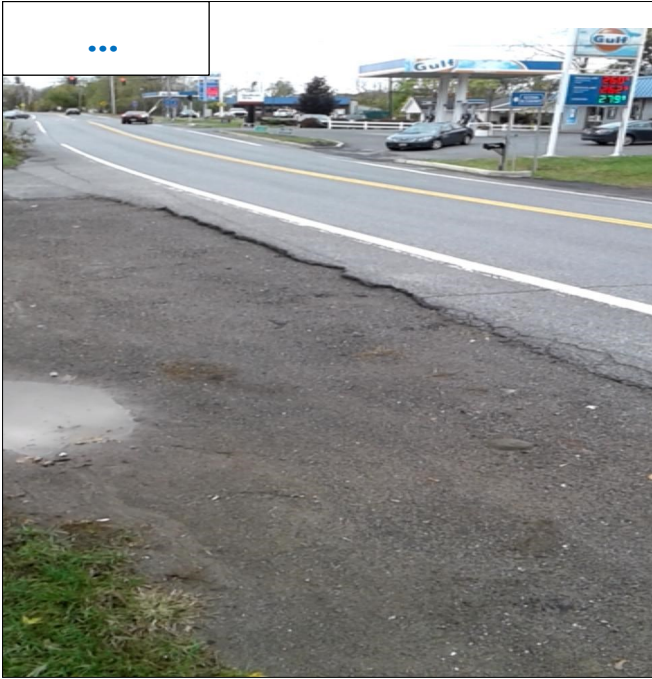
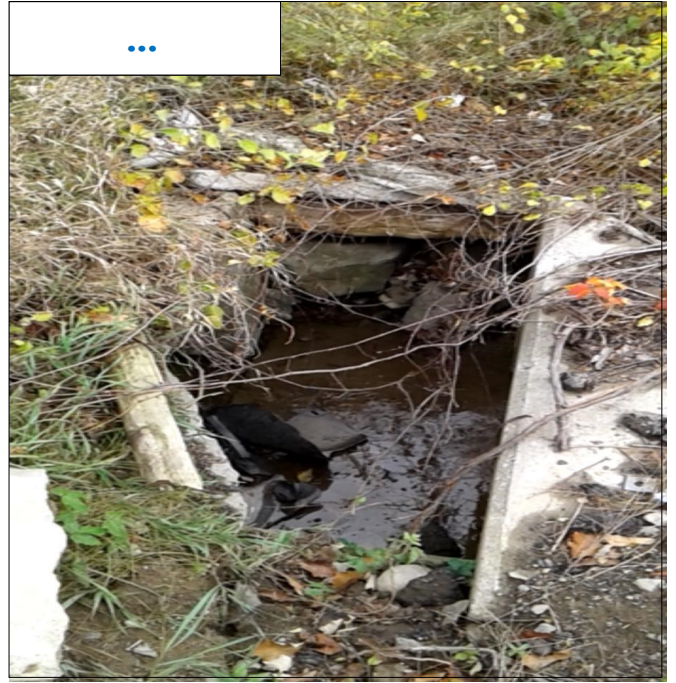
Material: Concrete
 Physical Barrier (s)/Severity: Deformation, Minor

Inlet Shape/Type: Box/Bridge with Abutments, Headwall and Wingwalls
 Inlet Drop/Grade: Perched
 Width: 3.5, Height: 2.2
 Substrate/Water Width: 0.50
 Water Depth: 0.10

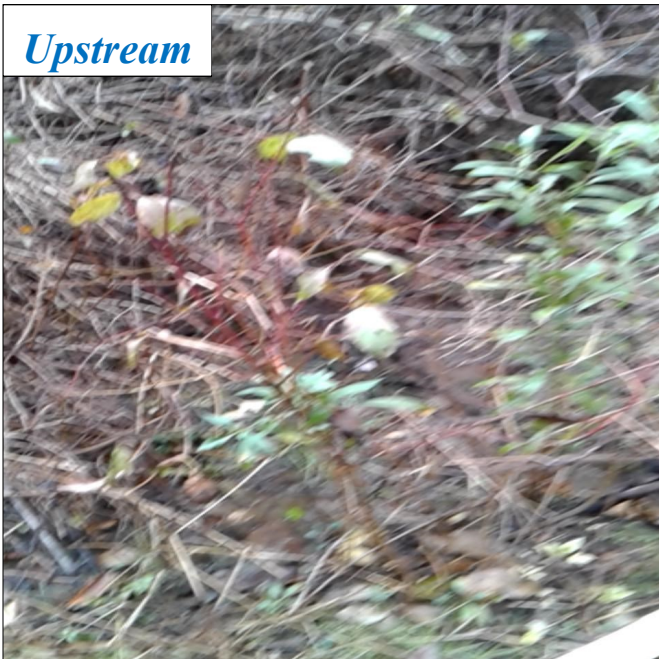
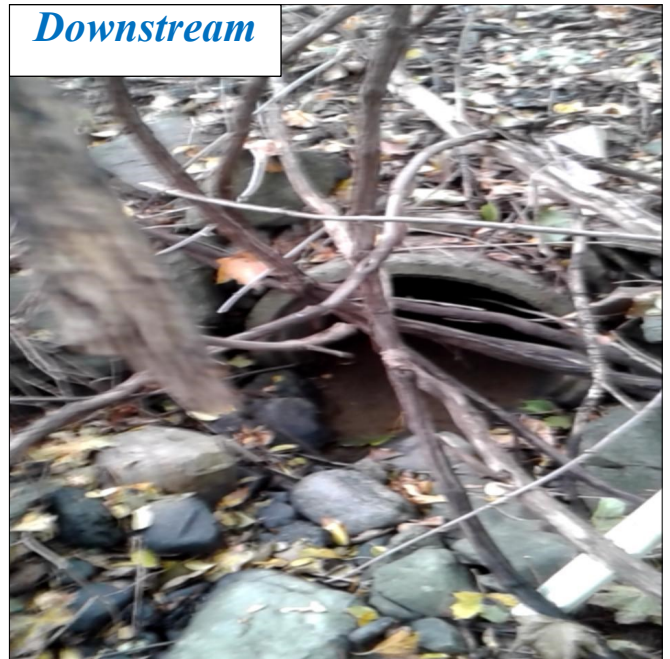
Scour Pool: None
Water Depth/Velocity Matches Stream:
Yes/Yes
Substrate Matches Stream: None
Substrate Type: Silt
Substrate Coverage: 75%

Crossing Comments: Another crossing just downstream

Return Interval (Years)	Peak Flow (cfs)	Culvert Capacity (cfs)	Pass/Fail
2	1.2	2.4	PASS
5	2.5	2.4	FAIL
25	5.3	2.4	FAIL
50	6.5	2.4	FAIL
100	7.9	2.4	FAIL
200	9.6	2.4	FAIL

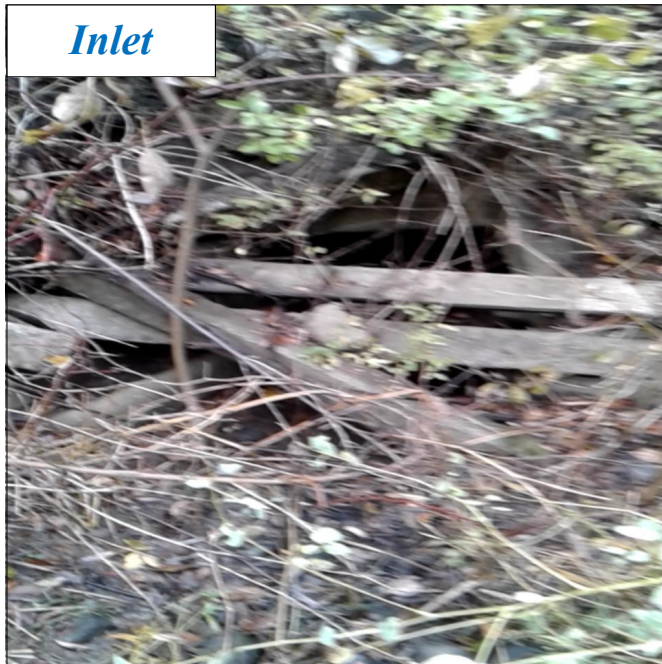
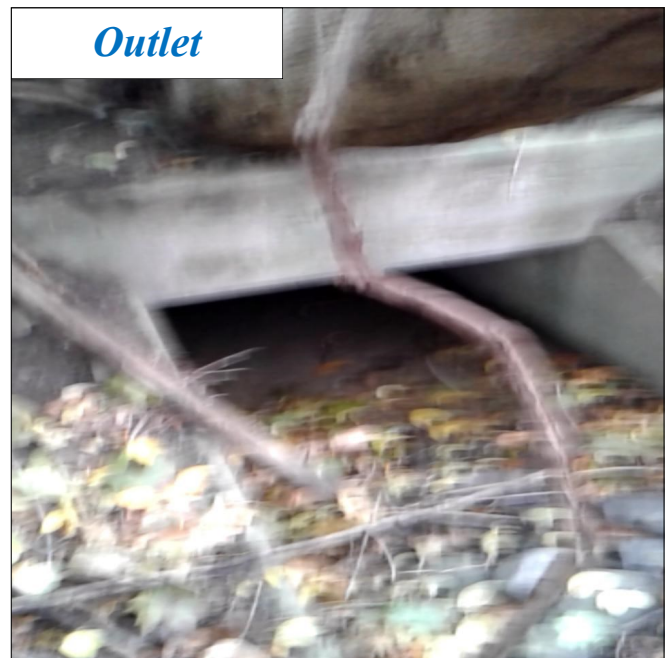
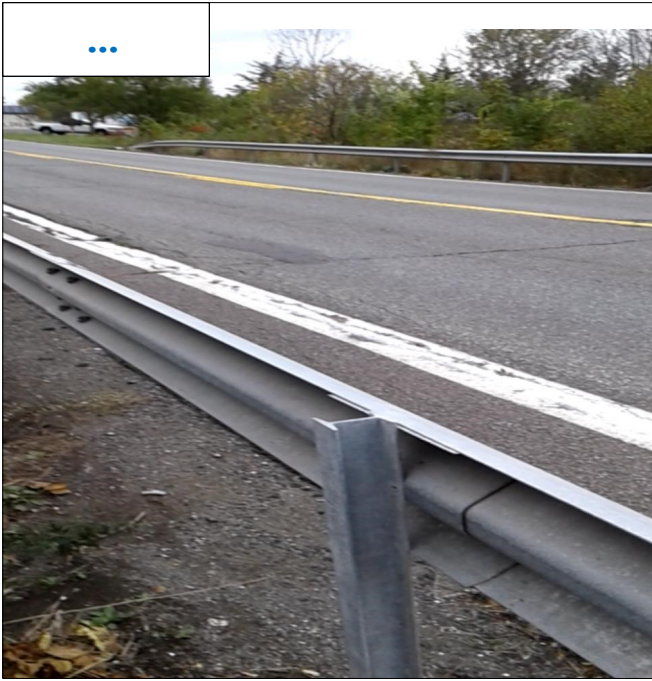
Material: Concrete
 Physical Barrier (s)/Severity: Debris/
 Sediment/Rock, Moderate

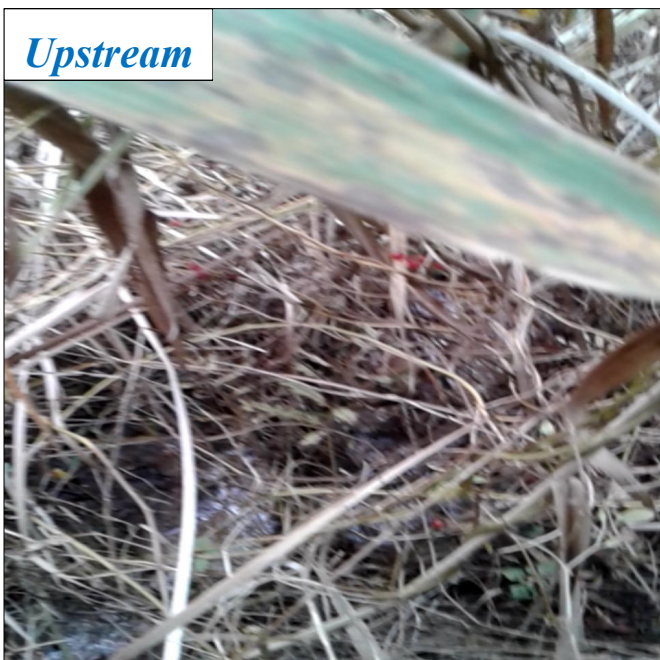
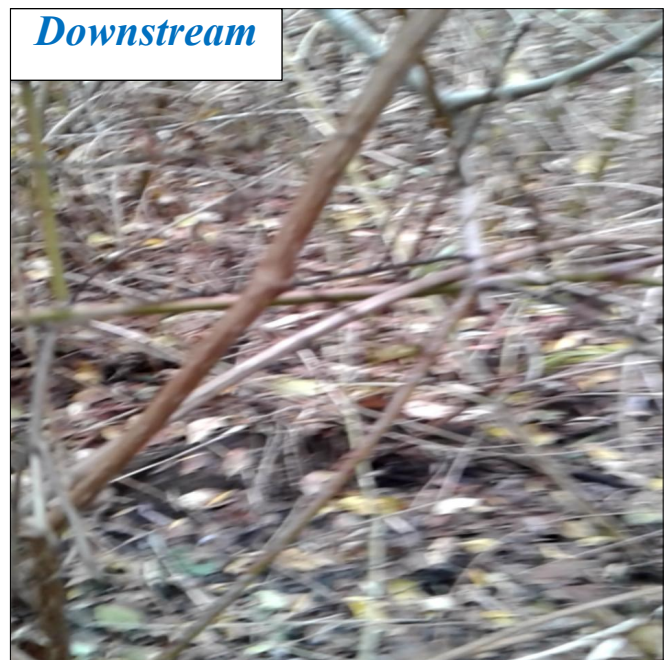
Scour Pool: None
Water Depth/Velocity Matches Stream:
No-Deeper/No-Slower
Substrate Matches Stream: Unknown
Substrate Type: Silt
Substrate Coverage: 100%

Crossing Comments: Filled with silt

Return Interval (Years)	Peak Flow (cfs)	Culvert Capacity (cfs)	Pass/Fail
2	2.0	2.8	PASS
5	3.3	2.8	FAIL
25	6.0	2.8	FAIL
50	7.2	2.8	FAIL
100	8.6	2.8	FAIL
200	10.4	2.8	FAIL

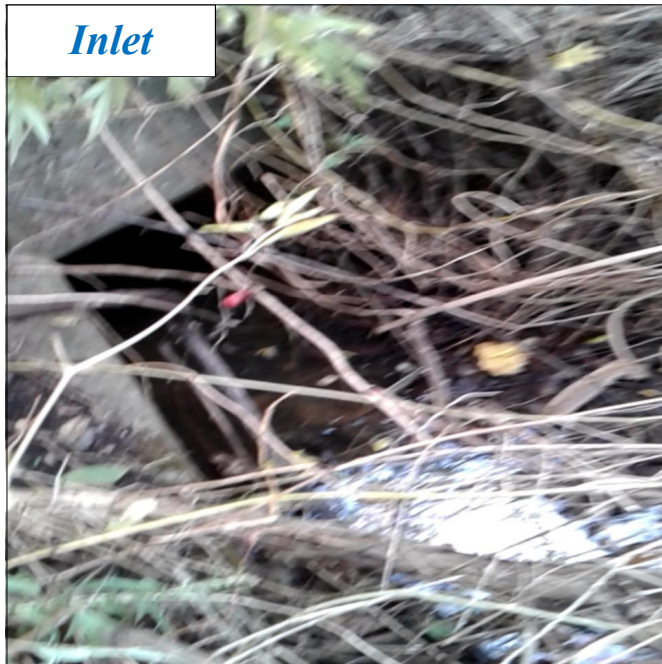
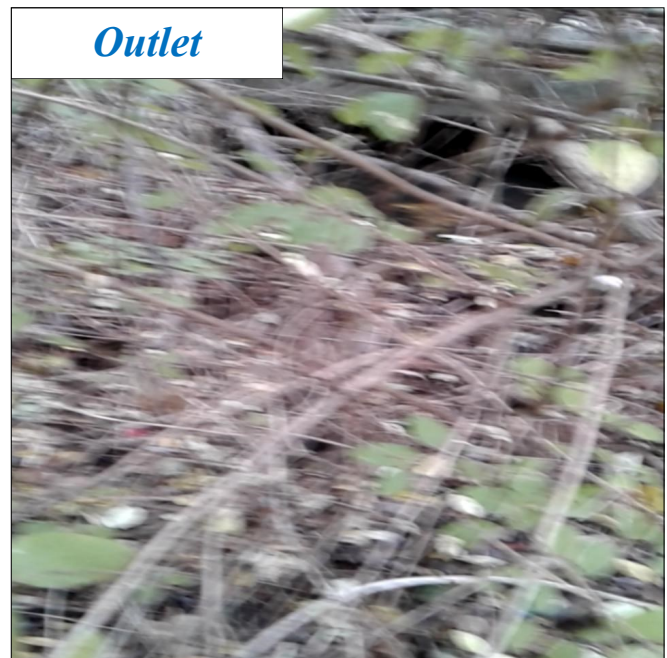
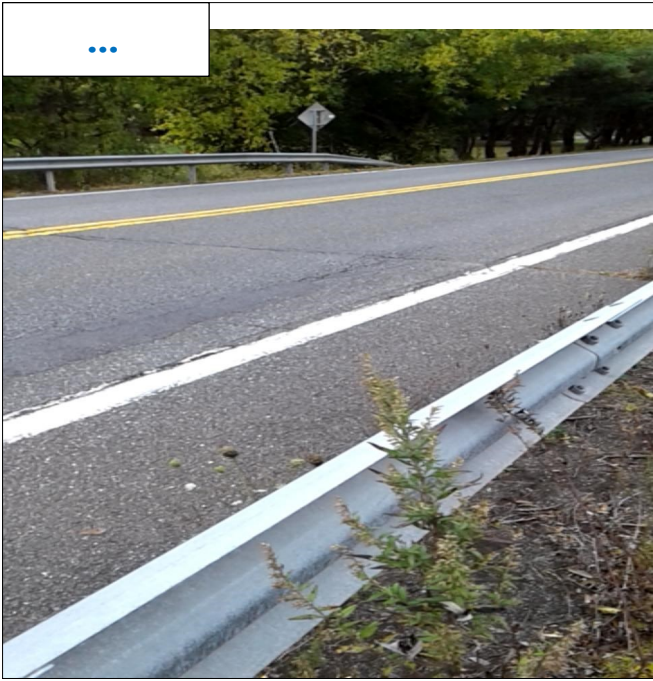
Material: Concrete
 Physical Barrier (s)/Severity: Debris/
 Sediment/Rock, Moderate

Slope Matches Stream (%): No data
 Structure Comments: Silted in
 Outlet Armoring: None

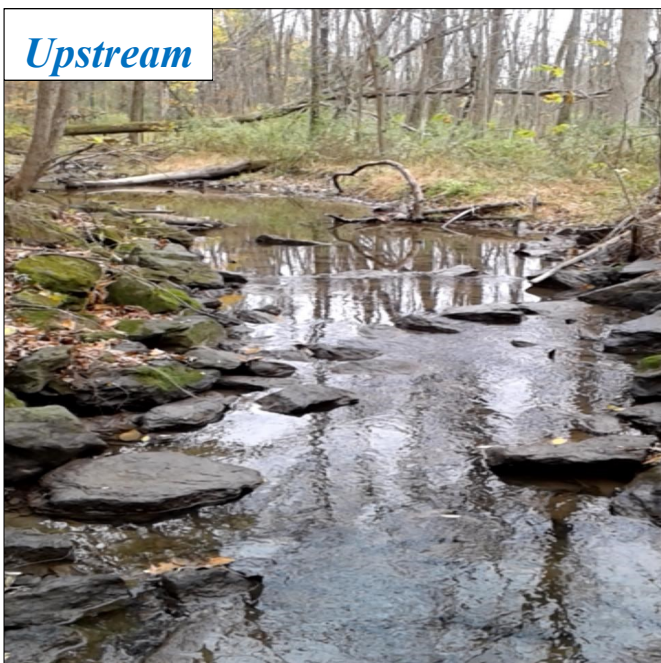
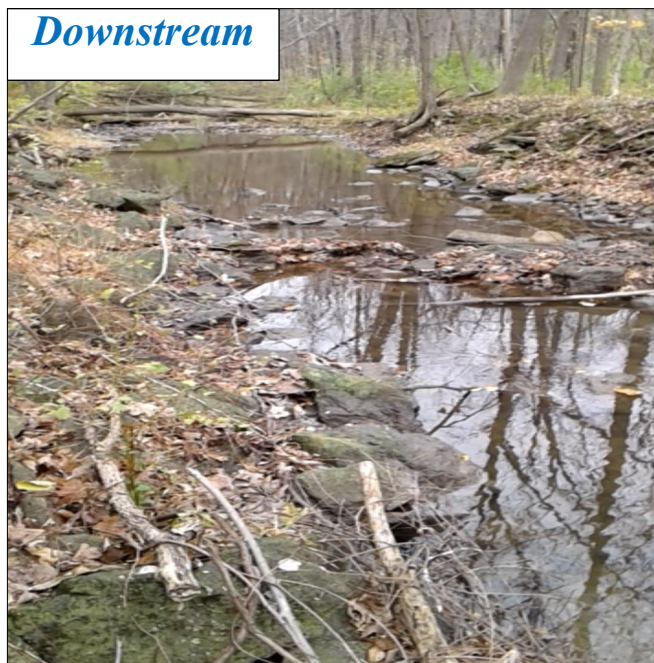
Scour Pool: None
Water Depth/Velocity Matches Stream:
No-Shallower/No-Faster
Substrate Matches Stream: Contrasting
Substrate Type: None
Substrate Coverage: None

Return Interval (Years)	Peak Flow (cfs)	Culvert Capacity (cfs)	Pass/Fail
2	13.8	18.7	PASS
5	27.8	18.7	FAIL
25	60.2	18.7	FAIL
50	75.1	18.7	FAIL
100	91.6	18.7	FAIL
200	112.4	18.7	FAIL

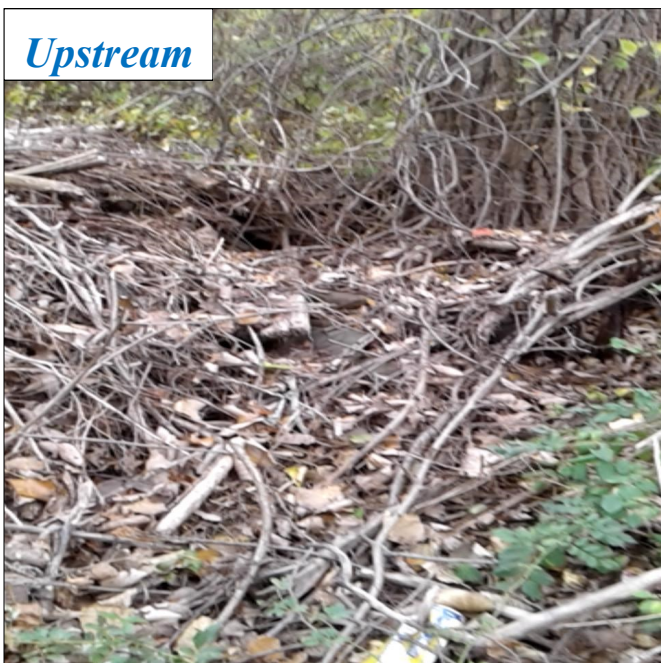
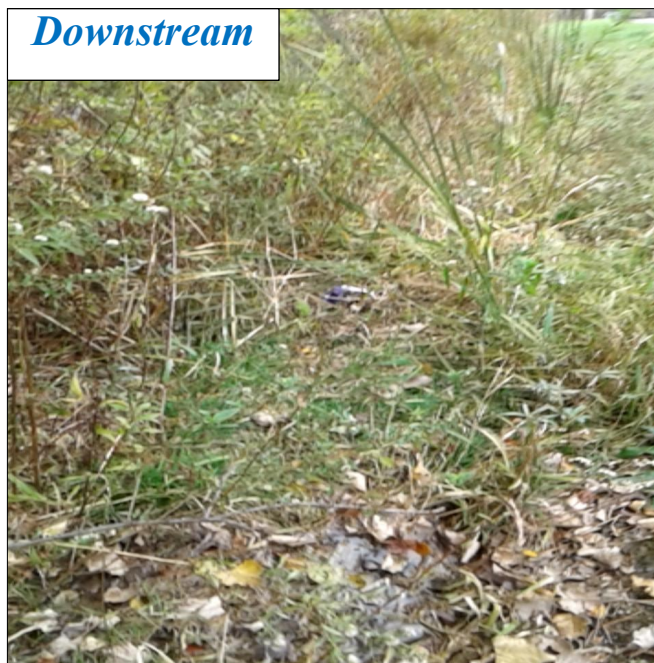
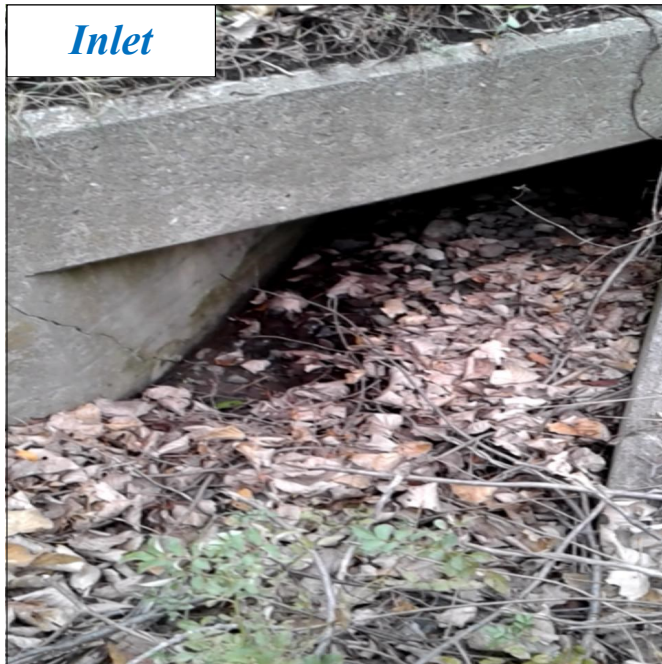
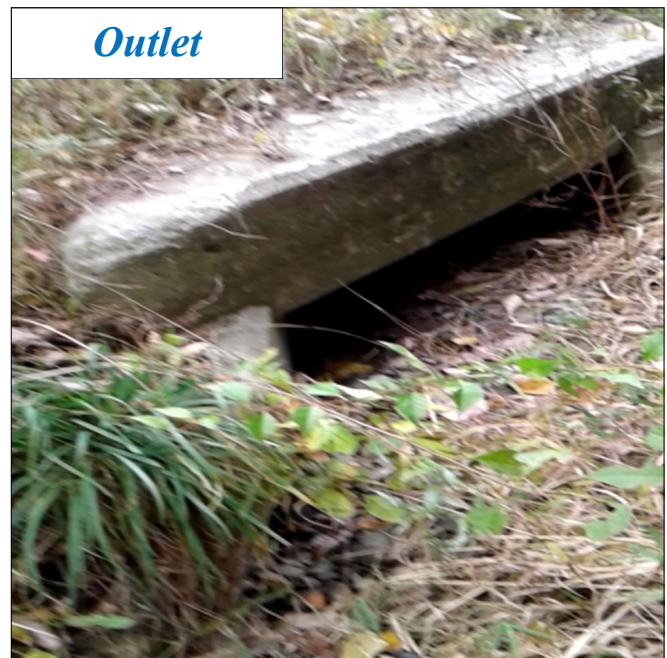
Crossing Comments: No flow

Material: Concrete
 Physical Barrier (s)/Severity: None, None
 Internal Features/Structures: None

Outlet Shape:
 Outlet Drop/Grade: Clogged/Collapsed/
 Submerged
 Drop to Stream Surface/Bottom: 0.00/0.00
 Width: 5.0, Height: 1.0
 Substrate/Water Width: 5.00
 Water Depth: 0.00

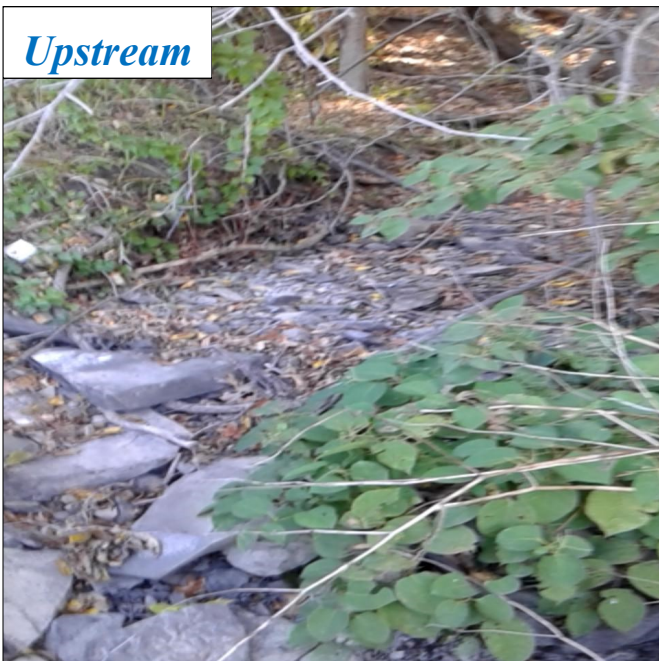
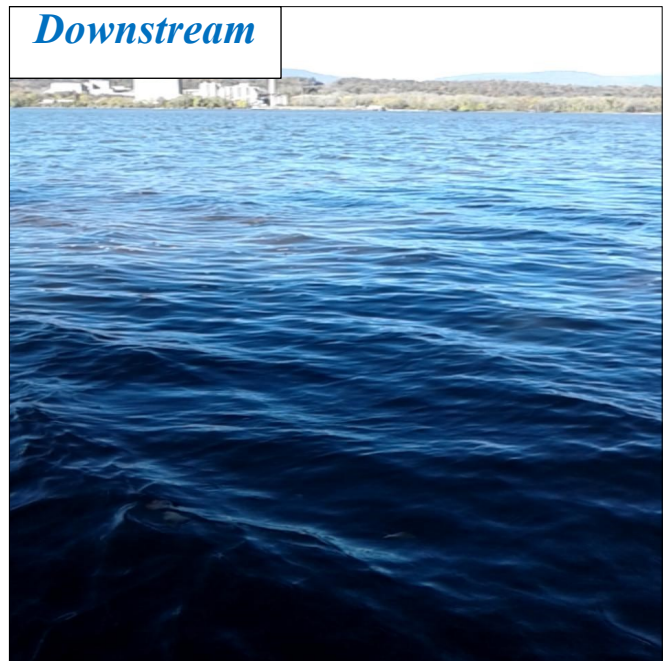
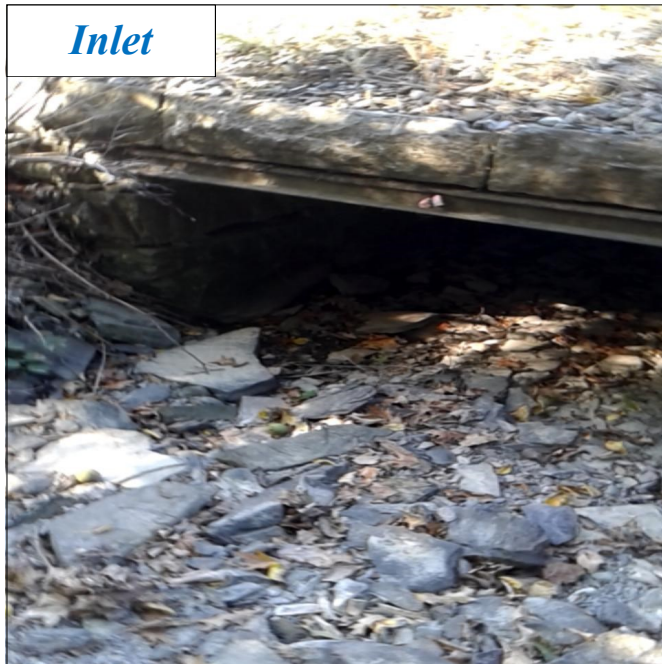
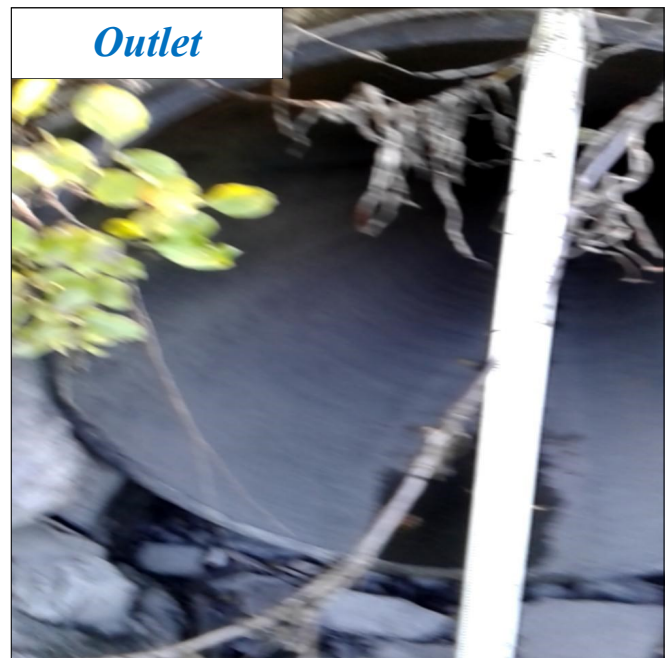
Coordinates: 42.13820, -73.89590
Location Description: Rail rd
Date Observed: 10/20/2017
Survey ID: 55467

Barrier Evaluation: Severe barrier
Aquatic Organism Passage Score: Reduced
AOP
Condition/Maintenance: OK
Max Return Interval: 1

Material: Combination
 Physical Barrier (s)/Severity: Debris/
 Sediment/Rock; Free Fall, Moderate

Slope Matches Stream (%): No data
 Structure Comments: Dry passage at low
 tide

Outlet Shape:
 Outlet Drop/Grade: Free Fall
 Drop to Stream Surface/Bottom: 0.80/2.50
 Width: 4.0, Height: 4.0
 Substrate/Water Width: 0.00
 Water Depth: 0.00

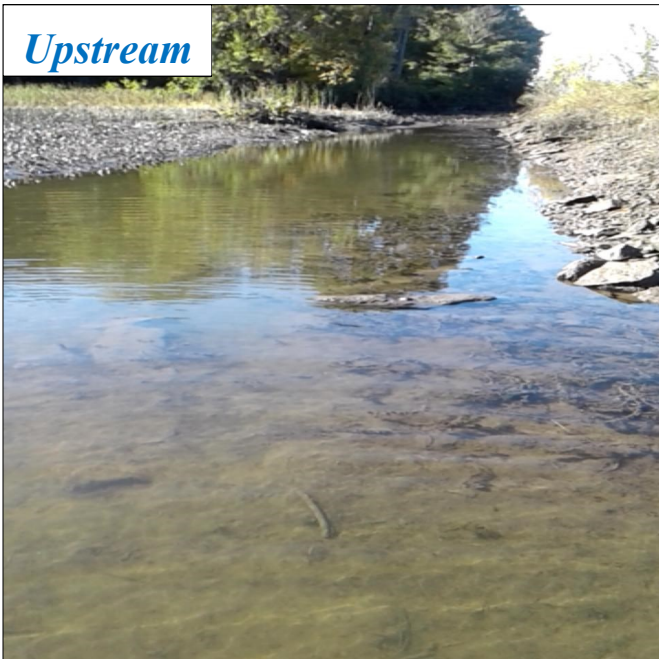
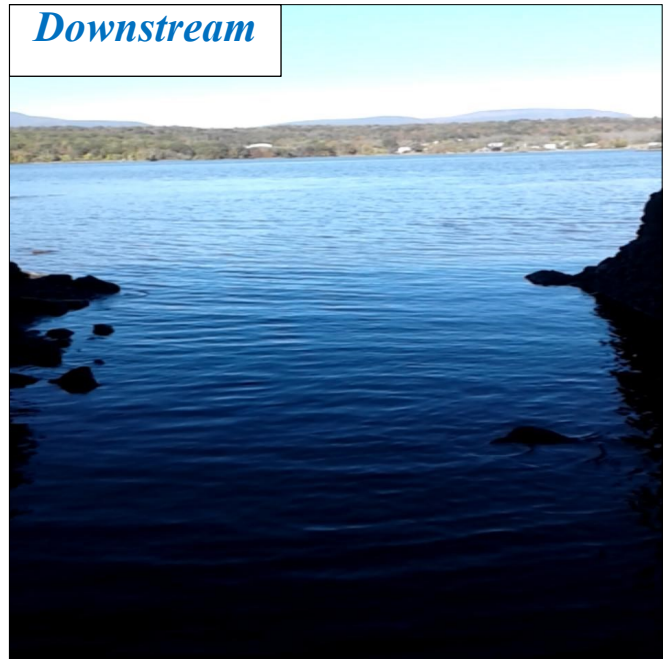
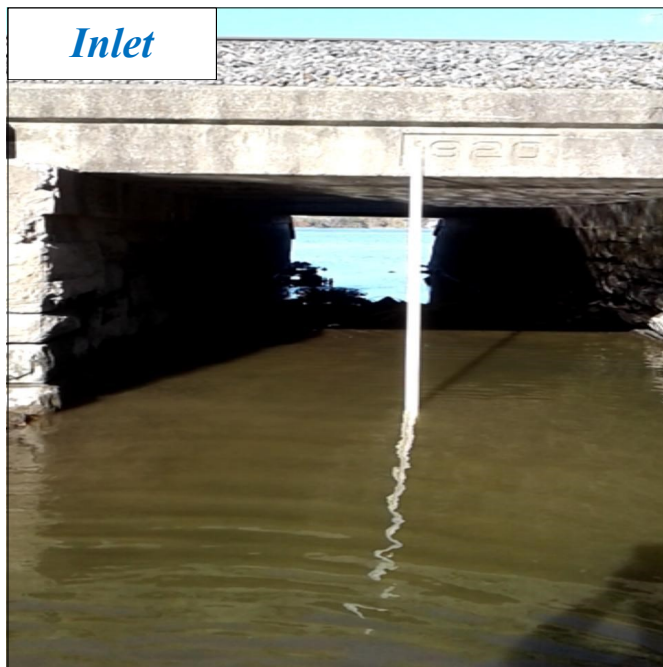
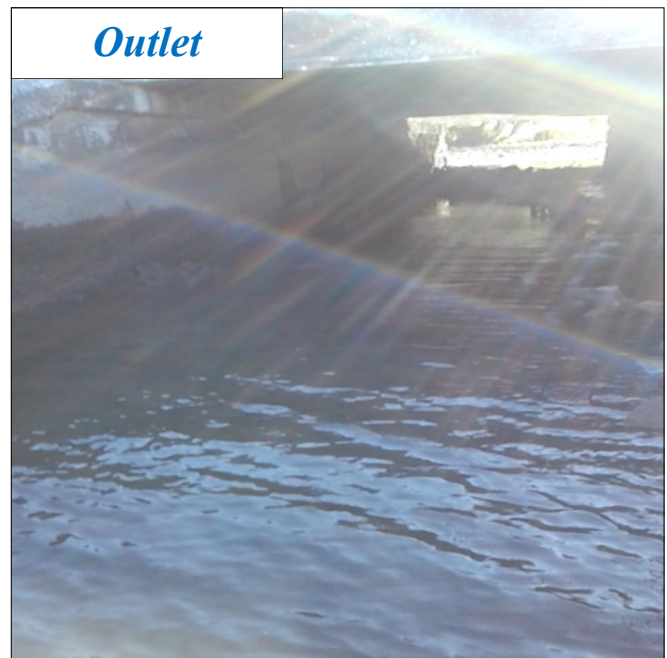
Coordinates: 42.12478, -73.90526
Location Description: 100 yrds south Cheviot landing
Date Observed: 10/20/2017
Survey ID: 55473

Crossing Comments: Measured at low tide

Material: Concrete
 Physical Barrier (s)/Severity: Debris/
 Sediment/Rock; Free Fall, Moderate

Slope Matches Stream (%): No data
 Structure Comments: Debris in crossing
 creates free fall

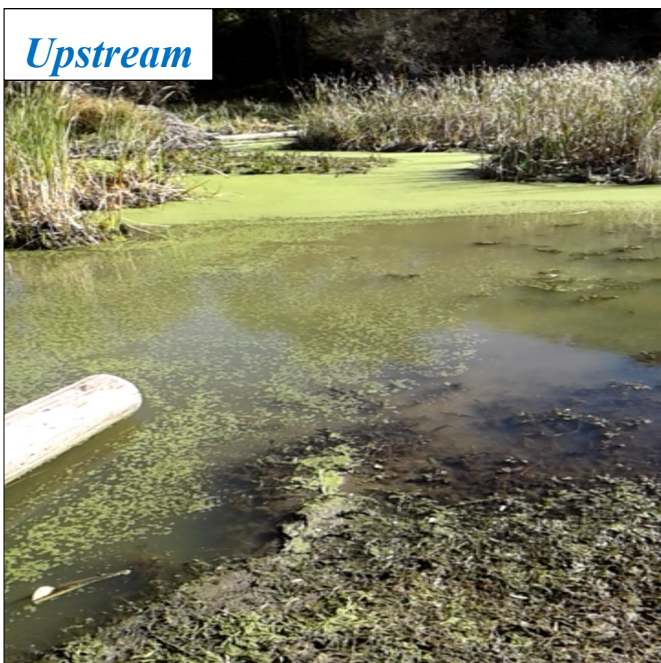
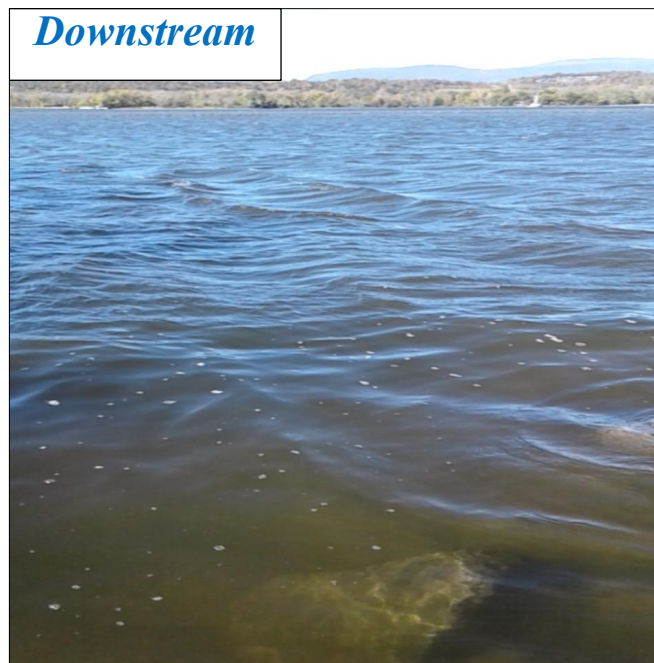
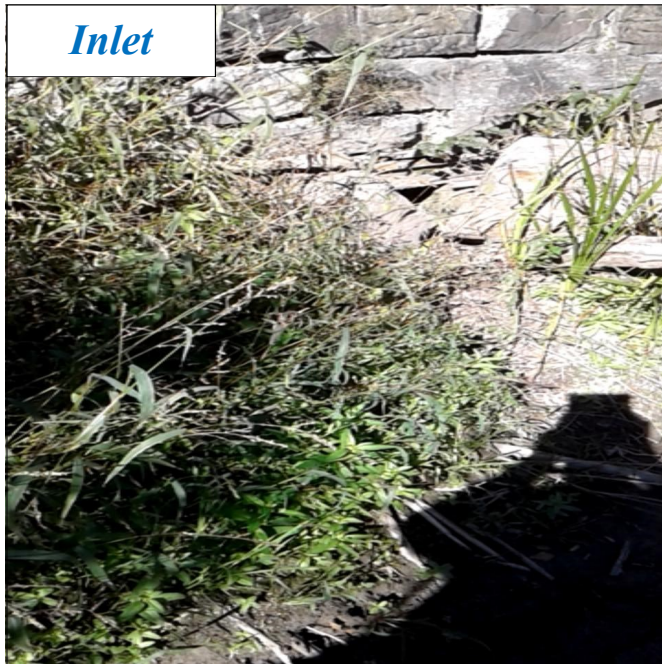
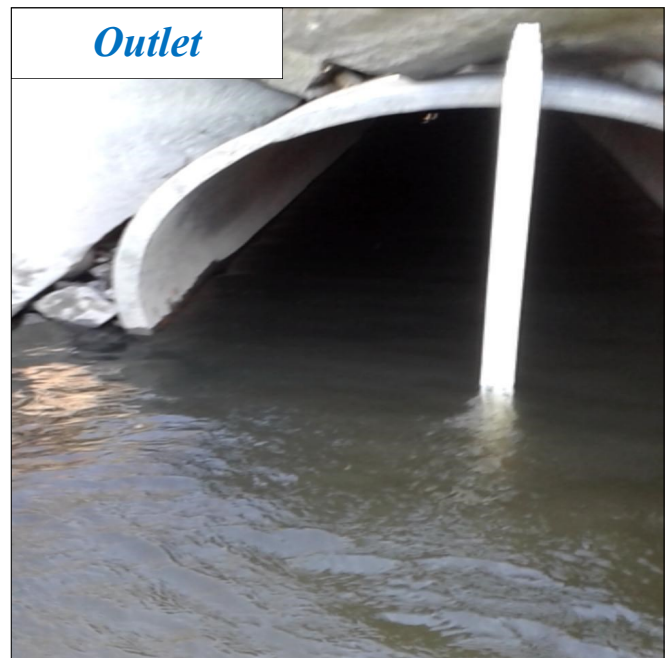
Coordinates: 42.14282, -73.89425
Location Description: Rail rd
Date Observed: 10/20/2017
Survey ID: 55475

Barrier Evaluation: Moderate barrier
Aquatic Organism Passage Score: No AOP
Condition/Maintenance: Poor
Max Return Interval: 0

Crossing Comments: Totally clogged

Material: Combination
 Physical Barrier (s)/Severity: Debris/
 Sediment/Rock; Free Fall, Severe

Slope Matches Stream (%): No data
 Structure Comments: Inlet totally clogged
 Outlet Armoring: Extensive

Inlet Shape/Type: Box/Bridge with Abutments, Headwall
 Inlet Drop/Grade: Clogged/Collapsed/
 Submerged
 Width: 5.0, Height: 0.5
 Substrate/Water Width: 5.00

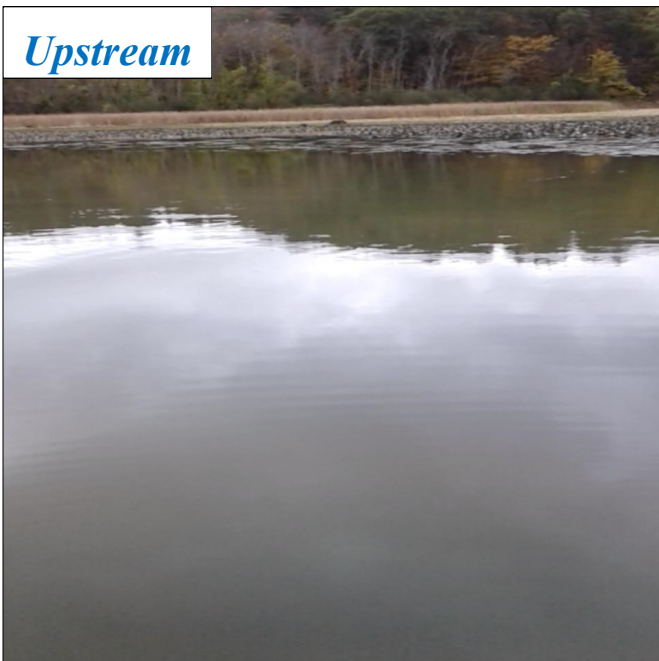
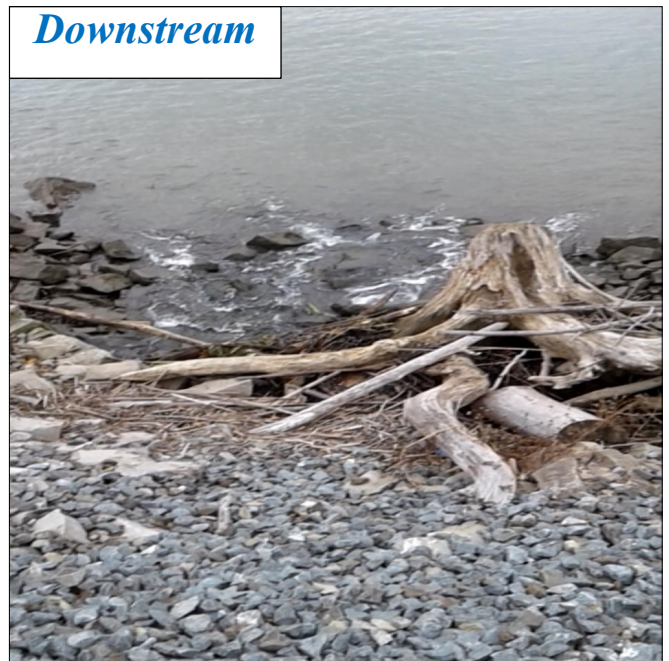
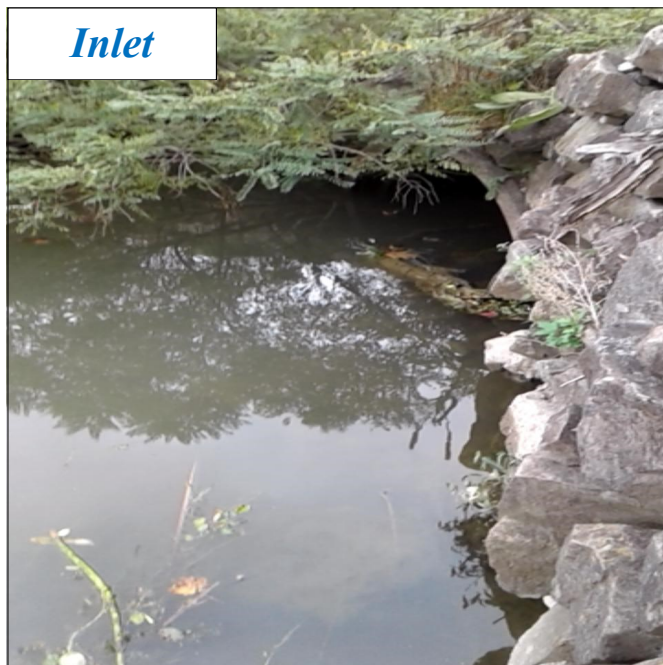
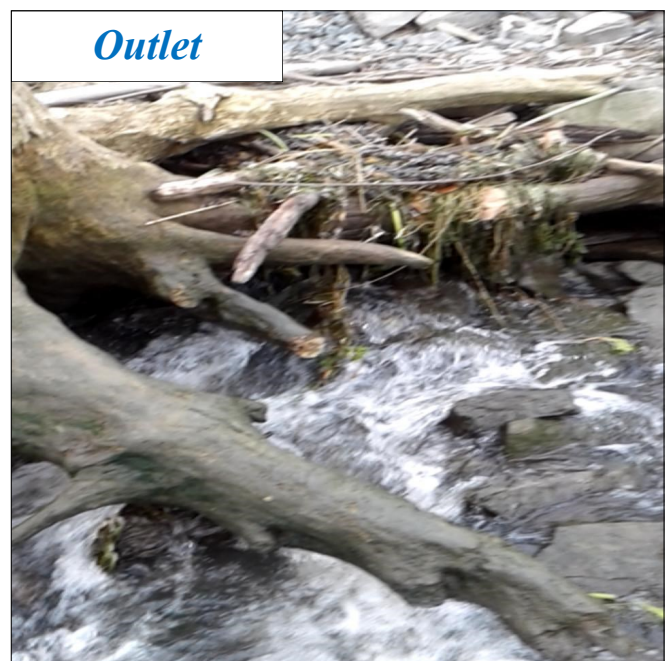
Coordinates: 42.17355, -73.86663
Location Description: Rail rd
Date Observed: 10/23/2017
Survey ID: 55648

Barrier Evaluation: no score - missing data
Aquatic Organism Passage Score: No AOP
Condition/Maintenance: Poor
Max Return Interval: 5

Crossing Comments: Outlet clogged collapsed

Material: Concrete
 Physical Barrier (s)/Severity: Debris/
 Sediment/Rock; Deformation, Severe

Slope Matches Stream (%): No data
 Structure Comments: Outlet collapsed
 Outlet Armoring: Not Extensive

Outlet Shape:
 Outlet Drop/Grade: Clogged/Collapsed/
 Submerged
 Drop to Stream Surface/Bottom: 1.50/3.00
 Width: 1.5, Height: 1.0
 Substrate/Water Width: 1.50
 Water Depth: No data

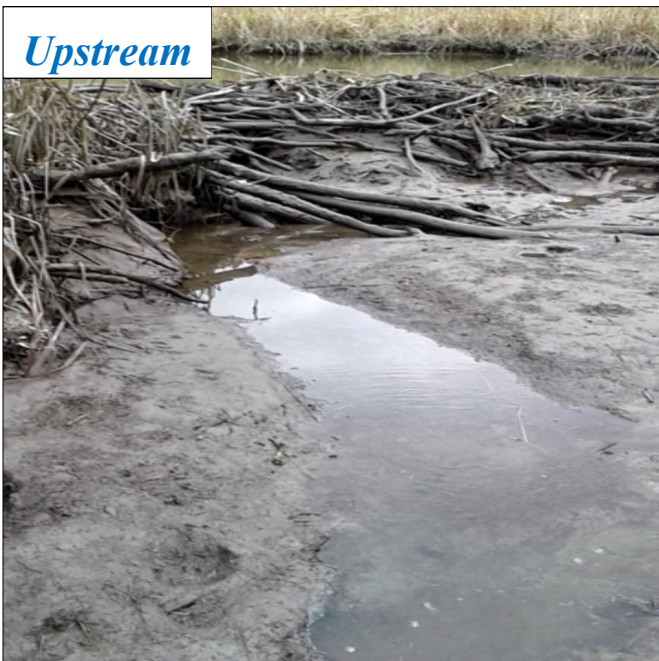
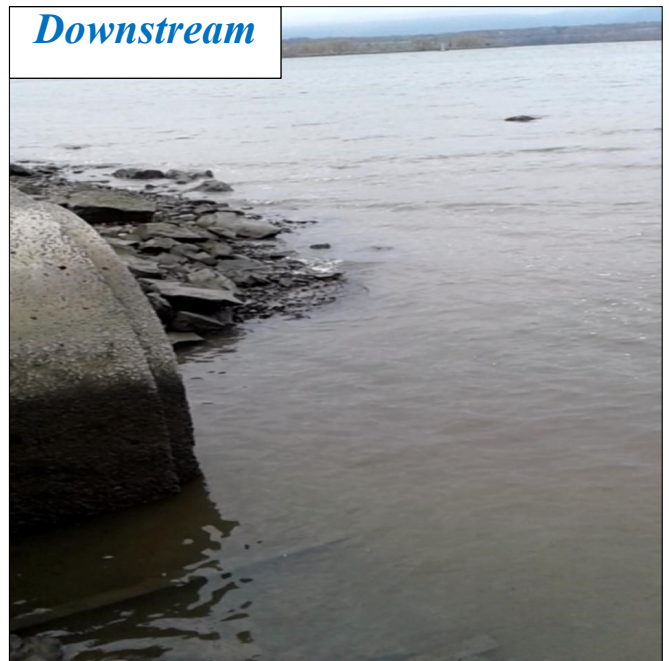
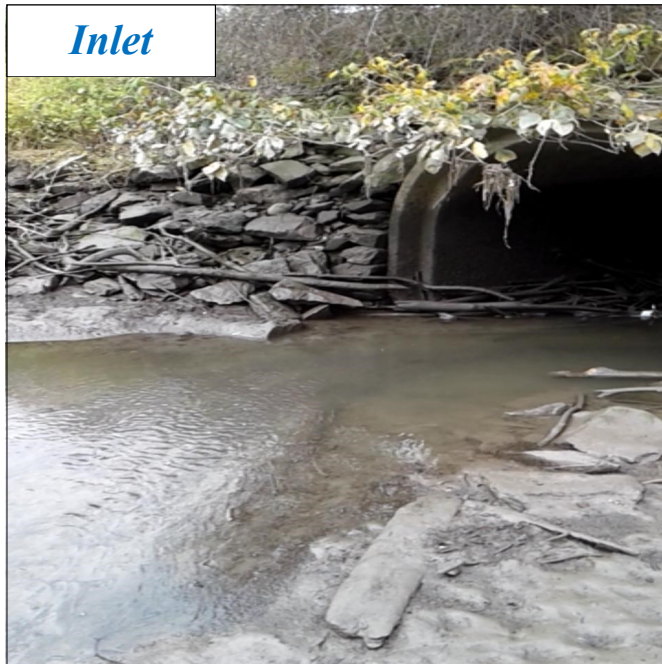
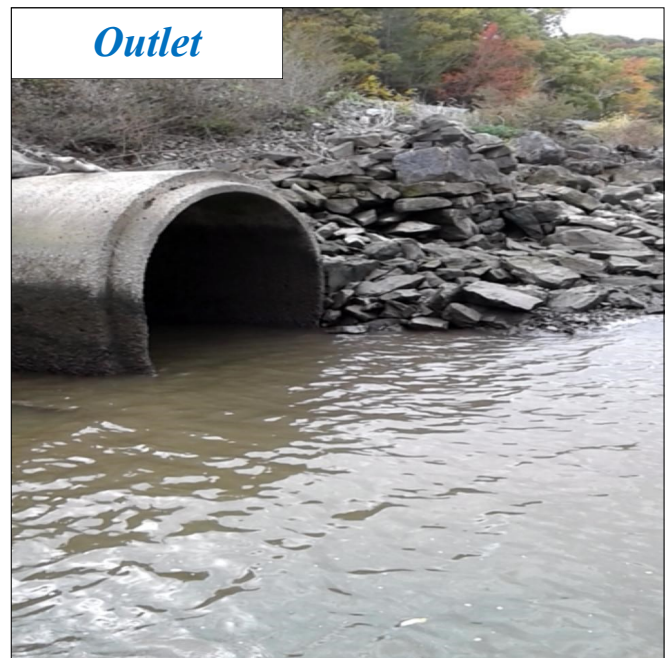
Coordinates: 42.17100, -73.87077
Location Description: Rail rd
Date Observed: 10/23/2017
Survey ID: 55651

Crossing Comments: Beaver dam directly upstream

Material: Concrete
 Physical Barrier (s)/Severity: Debris/
 Sediment/Rock, Minor

Slope Matches Stream (%): No data
 Structure Comments: Beaver sticks in culvert
