Town of Germantown

Road-Stream Crossing Inventory & Management Plan

Town of Germantown Road-Stream Crossing Inventory

Executive Summary – December 2023

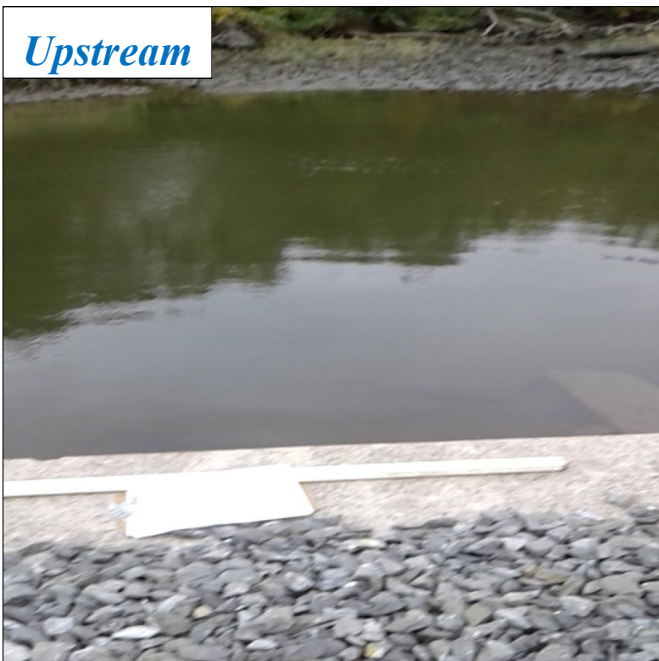
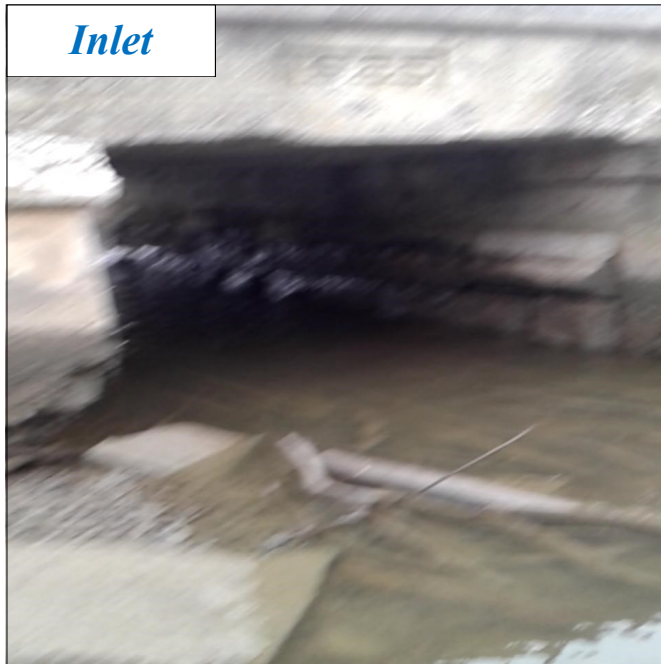
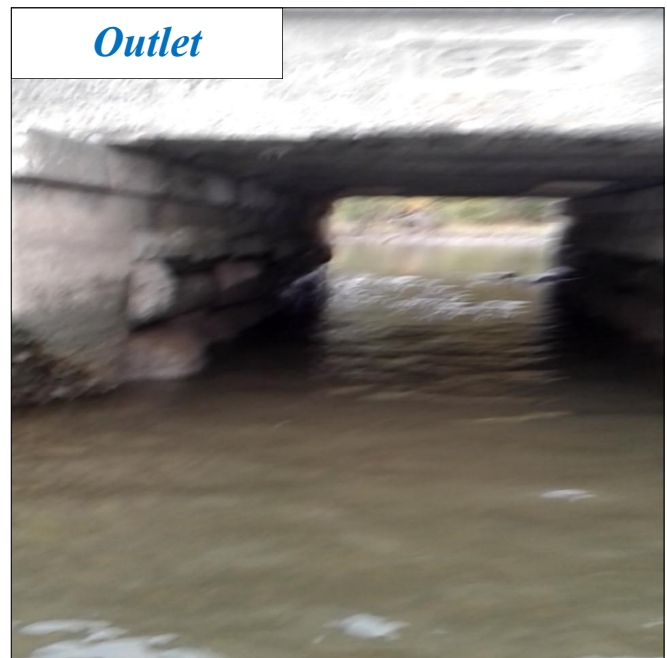
Coordinates: 42.16069, -73.88365
Location Description: Germantown bay
Date Observed: 10/23/2017
Survey ID: 55655

Barrier Evaluation: Insignificant barrier
Aquatic Organism Passage Score: Reduced
AOP
Condition/Maintenance: Poor
Max Return Interval: No data

Crossing Comments: Crossing drains tidal bay

Material: Concrete
 Physical Barrier (s)/Severity: Debris/
 Sediment/Rock, Minor

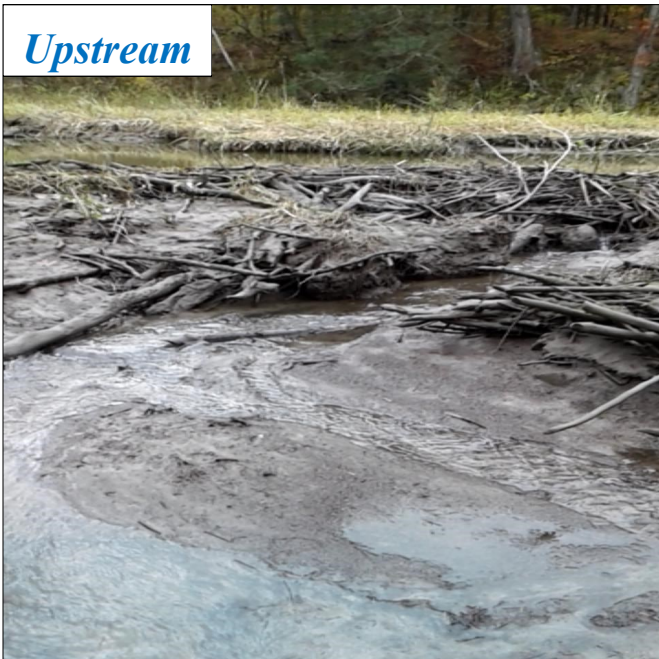
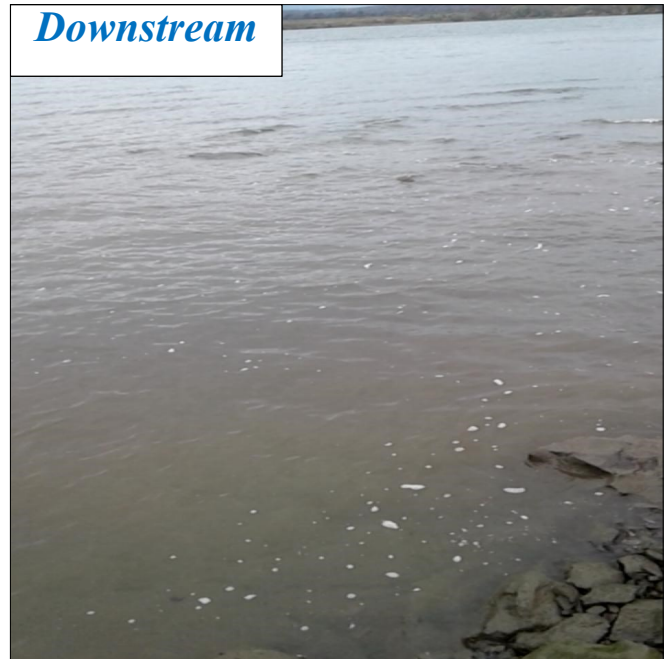
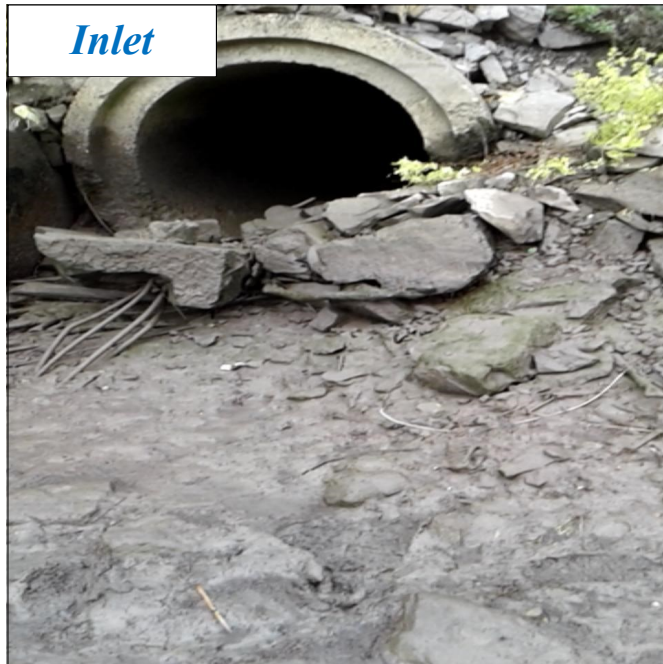
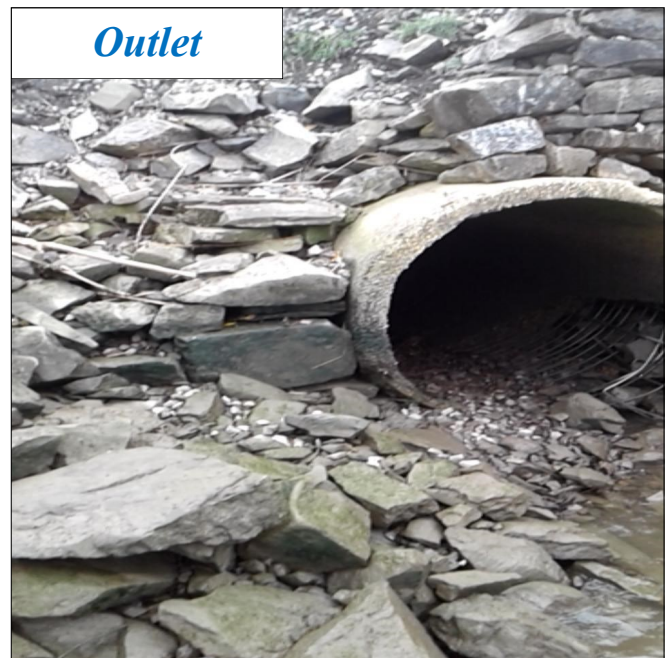
Coordinates: 42.17103, -73.87082
Location Description: Rail rd
Date Observed: 10/23/2017
Survey ID: 55657

Barrier Evaluation: Severe barrier
Aquatic Organism Passage Score: Reduced
AOP
Condition/Maintenance: Poor
Max Return Interval: No data

Crossing Comments: No flow at low tide

Material: Concrete
 Physical Barrier (s)/Severity: Debris/
 Sediment/Rock, Moderate

Inlet Shape/Type: Round Culvert, None
 Inlet Drop/Grade: Perched
 Width: 4.0, Height: 4.0
 Substrate/Water Width: 0.00
 Water Depth: 0.00

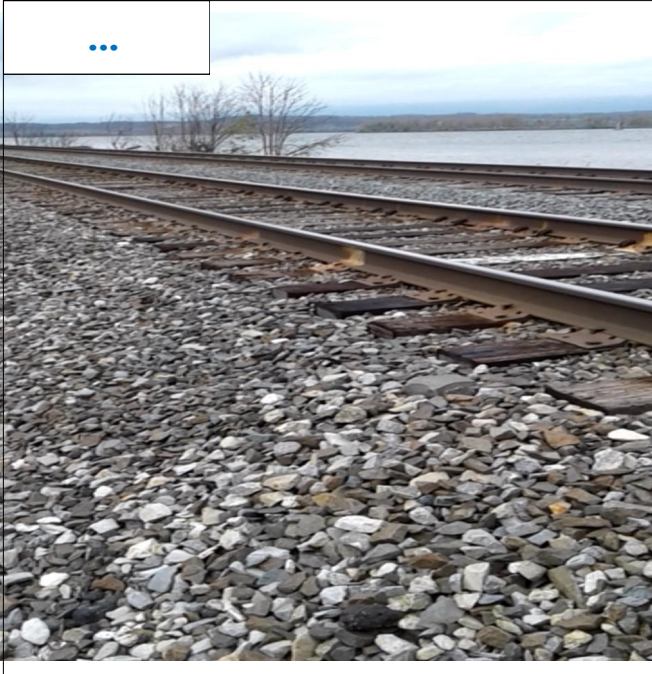
ADDITIONAL PHOTOS

Outlet Shape:
 Outlet Drop/Grade: Free Fall
 Drop to Stream Surface/Bottom: 0.50/1.20
 Width: 4.0, Height: 4.0
 Substrate/Water Width: 0.00
 Water Depth: 0.00
